Grounding Caption

Medical Report

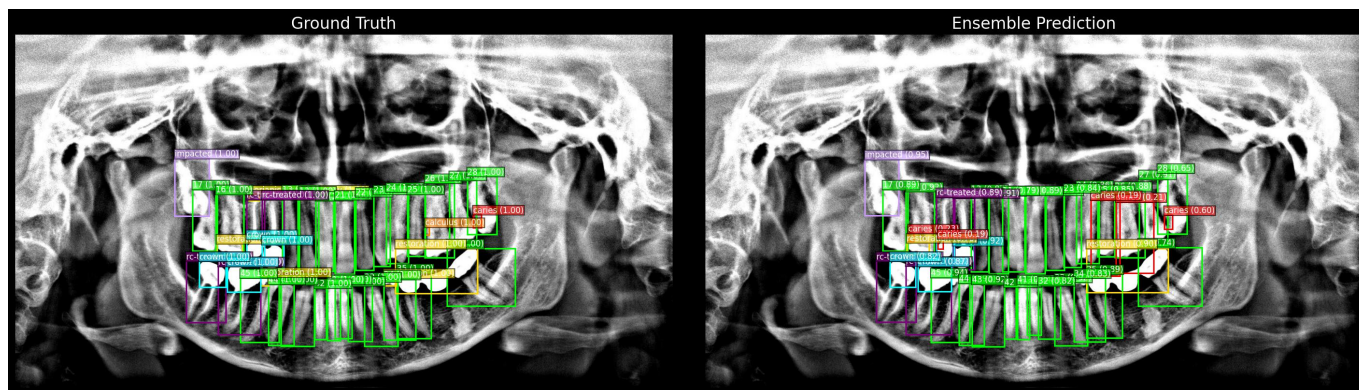
Teeth visibility with center points (total: 24):

```
[
{'point_2d': [648, 727], 'tooth_id': '45', 'score': 0.94},
{'point_2d': [704, 738], 'tooth_id': '44', 'score': 0.93},
{'point_2d': [568, 497], 'tooth_id': '16', 'score': 0.92},
{'point_2d': [748, 741], 'tooth_id': '43', 'score': 0.92},
{'point_2d': [968, 737], 'tooth_id': '33', 'score': 0.92},
{'point_2d': [1185, 468], 'tooth_id': '27', 'score': 0.91},
{'point_2d': [925, 522], 'tooth_id': '22', 'score': 0.91},
{'point_2d': [502, 489], 'tooth_id': '17', 'score': 0.89},
{'point_2d': [870, 727], 'tooth_id': '31', 'score': 0.89},
{'point_2d': [1056, 717], 'tooth_id': '35', 'score': 0.89},
{'point_2d': [873, 527], 'tooth_id': '21', 'score': 0.89},
{'point_2d': [776, 527], 'tooth_id': '12', 'score': 0.88},
{'point_2d': [1123, 500], 'tooth_id': '26', 'score': 0.88},
{'point_2d': [725, 522], 'tooth_id': '13', 'score': 0.87},
{'point_2d': [1012, 507], 'tooth_id': '24', 'score': 0.86},
{'point_2d': [1060, 504], 'tooth_id': '25', 'score': 0.85},

{'point_2d': [806, 735], 'tooth_id': '42', 'score': 0.84},
{'point_2d': [972, 516], 'tooth_id': '23', 'score': 0.84},
{'point_2d': [841, 732], 'tooth_id': '41', 'score': 0.84},
{'point_2d': [1016, 727], 'tooth_id': '34', 'score': 0.83},
{'point_2d': [910, 733], 'tooth_id': '32', 'score': 0.82},
{'point_2d': [815, 525], 'tooth_id': '11', 'score': 0.79},
{'point_2d': [1229, 639], 'tooth_id': '37', 'score': 0.74},
{'point_2d': [1235, 446], 'tooth_id': '28', 'score': 0.65}
]
```

Wisdom teeth detection (total: 1):

```
[
{'box_2d': [1196, 365, 1274, 527], 'tooth_id': '28', 'is_impacted': false, 'score': 0.65}
]
```

Dental Pathological Findings (total: 6):

```
[
{'box_2d': [1086, 441, 1186, 630], 'tooth_id': '26', 'label': 'caries', 'score': 0.21},
{'box_2d': [1020, 436, 1097, 637], 'tooth_id': '25', 'label': 'caries', 'score': 0.19},
{'box_2d': [421, 329, 511, 477], 'tooth_id': 'unknown', 'label': 'impacted', 'score': 0.95, 'near_tooth': '17'},
{'box_2d': [1214, 476, 1235, 514], 'tooth_id': 'unknown', 'label': 'caries', 'score': 0.6, 'near_tooth': '27'},
{'box_2d': [536, 524, 550, 545], 'tooth_id': 'unknown', 'label': 'caries', 'score': 0.23, 'near_tooth': '16'},
{'box_2d': [614, 539, 629, 566], 'tooth_id': 'unknown', 'label': 'caries', 'score': 0.19, 'near_tooth': '16'}
]
```

Historical Treatments (total: 10):

```
[
{'box_2d': [530, 610, 650, 792], 'tooth_id': 'unknown', 'label': 'rc-treated', 'score': 0.92, 'near_tooth': '45'},
{'box_2d': [655, 556, 711, 620], 'tooth_id': 'unknown', 'label': 'crown', 'score': 0.92, 'near_tooth': '13'},
{'box_2d': [655, 431, 711, 620], 'tooth_id': 'unknown', 'label': 'rc-treated', 'score': 0.91, 'near_tooth': '13'},
{'box_2d': [453, 598, 557, 759], 'tooth_id': 'unknown', 'label': 'rc-treated', 'score': 0.91, 'near_tooth': '45'},
{'box_2d': [1008, 564, 1224, 680], 'tooth_id': 'unknown', 'label': 'restoration', 'score': 0.9, 'near_tooth': '35'},
{'box_2d': [611, 428, 659, 588], 'tooth_id': 'unknown', 'label': 'rc-treated', 'score': 0.89, 'near_tooth': '16'},
{'box_2d': [562, 611, 650, 679], 'tooth_id': 'unknown', 'label': 'crown', 'score': 0.87, 'near_tooth': '45'},

```
{'box_2d': [488, 598, 556, 666], 'tooth_id': 'unknown', 'label': 'crown', 'score': 0.82, 'near_tooth': '16'},  
{'box_2d': [612, 542, 658, 588], 'tooth_id': 'unknown', 'label': 'crown', 'score': 0.81, 'near_tooth': '16'},  
{'box_2d': [532, 549, 591, 579], 'tooth_id': 'unknown', 'label': 'restoration', 'score': 0.7, 'near_tooth': '16'}  
]
```

A total of 24 teeth were visualized within the panoramic field. The right lower third molar (#28) is present and unimpacted. No evidence of missing teeth was identified.

- **#26 (left lower first molar):** Suspicious for caries with limited radiographic clarity.
- **#25 (left lower second premolar):** Areas of concern noted for potential caries.
- **Near #17 (left lower first molar):** Clear indication of impacted third molar (likely #18).
- **Near #27 (right lower first molar):** Suspicious for caries involving adjacent alveolar bone.
- **Near #16 (left upper first molar):** Two distinct areas suspicious for caries in the mesial and distal regions.

- **Near #45 (right upper first molar):** Root canal-treated tooth with associated crown.
 - **Near #13 (left upper lateral incisor):** Root canal-treated and crowned.
 - **Near #16 (left upper first molar):** Multiple restorations and a root canal-treated crown.
 - **Near #35 (right lower first molar):** Composite restoration.
-

1. Impacted left lower third molar (#18) near #17 requires evaluation for surgical removal.
2. Deep suspicious caries on #26 and #25 demand urgent dental assessment.
3. Adjacent caries near #16 and #27 necessitate further diagnostic imaging to confirm extent.

- Reinforce oral hygiene protocols, emphasizing interdental cleaning for areas near #16 and #27.
- Monitor radiographic changes in low-confidence carious lesions (#26, #25) during follow-ups.
- Schedule professional scaling to address potential calculus in the posterior regions.

- **Urgent:** Refer to endodontist for #26 and #25 within 1 week for caries confirmation.
- **Surgical Consultation:** Orthodontic or surgical evaluation for impacted #18 within 2 weeks.
- **Recall:** 3-month interval for monitoring suspicious lesions; 6-month recall for stable restorations.
- **Referral Note:** Consult periodontist for calculus assessment near #16 and #27.
