Grounding Caption

Oral Panoramic Radiographic Examination Report

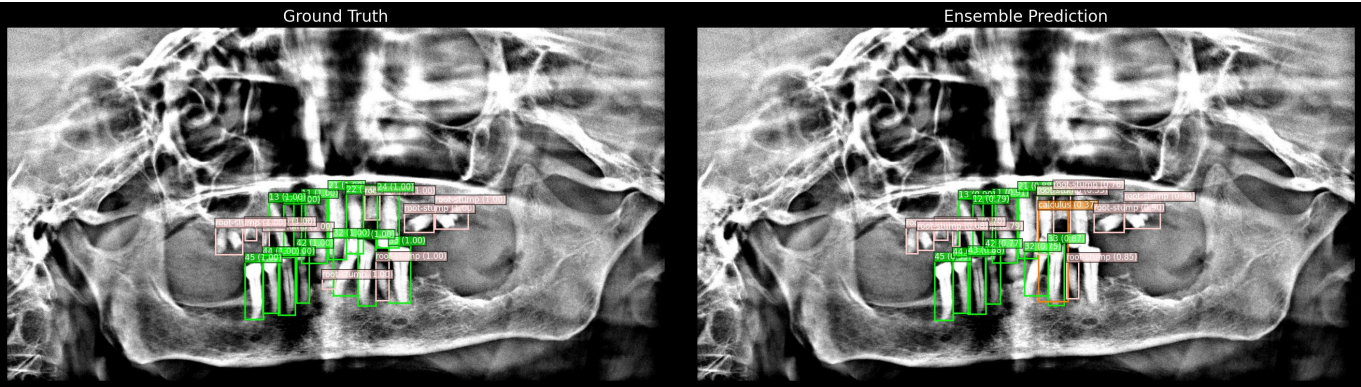
A total of 11 teeth were visualized within the field of view. No wisdom teeth (third molars) were identified in either arch. The remaining teeth demonstrate variable visibility based on proximity to anatomical landmarks and angulation.

- 1. **#33:** Suspicious for minimal subgingival calculus noted on the buccal surface.
- 2. **Near #22:** Definitive signs of residual root stumps in the distal region, consistent with prior endodontic or restorative intervention. Additional root stumps identified in the mesial aspect of #22.
- 3. **Near #13:** Areas of concern for residual root stumps in adjacent interproximal regions (buccal and lingual).
- 4. **Near #33:** Evidence of residual root stumps in the distal aspect.
- 5. **Near #45:** Suggestive of residual root fragments in the mesial region.

Notably, multiple root stumps are clustered around #22 and #13, indicating potential incomplete extraction or residual root fragments.

- 1. **Residual root stumps** (particularly near #22 and #13): Requires clinical correlation to assess for biofilm accumulation or periodontal compromise.
- 2. **Subgingival calculus on #33:** Indicates localized plaque retention and potential for subgingival biofilm formation.

- 1. Reinforce interdental cleaning techniques (e.g., flossing, interdental brushes) for #33 and adjacent regions.
- 2. Monitor for progression of residual root stumps near #22 and #13 to rule out apical pathology or periodontal involvement.

- 1. **Referral to periodontal specialist:** For evaluation of residual root stumps near #22 and #13 to determine need for surgical removal.
 - 2. **Recall in 3–6 months:** For re-evaluation of calculus on #33 and monitoring of residual root stumps.
 - 3. **Clinical examination:** Urgent assessment of #22 and #13 interproximal regions for signs of overhanging restorations or caries.
-
