Grounding Caption

Oral Panoramic Radiographic Examination Report

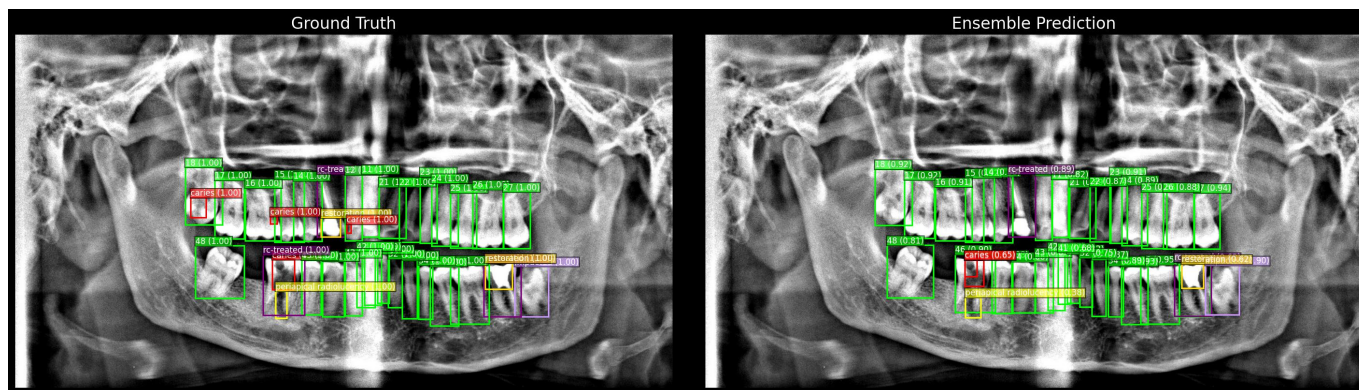
- **Total visualized teeth:** 28 teeth (FDI numbering system).
- **Wisdom teeth status:**
- #18 (mandibular left third molar) and #48 (maxillary left third molar) are fully erupted and unimpacted.
- **Overall dental alignment:** No significant malpositioning or crowding observed.

1. **Impacted tooth near #37 (mandibular right first molar):** Clear indication of an impacted tooth adjacent to #37.
2. **Caries suspicious in proximity to #46 (maxillary left first molar):** Two suspicious carious lesions detected near #46.
3. **Periapical radiolucency near #46:** Areas of concern noted for periapical radiolucency adjacent to #46, requiring further evaluation.

1. **Root canal-treated tooth #37:** Evidence of prior root canal therapy.
 2. **Restoration near #37:** A restoration is present adjacent to the root canal-treated tooth.
 3. **Root canal-treated tooth near #12 (maxillary right first premolar):** A rc-treated tooth detected in proximity to #12.
-

1. **Impacted tooth near #37:** Requires clinical correlation to assess for potential impaction-related complications (e.g., periodontal issues, caries).
2. **Caries suspicion near #46:** Confirmatory diagnosis and intervention necessary to prevent progression.
3. **Periapical radiolucency near #46:** Indicates possible apical pathology; endodontic evaluation is warranted.

- **Oral hygiene reinforcement:** Emphasize biofilm control around #37 and #46 to mitigate caries risk.
- **Calculus monitoring:** Although no calculus is explicitly noted, routine scaling is recommended to maintain periodontal health.

1. **6-month recall:** To monitor the impacted tooth near #37 and carious lesions near #46.
 2. **Referral to endodontist:** For #46 to assess the periapical radiolucency and confirm the need for treatment.
 3. **Review of historical interventions:** Confirm the integrity of restorations near #37 and evaluate the long-term success of root canal therapy in #37 and #12.
-
