Grounding Caption

Medical Report

Oral Panoramic Radiographic Report

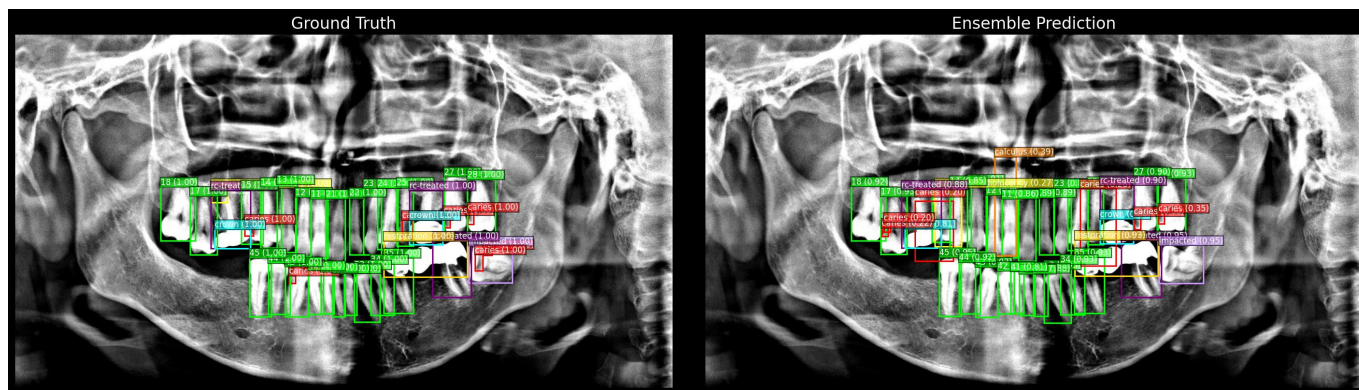
Teeth visibility with center points (total: 24):

Wisdom teeth detection (total: 2):

Dental Pathological Findings (total: 9):

- **Tooth Count:** 24 teeth visualized, including both maxillary and mandibular arches.
- **Wisdom Teeth:**
- #18 (left mandibular) and #28 (right maxillary) are present but **not impacted**.

1. **#15 (left first premolar):**
 - Suspicious for **periapical radiolucency**.
 - Suspicious for **caries** on the mesial surface.
2. **#11 (left lateral incisor):**
 - Evidence of **calculus deposition**.
3. **#25 (right first molar):**
 - Suspicious for **caries** in the distal aspect.
4. **Near #28 (right maxillary molar):**
 - Clear indication of an **impacted tooth** in the posterior region.
5. **Near #27 (right second molar):**
 - Suspected **caries** in the interproximal area.
6. **Near #17 (right first molar):**
 - Areas of concern for **caries** on both the mesial and distal aspects.

1. **Near #35 (left second molar):**
 - Presence of a **root canal-treated (rc-treated) tooth** with a **restoration**.
 2. **Near #25 (right first molar):**
 - **Crown** placement noted, with evidence of prior root canal treatment.
 3. **Near #15 (left first premolar):**
 - **Crown** placement and **root canal-treated tooth** documented.
-

1. **Impacted tooth near #28** requires clinical evaluation for extraction planning.
2. **Periapical radiolucency on #15** suggests possible endodontic pathology, necessitating further investigation.

3. **Multiple suspicious carious lesions** near #17, #25, and #27 demand early intervention.

- Reinforce **oral hygiene protocols** to manage calculus deposition on #11.
- Monitor **suspected caries** near #17 and #27 with frequent recalls.
- Advise **fluoride application** for high-risk caries areas.

- **Referral to endodontist** for assessment of #15 and #28.
 - **6-month recall** for monitoring carious lesions and impacted tooth status.
 - **Dental hygiene session** to address calculus and biofilm control.
-
