# Medical Report

## Oral Panoramic Radiographic Examination Report

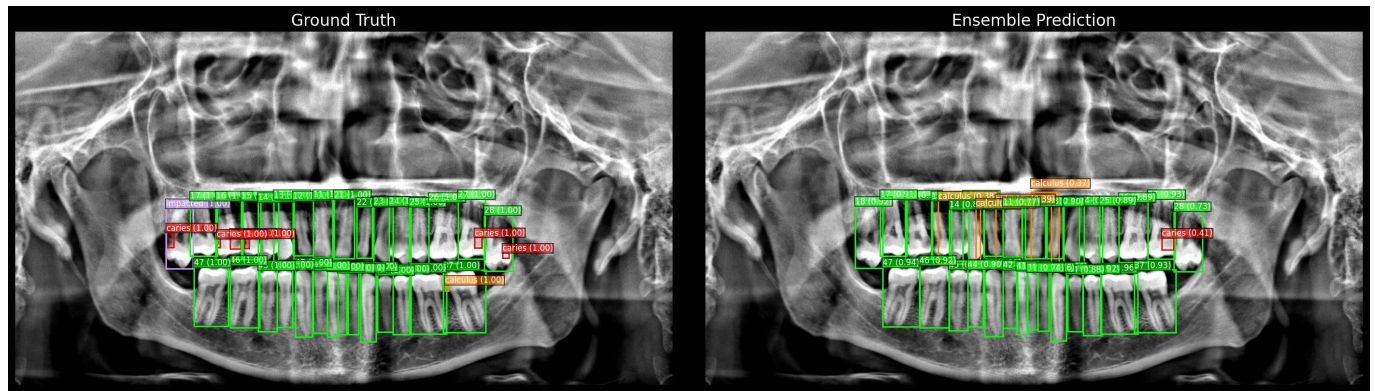
```
[
{'box_2d': [616, 446, 727, 613], 'tooth_id': '13', 'label': 'calculus', 'score': 0.38},
{'box_2d': [768, 453, 915, 606], 'tooth_id': '21', 'label': 'calculus', 'score': 0.39},
{'box_2d': [861, 424, 935, 616], 'tooth_id': '21', 'label': 'calculus', 'score': 0.37},
{'box_2d': [716, 464, 837, 607], 'tooth_id': '12', 'label': 'calculus', 'score': 0.45},
{'box_2d': [1208, 544, 1238, 576], 'tooth_id': 'unknown', 'label': 'caries', 'score': 0.41, 'near_tooth': '27'}
]
```

A total of 30 teeth are visualized. Wisdom teeth (#18 and #28) are present and **not impacted**. No evidence of dental implants, crowns, or root canal treatments is observed.

- **Calculus deposits:**
- **Suspicious for calculus** noted on #12, #13, and #21 (areas of concern for mineralized biofilm).
- **Suspicious for caries:** A small radiolucent lesion is observed **near tooth #27** (interproximal region).

1. **Caries suspicion near #27:** Immediate evaluation required to confirm carious involvement and prevent progression.
2. **Calculus deposits on #12, #13, #21:** Indicates localized plaque accumulation necessitating professional scaling.

- Reinforce oral hygiene practices, emphasizing interdental cleaning (flossing or interdental brushes) for affected quadrants.
- Monitor calculus-prone areas during routine hygiene visits.

- Schedule a **6-month recall** for professional scaling and reevaluation of calculus deposits.
  - Reassess the suspicious carious lesion near #27 with targeted radiographs or visual examination.
  - Consider referral to a periodontist for calculus management if biofilm control remains suboptimal.
-
