Grounding Caption

This localization caption provides multi-dimensional spatial analysis of anatomical structures and pathological findings for this panoramic dental X-ray image, including:

Medical Report

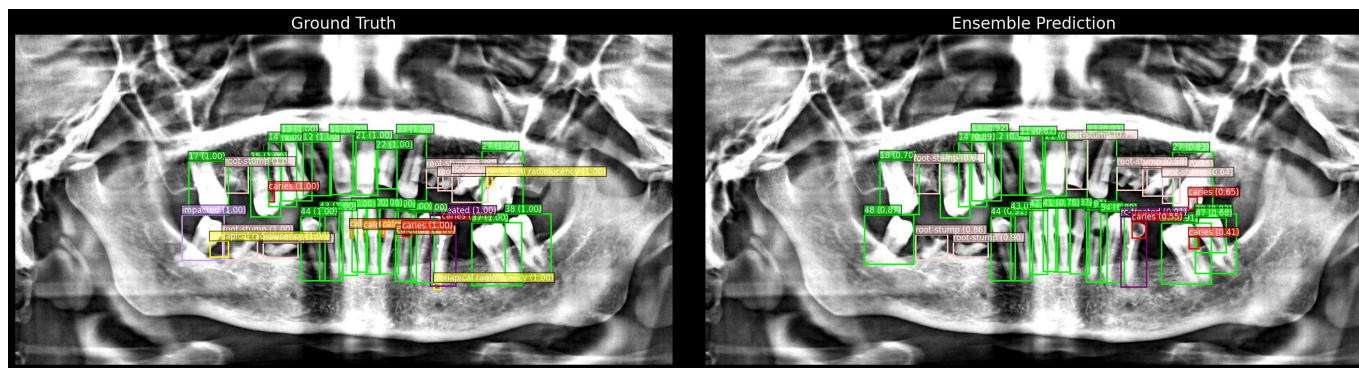
Teeth visibility with center points (total: 21):

Wisdom teeth detection (total: 3):

Dental Pathological Findings (total: 10):

Historical Treatments (total: 1):

A total of 21 teeth are visualized. Wisdom teeth (#38, #48) are present and non-impacted; #18 is partially visible with uncertain position. No significant bone resorption or structural anomalies affecting the dental arch are observed.

- **Caries:** Suspicious for carious lesions near #27 (score: 0.65) and #34 (score: 0.55).
- **Root Stumps:** Root stumps present near #44 (score: 0.9) and #48 (score: 0.86). Suspicious root stumps noted near #21 (score: 0.75), #27 (score: 0.64), and #18 (score: 0.64). Areas of concern for residual root fragments near #23 (score: 0.58) and #27 (score: 0.64).

Evidence of root canal treatment near #34. No restorations, crowns, or implants detected.

- Suspicious carious lesions near #27 and #34 require clinical correlation.
- Root stumps near #44 and #48 necessitate evaluation for residual apical pathology.
- Uncertain root fragments near #21, #23, #27, and #18 may require further imaging (e.g., CBCT) to assess for infection or impingement.

- Reinforce oral hygiene protocols to mitigate caries risk in posterior teeth.
- Monitor suspicious root stumps for signs of inflammation or resorption.

- Schedule clinical examination and intraoral radiographs for #27 and #34 within 1 month.
- Refer to endodontist for evaluation of root stumps near #44 and #48.
- 6-month recall for panoramic imaging to assess stability of residual root fragments.
