Grounding Caption

This localization caption provides multi-dimensional spatial analysis of anatomical structures and pathological findings for this panoramic dental X-ray image, including:

Medical Report

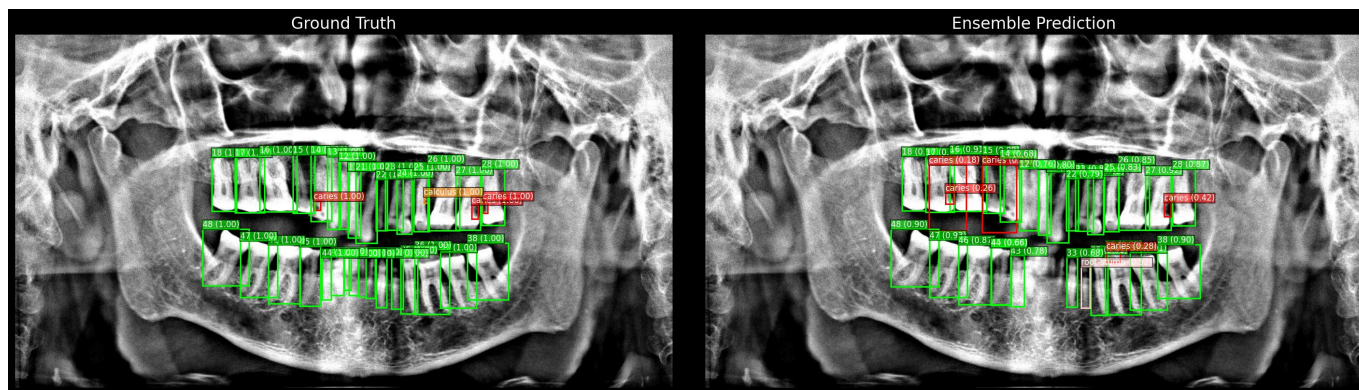
Teeth visibility with center points (total: 26):

Wisdom teeth detection (total: 4):

```
[
{'box_2d': [520, 321, 582, 464], 'tooth_id': '18', 'is_impacted': false, 'score': 0.96},
{'box_2d': [490, 513, 617, 665], 'tooth_id': '48', 'is_impacted': false, 'score': 0.9},
{'box_2d': [1196, 554, 1309, 696], 'tooth_id': '38', 'is_impacted': false, 'score': 0.9},
{'box_2d': [1236, 354, 1296, 504], 'tooth_id': '28', 'is_impacted': false, 'score': 0.87}
]
```

Dental Pathological Findings (total: 6):

```
[
{'box_2d': [592, 343, 690, 516], 'tooth_id': '17', 'label': 'caries', 'score': 0.18},
{'box_2d': [732, 343, 822, 523], 'tooth_id': '15', 'label': 'caries', 'score': 0.2},
{'box_2d': [995, 613, 1017, 722], 'tooth_id': 'unknown', 'label': 'root-stump', 'score': 0.52, 'near_tooth': '35'},
{'box_2d': [1214, 443, 1232, 479], 'tooth_id': 'unknown', 'label': 'caries', 'score': 0.42, 'near_tooth': '27'},
{'box_2d': [1060, 570, 1098, 600], 'tooth_id': 'unknown', 'label': 'caries', 'score': 0.28, 'near_tooth': '36'},
{'box_2d': [634, 417, 656, 447], 'tooth_id': 'unknown', 'label': 'caries', 'score': 0.26, 'near_tooth': '17'}
]
```

- A total of 26 teeth are visualized. All four wisdom teeth (#18, #28, #38, #48) are present and non-impacted.
- No implants or crowns are observed.

- **#17 (Left First Molar):** Suspicious for caries; areas of concern noted.
- **#15 (Left Canine):** Suspected caries with low confidence.
- **Near #35 (Right First Molar):** Suspicious for a root stump in the adjacent region.
- **Near #27 (Right Second Premolar):** Areas of concern suggestive of caries.
- **Near #36 (Right Second Molar):** Suspected caries in proximity.
- **Near #17 (Left First Molar):** Additional suspicious caries in adjacent area.

- No prior restorations, root canal treatments, or implants are detected.

- **Suspicious caries on #17 and #15** require evaluation for potential restorative intervention.
- **Root stump near #35** may indicate residual apical tissue or incomplete extraction; further assessment is warranted.
- **Caries-like lesions near #27, #36, and #17** should be prioritized for diagnostic confirmation.

- Reinforce oral hygiene protocols to mitigate caries progression.
- Monitor suspicious areas near #27, #36, and #17 for radiographic and clinical changes.

- Schedule a **6-month recall** for re-evaluation of caries susceptibility and root stump status.
- **Referral to endodontist** is recommended for #17 and #15 if caries progression is confirmed.
- Consider **surgical evaluation** for the root stump near #35 to rule out infection or cystic degeneration.
