Grounding Caption

This localization caption provides multi-dimensional spatial analysis of anatomical structures and pathological findings for this panoramic dental X-ray image, including:

Medical Report

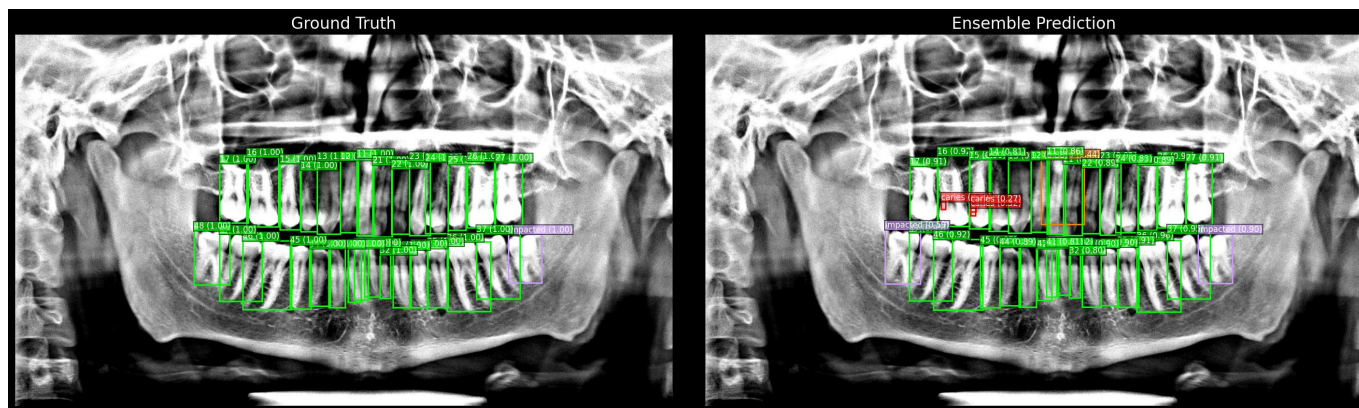
Teeth visibility with center points (total: 28):

Dental Pathological Findings (total: 6):

```
[
  {'box_2d': [880, 324, 993, 496], 'tooth_id': '21', 'label': 'calculus', 'score': 0.44},
  {'box_2d': [1293, 521, 1382, 650], 'tooth_id': 'unknown', 'label': 'impacted', 'score': 0.9, 'near_tooth': '37'},
  {'box_2d': [471, 509, 563, 652], 'tooth_id': 'unknown', 'label': 'impacted', 'score': 0.59, 'near_tooth': '47'},
  {'box_2d': [695, 453, 708, 473], 'tooth_id': 'unknown', 'label': 'caries', 'score': 0.32, 'near_tooth': '15'},
  {'box_2d': [618, 437, 630, 457], 'tooth_id': 'unknown', 'label': 'caries', 'score': 0.29, 'near_tooth': '16'},
  {'box_2d': [695, 441, 709, 463], 'tooth_id': 'unknown', 'label': 'caries', 'score': 0.27, 'near_tooth': '15'}
]
```

A total of 28 teeth are visualized in the panoramic radiograph. All four wisdom teeth (#18, #28, #38, #48) are absent or anatomically absent. The dentition demonstrates no significant radiographic abnormalities in alignment or eruption.

- Sign of impacted tooth** near #37 (FDI 37) with a radiographic shadow consistent with unerupted or partially erupted morphology.
- Suspicious radiolucency** near #47 (FDI 47) raises concern for impacted tooth, though further diagnostic imaging may be required to confirm.
- Suspicious for carious lesions** near #15 (FDI 15) and #16 (FDI 16), with overlapping radiolucent areas suggestive of early decay.
- Suspicious for calculus deposition** on #21 (FDI 21), indicated by localized radiopaque stippling along the interproximal surface.

- Impacted tooth near #37:** Immediate clinical evaluation is required to assess eruption potential and rule out adjacent root resorption.
- Suspicious caries near #15 and #16:** Monitor for progression to irreversible damage; consider exploratory treatment if clinical signs emerge.

- Calculus management:** Reinforce biofilm control and professional scaling for #21 to prevent periodontal complications.
- Oral hygiene reinforcement:** Emphasize interproximal cleaning techniques for #15 and #16 to mitigate caries risk.

- Referral to oral surgeon:** For impacted tooth near #37 to determine surgical intervention necessity.
- 6-month recall:** To reassess carious lesions and calculus status.
- Radiographic monitoring:** Annual panoramic imaging to track impacted tooth progression and caries stability.
