## Grounding Caption

## Medical Report

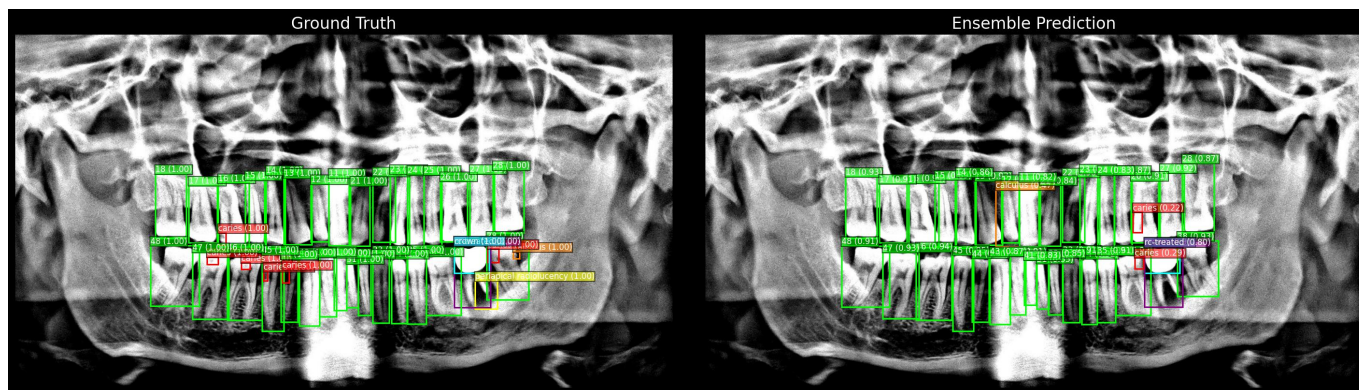
This localization caption provides multi-dimensional spatial analysis of anatomical structures and pathological findings for this panoramic dental X-ray image, including:

A total of 31 teeth are visualized within the panoramic image. All four wisdom teeth (#18, #28, #38, #48) are present and unimpacted. No abnormalities in overall tooth alignment or positional anomalies are noted.

- **#12 (Left Lateral Incisor)**: Evidence of calculus deposition.
- **Near #36 (Right First Molar)**: Areas of concern for caries.
- **Near #26 (Left First Molar)**: Suspicious radiolucent regions suggesting potential caries.

- **#38 (Right Third Molar)**: Presence of a crown.
  - **#36 (Right First Molar)**: Root canal-treated tooth with visible restoration.
-

1. **Caries suspicion near #36 and #26**: Requires immediate clinical correlation to confirm carious lesions.
2. **Calculus on #12**: Indicates localized plaque accumulation and potential periodontal risk.
3. **Root canal-treated #36**: Monitor for recurrent caries or apical pathology.

- Reinforce oral hygiene protocols, emphasizing interproximal cleaning near #36 and #26.
- Schedule professional scaling to address calculus on #12 and adjacent areas.
- Educate on dietary modifications to reduce caries risk in high-risk zones.

- **6-month recall** for re-evaluation of suspicious lesions near #36 and #26.
- **Referral to endodontist** if caries confirmation or apical pathology is detected on #36.
- **Digital radiography** recommended for detailed assessment of questionable caries.
