## Grounding Caption

# Medical Report

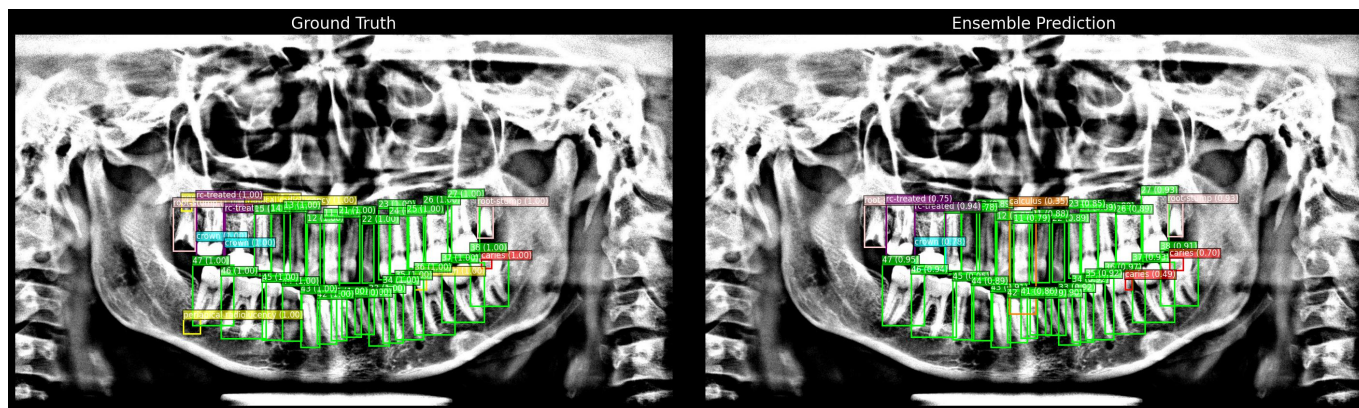
This localization caption provides multi-dimensional spatial analysis of anatomical structures and pathological findings for this panoramic dental X-ray image, including:

A total of 27 teeth are visualized within the panoramic field. All detected wisdom teeth (#38) are present and unimpacted. The dental arches demonstrate a mix of fully erupted and partially erupted teeth, with no evidence of congenitally missing permanent teeth.

- Suspicious for calculus deposition on #11 (score < 0.80).
- Root stumps noted near #27 and #47, with no associated radiographic periapical pathology.
- Suspicious for carious lesions near #38 and #36 (scores < 0.80).

- Evidence of root canal treatment on #15, with residual radiolucency at the apical region.
  - Presence of a crown near #15, consistent with prior restorative intervention.
-

- Immediate attention required for suspicious carious lesions near #38 and #36.
- Evaluation of root stumps near #27 and #47 for potential extraction or endodontic viability.
- Assessment of calculus on #11 to determine need for prophylaxis or scaling.

- Reinforce oral hygiene protocols, emphasizing interproximal cleaning around #27, #36, and #38.
- Monitor suspicious carious lesions for progression via 3- to 6-month recalls.

- Schedule a 6-month recall for caries monitoring and periodontal evaluation of #11.
- Referral to endodontist for comprehensive assessment of #15 (multiple prior interventions).
- Consider panoramic and bitewing radiographs to clarify caries status near #36 and #38.
