## Grounding Caption

# Medical Report

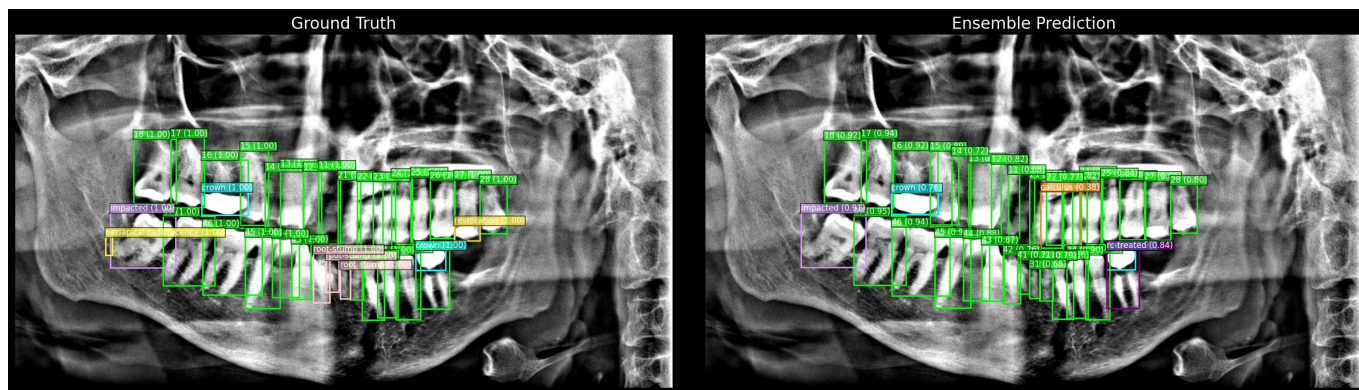
This localization caption provides multi-dimensional spatial analysis of anatomical structures and pathological findings for this panoramic dental X-ray image, including:

A total of 28 teeth are visualized within the panoramic image. Wisdom teeth status includes two detected teeth: tooth #18 (upper left first molar) and #28 (upper left third molar), both unimpacted. No immediate signs of missing posterior teeth are observed.

- A suspicious area of **calculus** is noted on tooth #23 (upper left first molar) based on radiographic density.
- A clear indication of an **impacted tooth** is observed near tooth #47 (lower left first molar), likely representing a horizontal impaction or resorption risk.

- A **crown** is present on tooth #16 (upper left second molar).
  - A **crown** is detected near tooth #35 (lower right first molar), with radiographic evidence of **root canal treatment (RC-treated)** on the adjacent structure.
-

1. **Impacted tooth near #47**: Requires evaluation to assess resorption risks and surgical planning.
2. **Suspected calculus on #23**: Indicates potential periodontal risk requiring
