## **Before Impact & After Impact: Tracks from Rover**

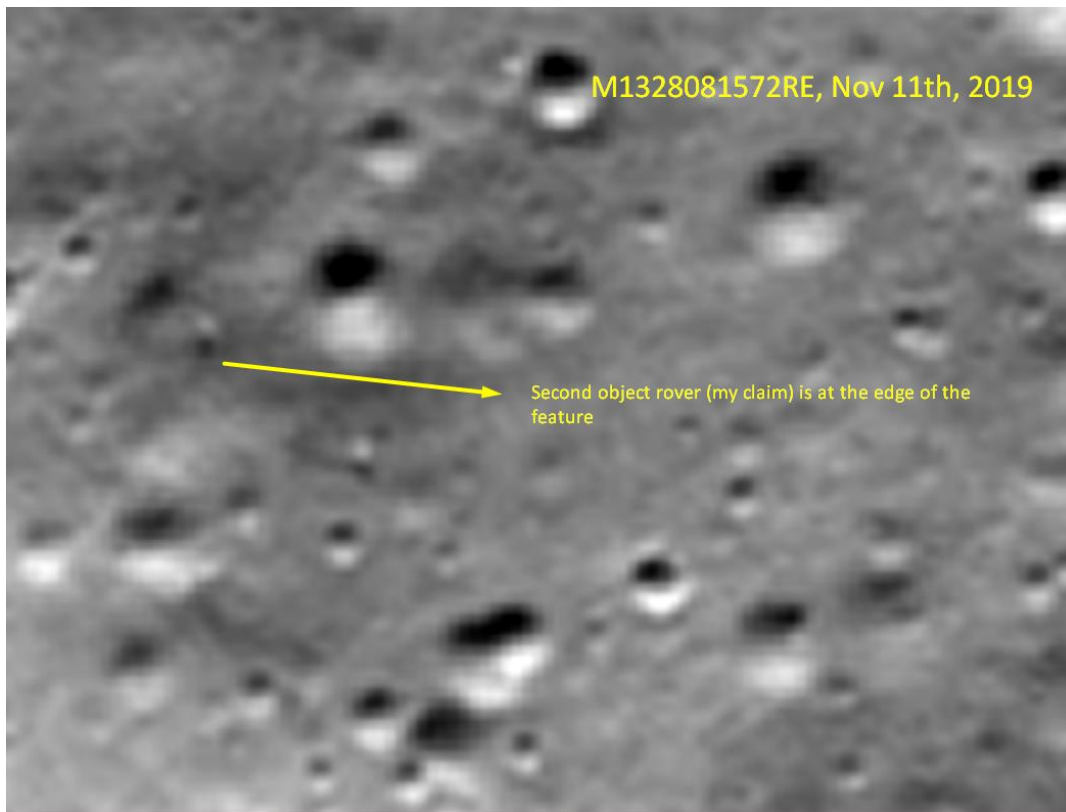
The below image is one of the best resolution images available for this area and taken at 0.45 m/pixel  
August 27<sup>th</sup>, 2015 and in this image the smaller object indicated in the email is at center of the feature  
Whereas the rover I am claiming is not visible in this clear resolution picture

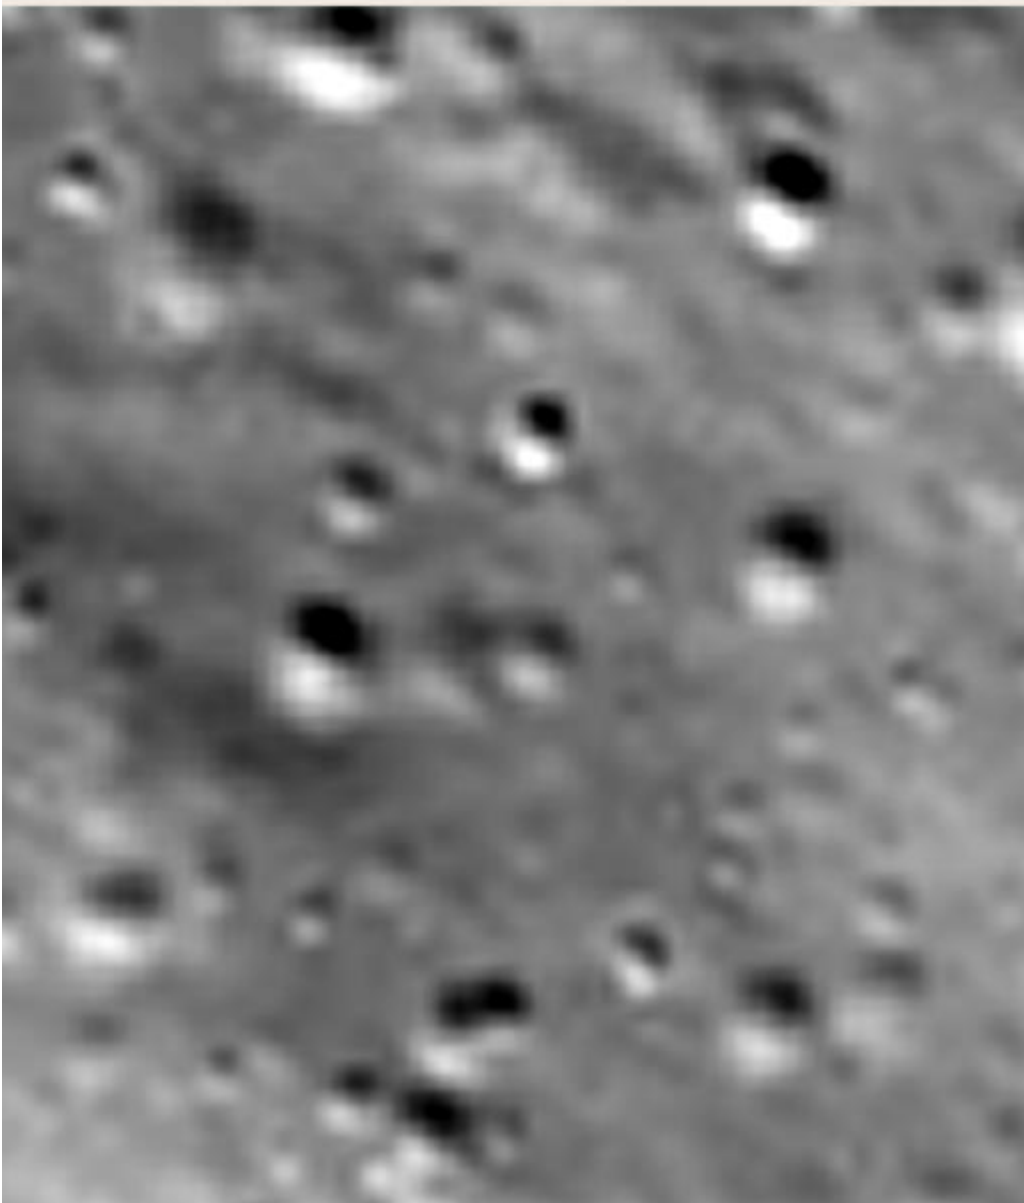
**July 13th, 2019**

M1317642917RE\_july13th2019.cub @ 24.9% (Gray = 1)

It's crystal clear that there was no object on the said position before Vikram Lander had a rough landing and the possible 2 objects which are there now might be the lander devoid of all the payloads and the rover itself as Lander's height was not more than 1.2 m and the dimensions were 2.54 X 2 X 1.2 m
