Composite repair for piping and pipeline

Qualification test programme. Joint Shell OU sponsored project

F.A.H. Janssen
P.J.M. van Loon
A. Mesman
H.J.B. van Zummeren

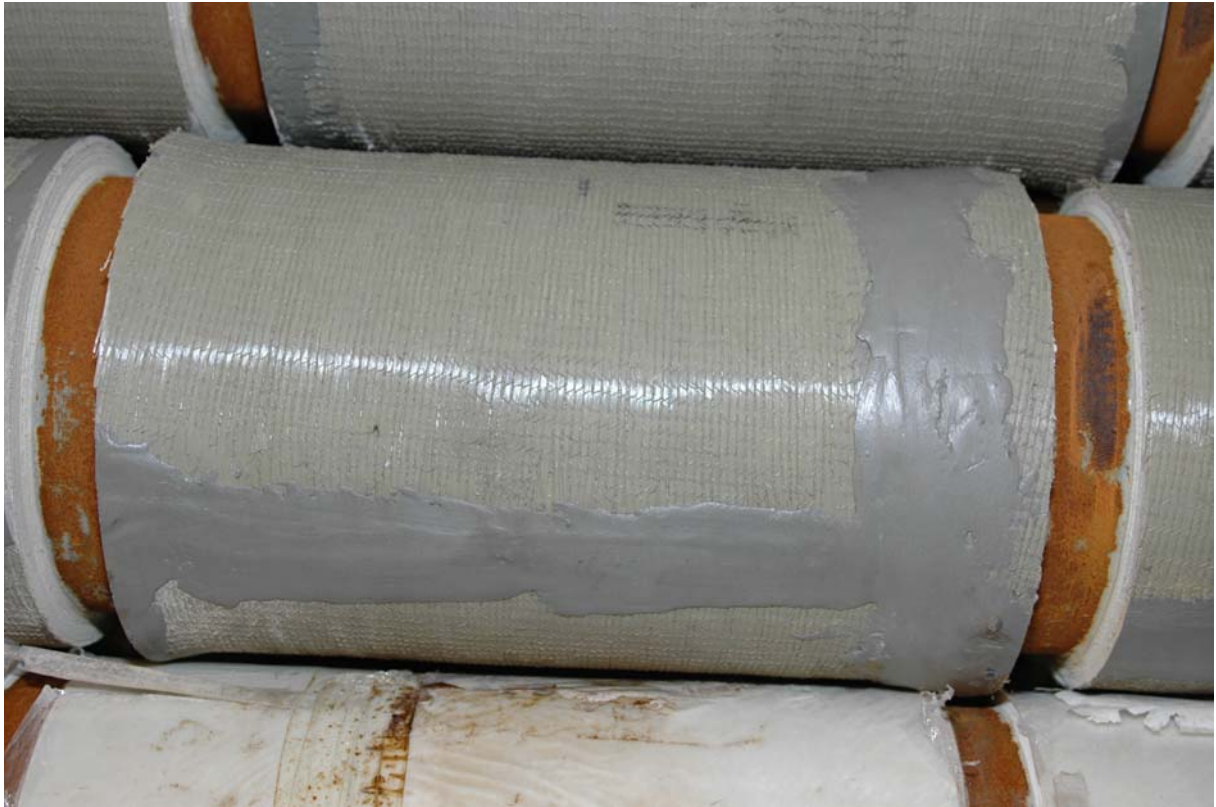
Figure 1 *Photograph showing the Armor plate testpool*

The Armor plate system has been applied on testspools with a “through-the-wall” defect, and spools with an external defect. Epoxy putty is used to fill irregular surfaces and defects of the steel pipe. Glass-fibre (fabric) reinforced epoxy is wrapped around the pipe. After wrapping, Mylar tape is applied over the “wet” composite. Curing time is about 12 hours, at ambient temperature. The Armor plate system has been applied with a thickness of 12.5 mm on testspools with a through the wall defect, and 5.5 mm for testspools with an external defect.

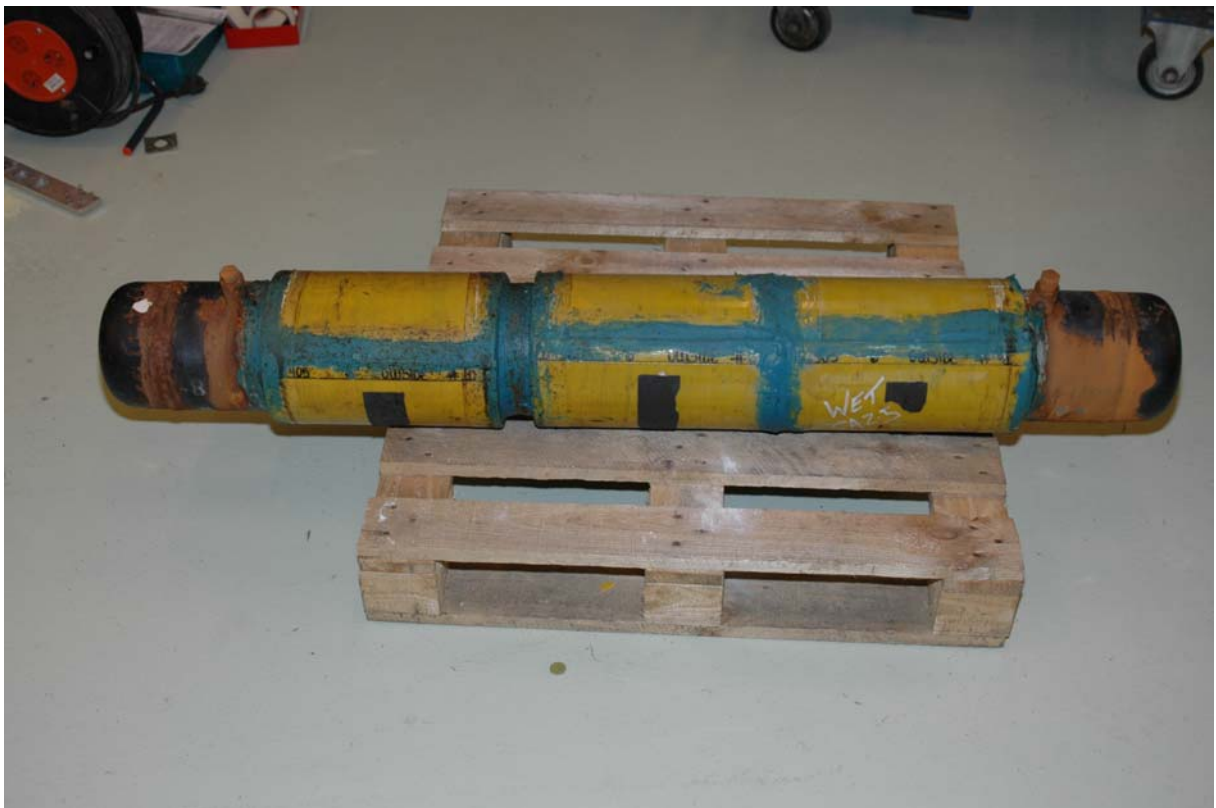
Figure 2 *Photograph showing the Clock spring testpool*

On the specific request of the Manufacturer, the Clockspring system has been applied on testspools with an external defect only. The spiral shaped composite wrap consists of a series of concentric layers, and is pre-cured on delivery. The material is wrapped around the steel pipe as a series of concentric layers. For the testspool, 8 layers have been applied. Toughened methacrylate adhesive is applied to the pipe surface and to each individual coil layer. After wrapping a mechanical strap is applied to consolidate the coil until full cure of the adhesive is achieved. Full curing of the adhesive typically requires 2 - 4 hours. The Clockspring system has been applied with a thickness of 15 mm on testspools with an external defect.

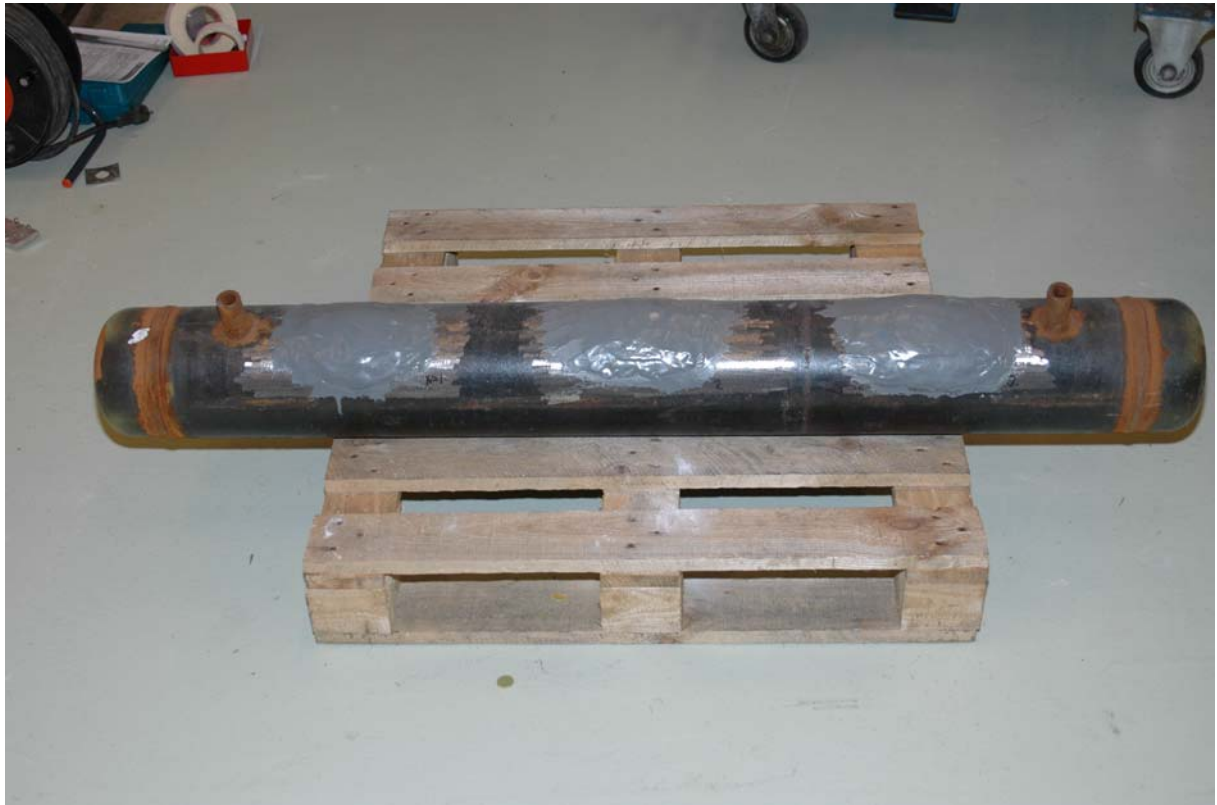
Figure 3 *Photograph showing the Diamant testspool*

The Diamant system has been applied on testspools with a through-the-wall defect only. For the Diamant repair system, surface preparation includes cleaning of the steel surface using Diamant cleaner, and application of a primer is not specified. The first layer applied, consists of UltraMetal 1250, reinforced with wire-mesh. Two series test spools have been prepared; one serie based on “1- layer” mesh reinforcement, and one serie based on “3-layer” mesh reinforcement. For completion of the repair, four layers of synthetic fibre reinforced UltraMetal-1250 have been applied. Total repair thickness is typically in the range 5 to 11 mm.

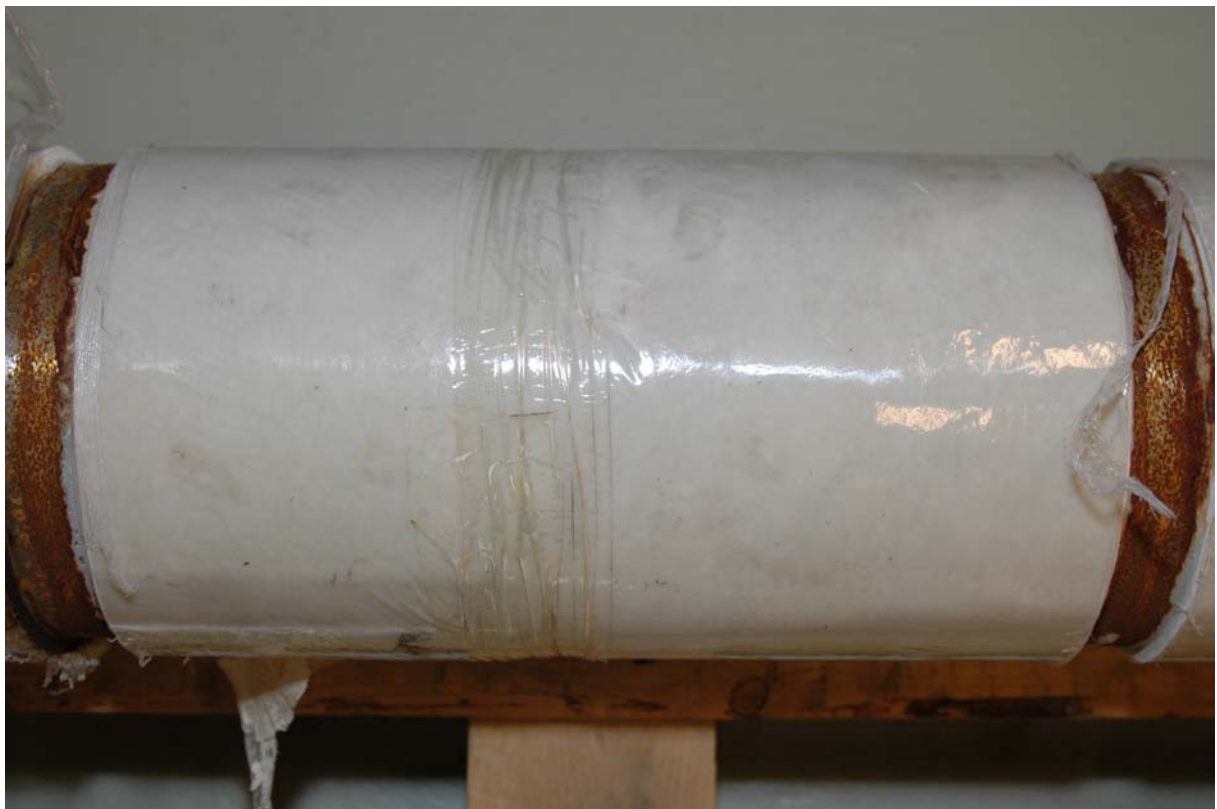
Figure 4 *Photograph showing the Fibaroll testspool*

The Fibaroll system has been applied on testspools with a “through-the-wall” defect, and spools with an external defect. A vinyl ester primer (Fibagel) is applied to the steel substrate. Gel time for the glass fibre reinforced Epoxy Novolac overwrap system is typically 5 minutes. In-door curing can be accelerated, using a 400 watts UV lamp. Emission of styrene, typical for vinyl ester and Novolac type resin systems, is minimal for the pre-gelled, fast curing Fibaroll resin system. The Fibaroll system has been applied with a thickness of 6 mm on testspools with a through the wall defect, and testspools with an external defect.

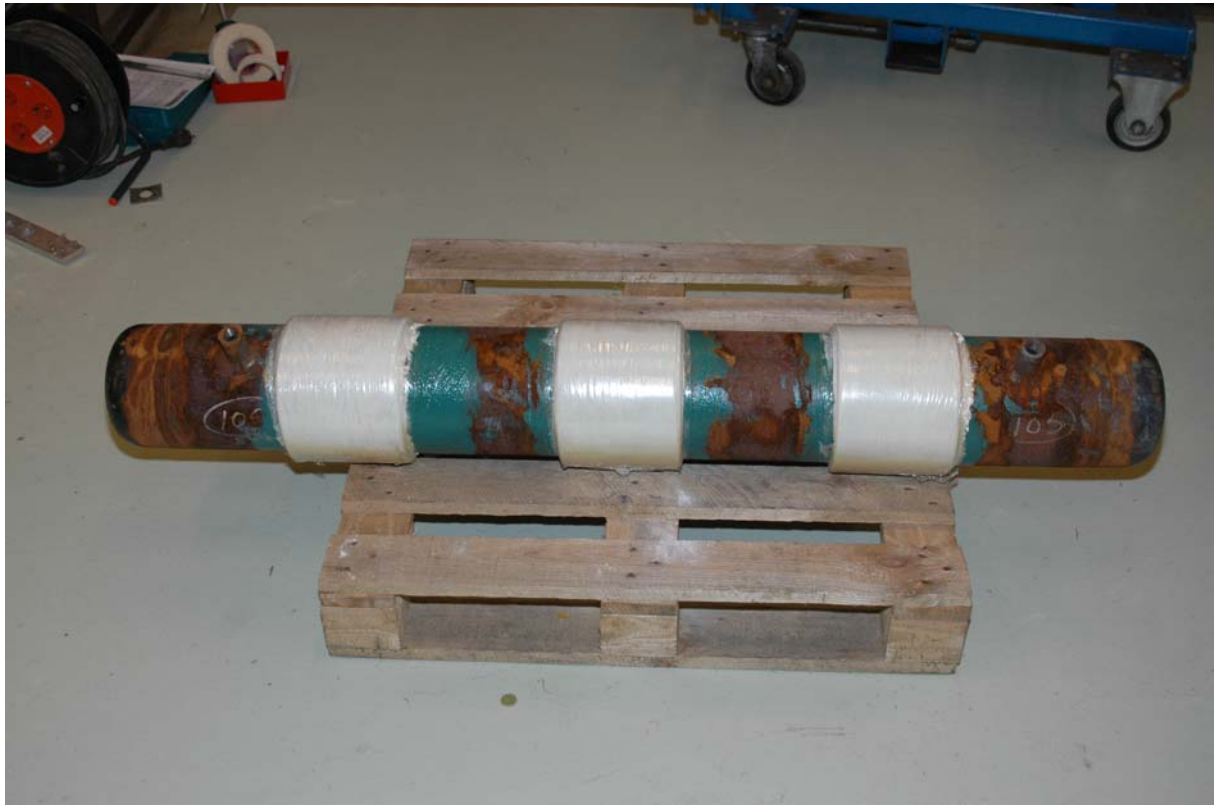
Figure 5 Photograph showing the Strongback testspool

The Strongback system has been applied on testspools with an external defect. A liquid polyamide cured epoxy is used as primer and to fill external defects. Kevlar fibres are incorporated for reinforcement of the primer (putty). A minimum of 8 plies of glass-fibre reinforced urethane resin has been applied. The Strongback system is based on curing agents with two color components that turn green, giving visual conformation of correct mix and state-of-cure. The Strongback system has been applied with a thickness of 13 mm on testspools with an external defect.

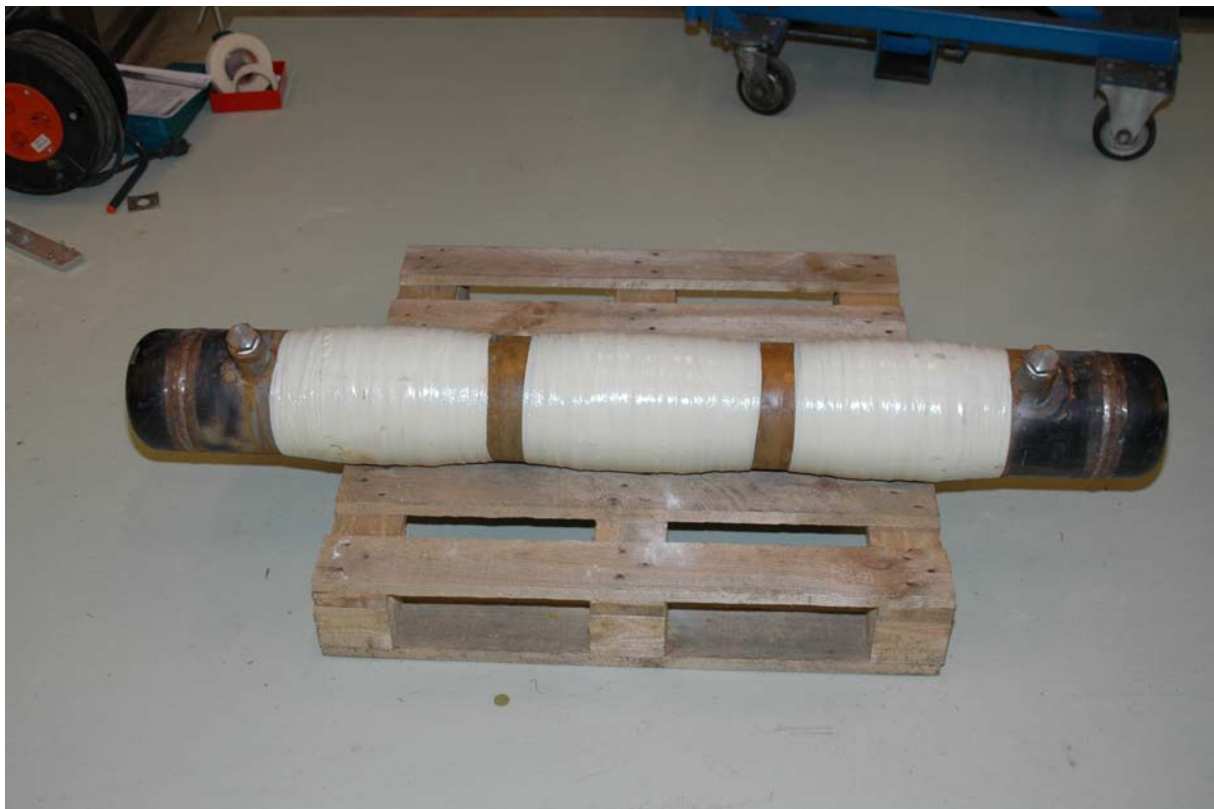
Figure 6 Photograph showing the Synthoglass testspool

The Synthoglass system has been applied on testspools with a through-the-wall defect, and spools with an external defect. An epoxy primer is applied to the steel substrate. Before wrapping, Synthoglass woven tape is immersed in water to activate the curing process. To keep the composite wrap in place during cure, a Saran film layer is applied over the Synthoglass composite. Time required to fully cure the Synthoglass system is approximately 24 hours, at 21 °C. The Synthoglass system has been applied with a thickness of 9 mm on testspools with both a through-the-wall defect and testspools with an external defect.

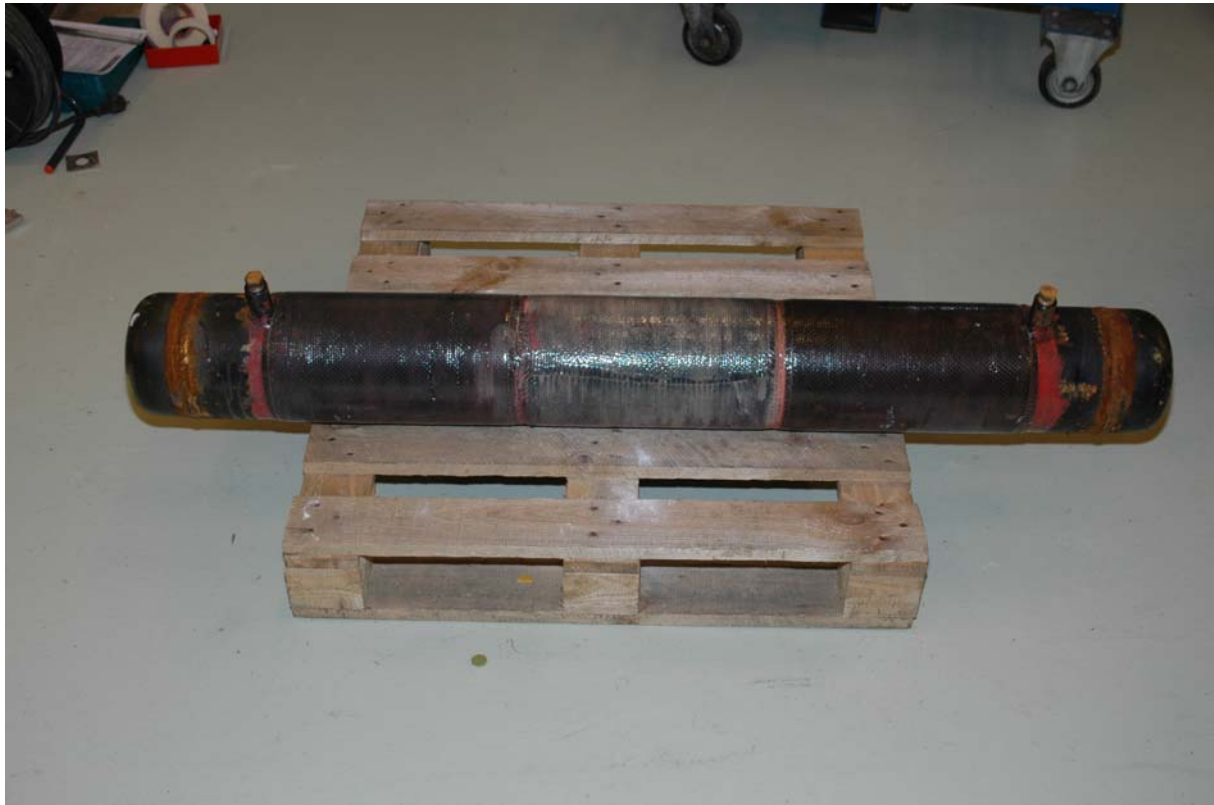
Figure 7 Photograph showing the TDW testpool

The TDW system has been applied on testspools with a through-the-wall defect, and spools with an external defect. An epoxy primer is applied to the steel surface to provide good bonding between the steel substrate and the carbon fibre fabric. Epoxy putty is used to fill external defects. The repair is applied by wrapping an epoxy reinforced carbon fibre fabric. For above ground application, exposed to intense UV radiation, a pigmented topcoat is recommended, e.g. epoxy, or polyurethane. Required curing time for the TDW system is typically 3 hours. The TDW system has been applied with a thickness of 3.5 mm on testspools with a through the wall defect, and thickness of 5 mm on testspools with an external defect.

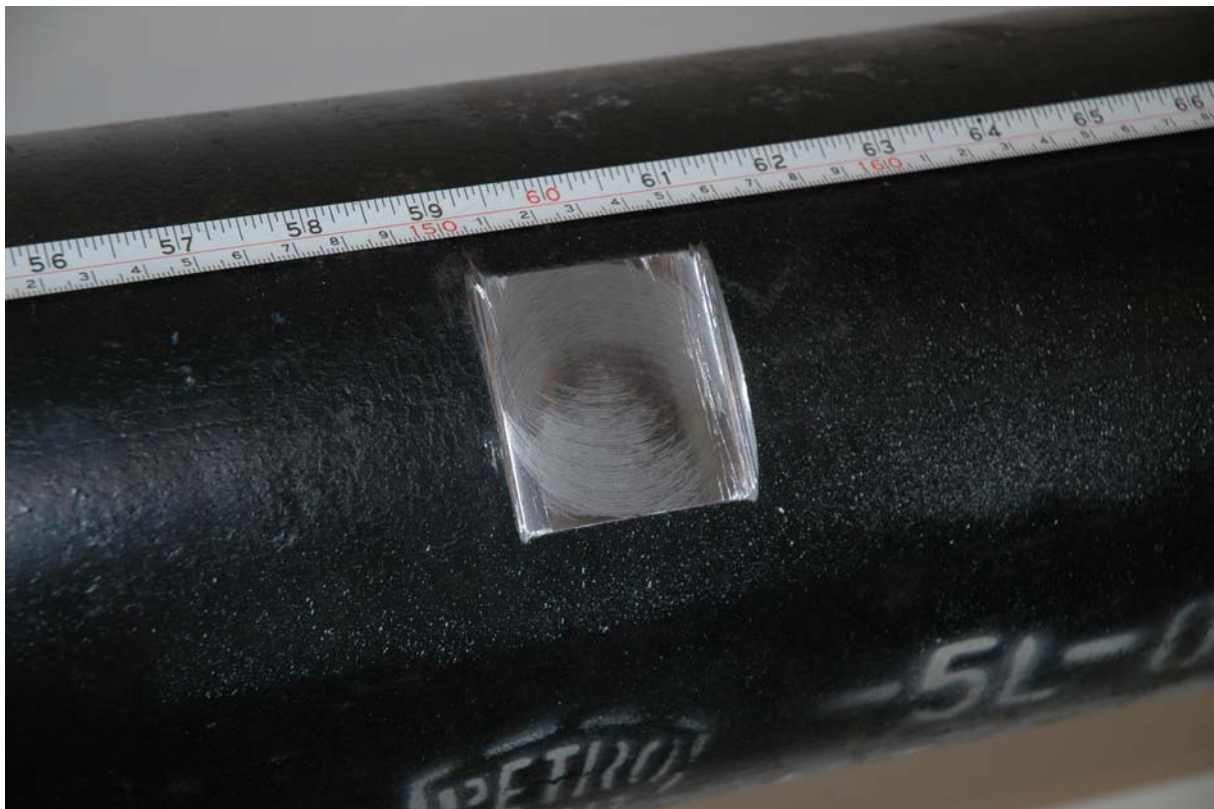
Figure 8 Photographh showing detail of the external machined defect

- “**External**” defect; depth 4 mm (i.e. 60 % wall loss), length 52 mm, and width 50 mm. Detail of the external machined defect is shown Figure 8;
- “**Through-the-wall**” defect; 5 mm diameter drilled hole.

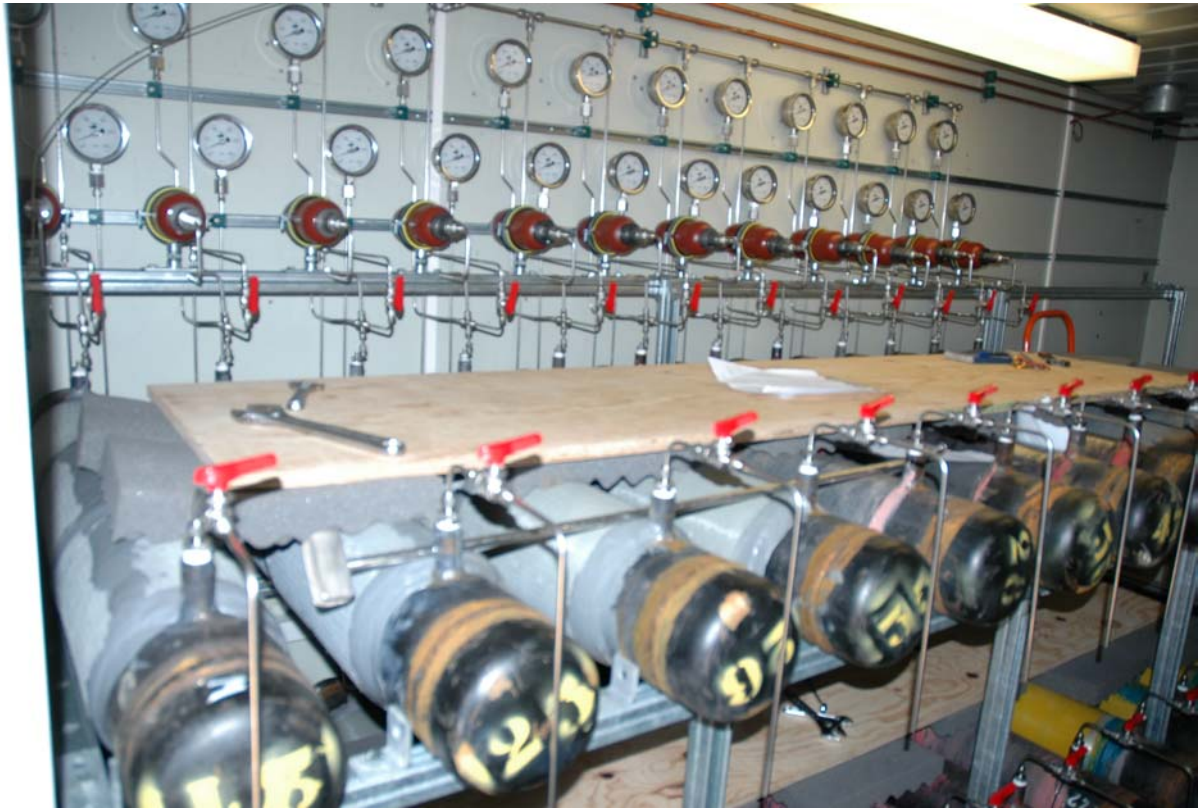
Figure 9 *Photograph showing the 1000 hr pressure test set-up*

To determine if the composite repair system is capable to restore the original minimum specified ultimate pressure strength (burst) of the pipe, also after ageing, 1000 hr tests have been performed, at a temperature of 65 °C, and pressure of 180 bar, i.e. equivalent to the field hydrotest pressure for a 6 inch diameter, Schedule 40, ASTM 106 Grade B steel pipe system. The 1000 hr experimental test set-up is shown in Figure 9.

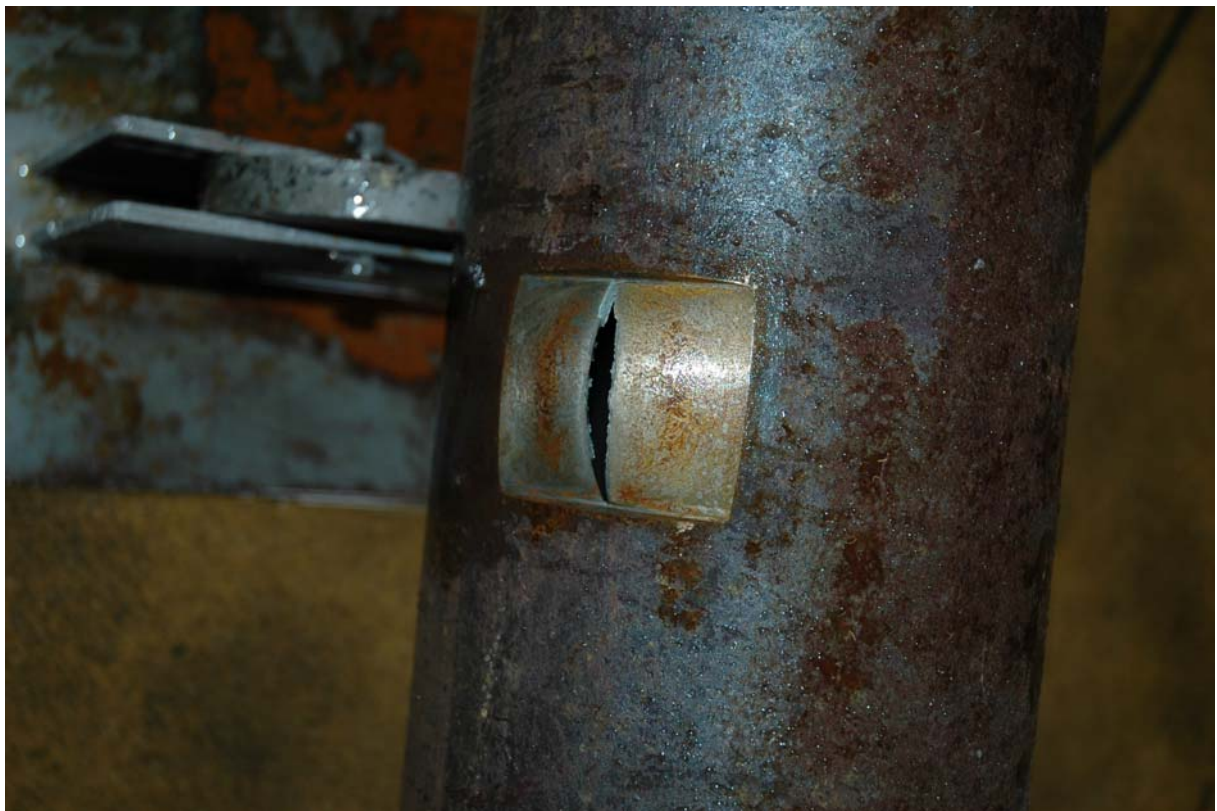
Figure 10 *Photograph showing rupture of the steel testpool*

The steel testspool (no. 69) failed at a pressure of 335 bar at the location of the external defect, see Figure 10. The burst pressure of 335 bar is lower than the “minimum” specified ultimate pressure strength (burst) of 365 bar for the “virgin” pipe, and therefore the damaged pipe is not fit for purpose, and repair is required, i.e. application of a composite over-wrap.

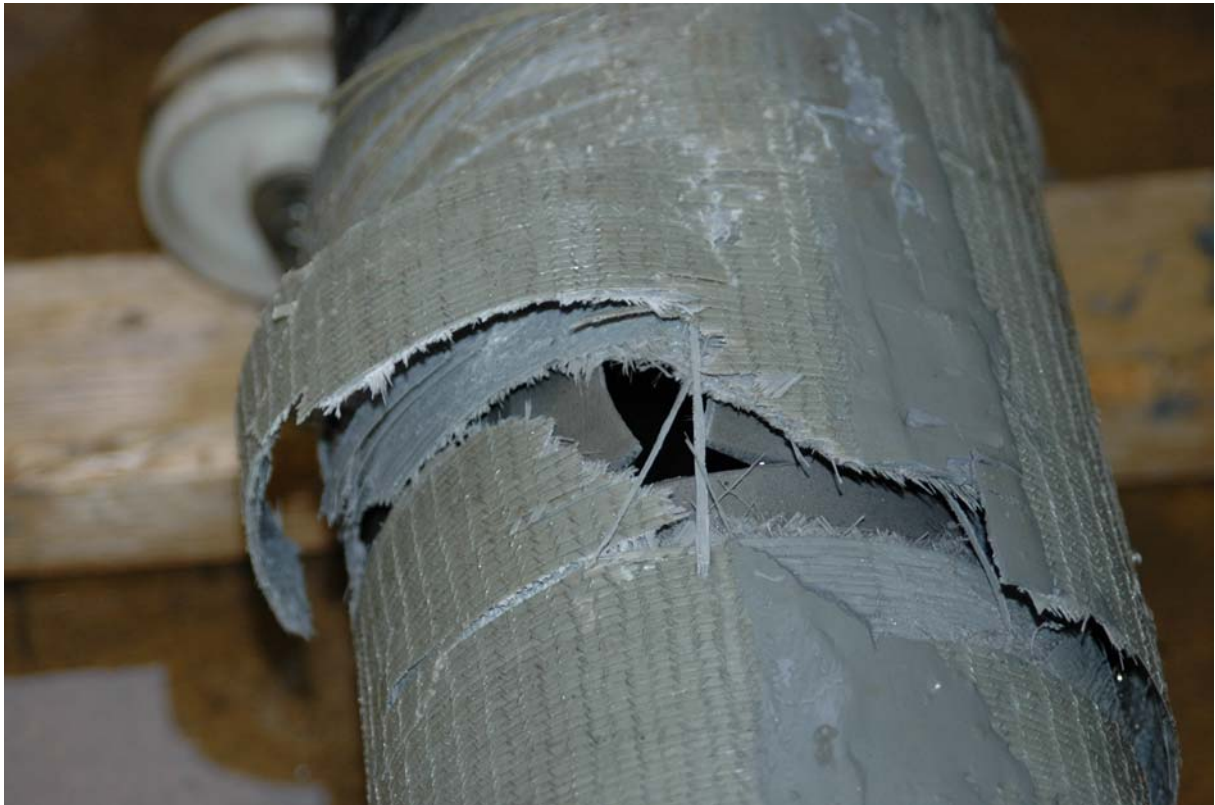
Figure 11 Photograph showing fracture of the Armor plate composite

At a pressure of 370 bar, fracture at the composite overwrap occurred, at a composite hoop strain of 0.8 % and 1.2 % at the steel wall. The burst pressure of 370 bar is only slightly higher than the minimum specified ultimate pressure strength of 365 bar (Table 8) for the “virgin” pipe. A photograph showing the fractured composite is presented in Figure 11.

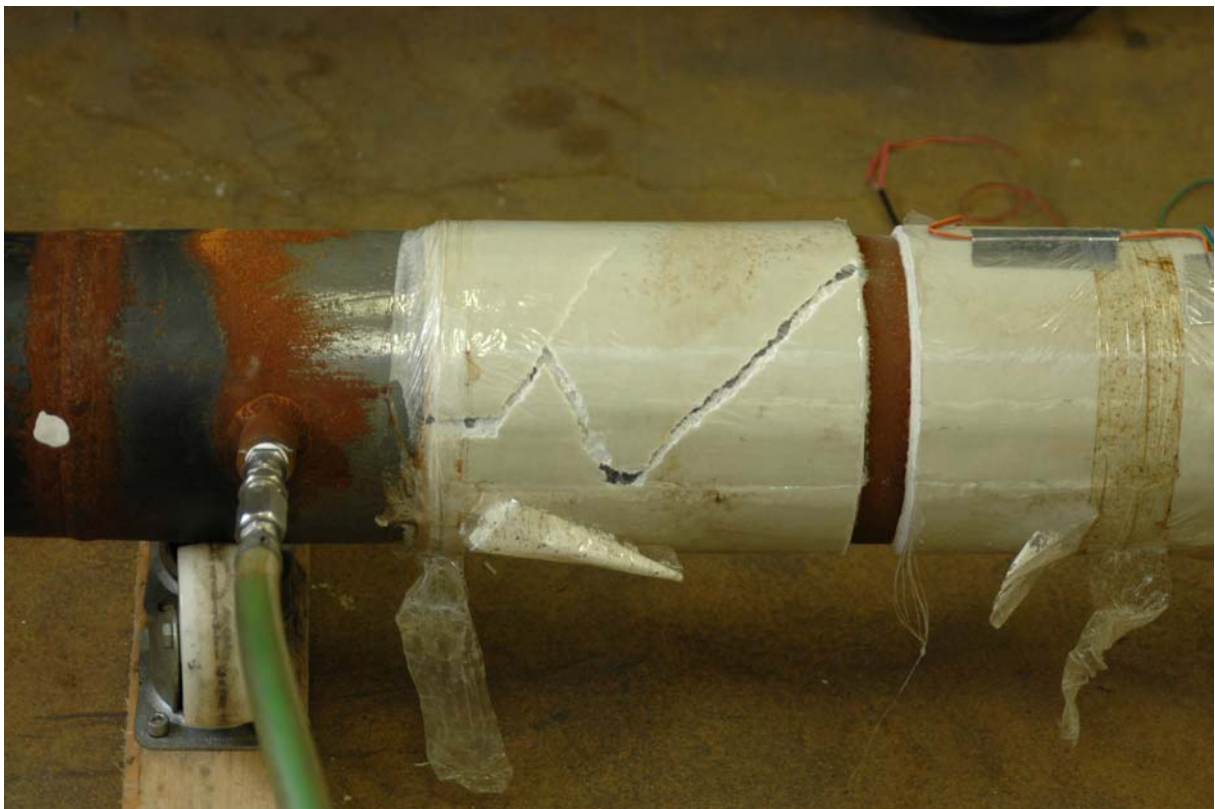
Figure 12 Photograph showing fracture of the Fibaroll composite

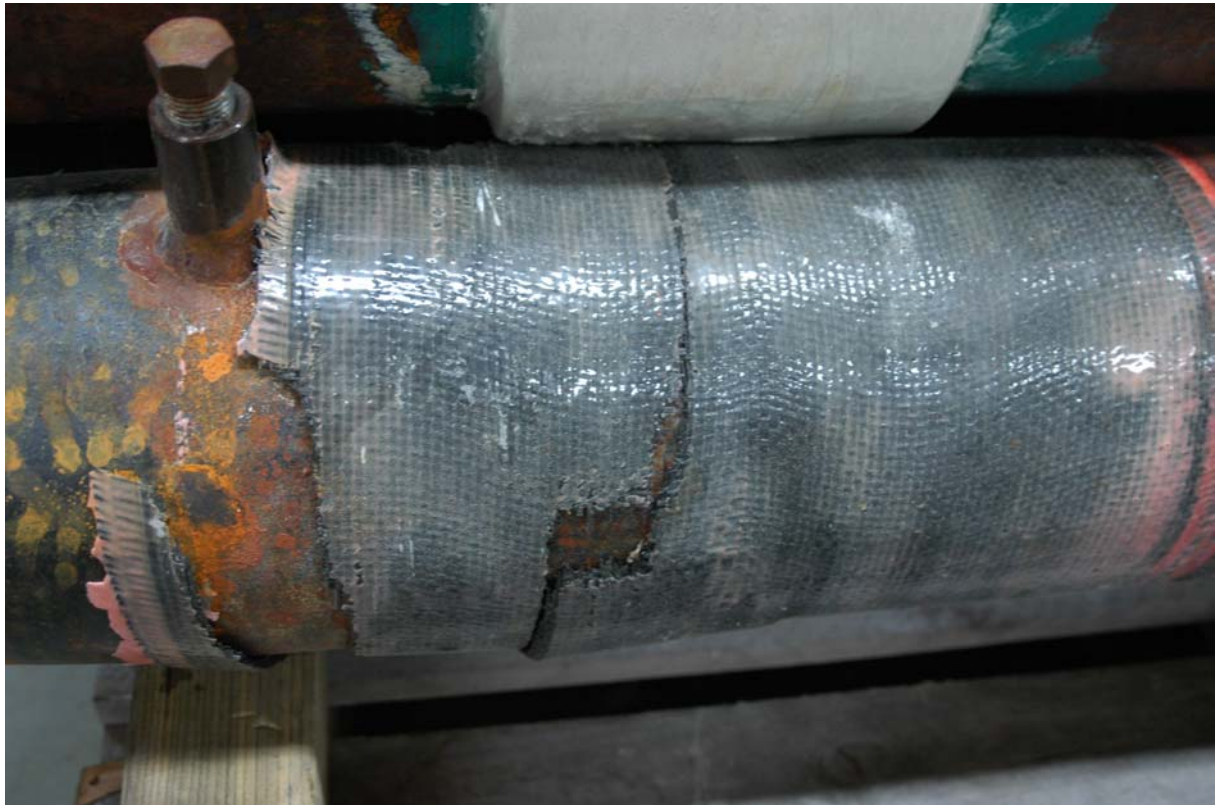
Figure 13 *Photograph showing fracture of the TDW composite*

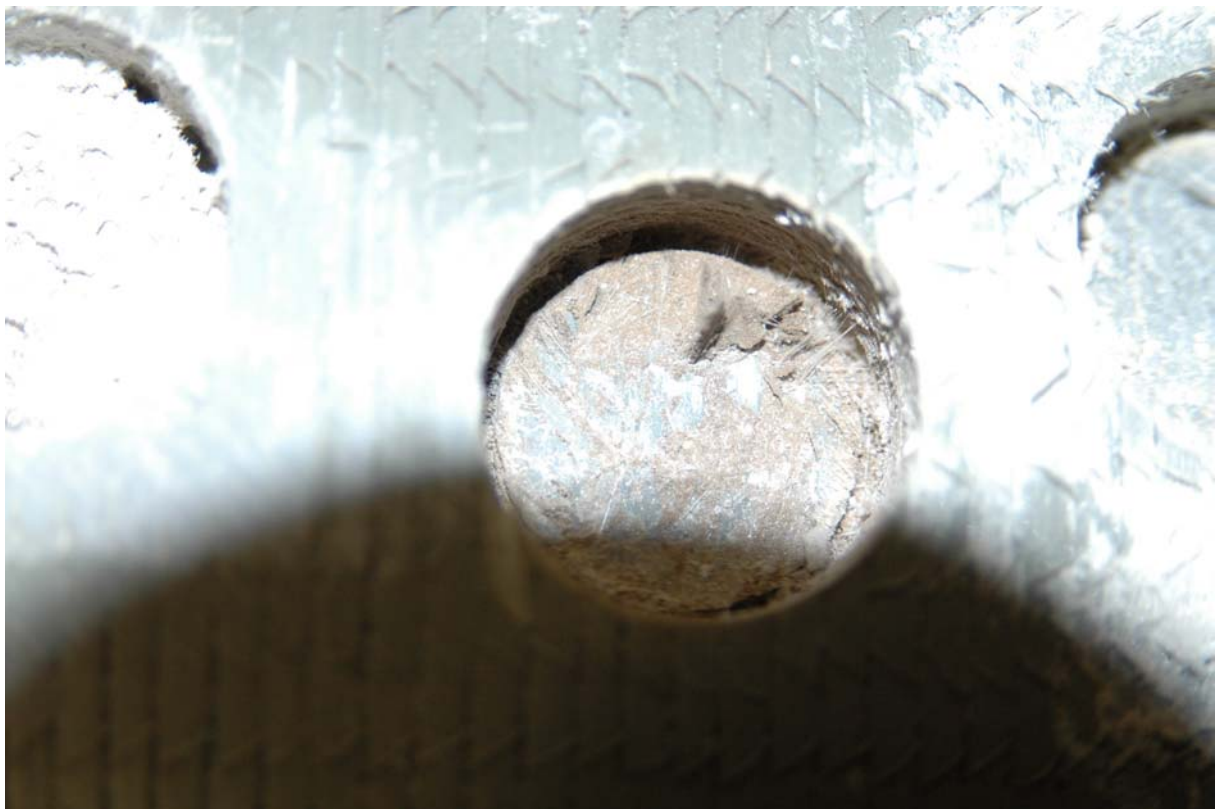
Figure 14 *Photograph showing the fracture surface after pull-off test*

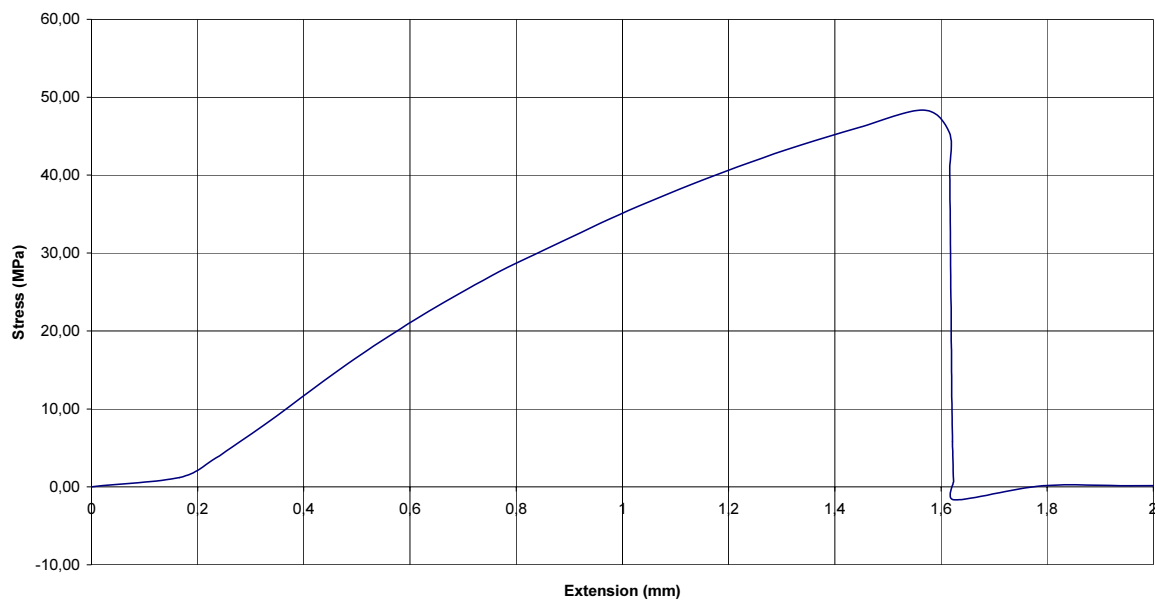
Figure 1-1
Stress strain curve diamant steel wire mesh reinforced ultra metal 1250 tensile specimen

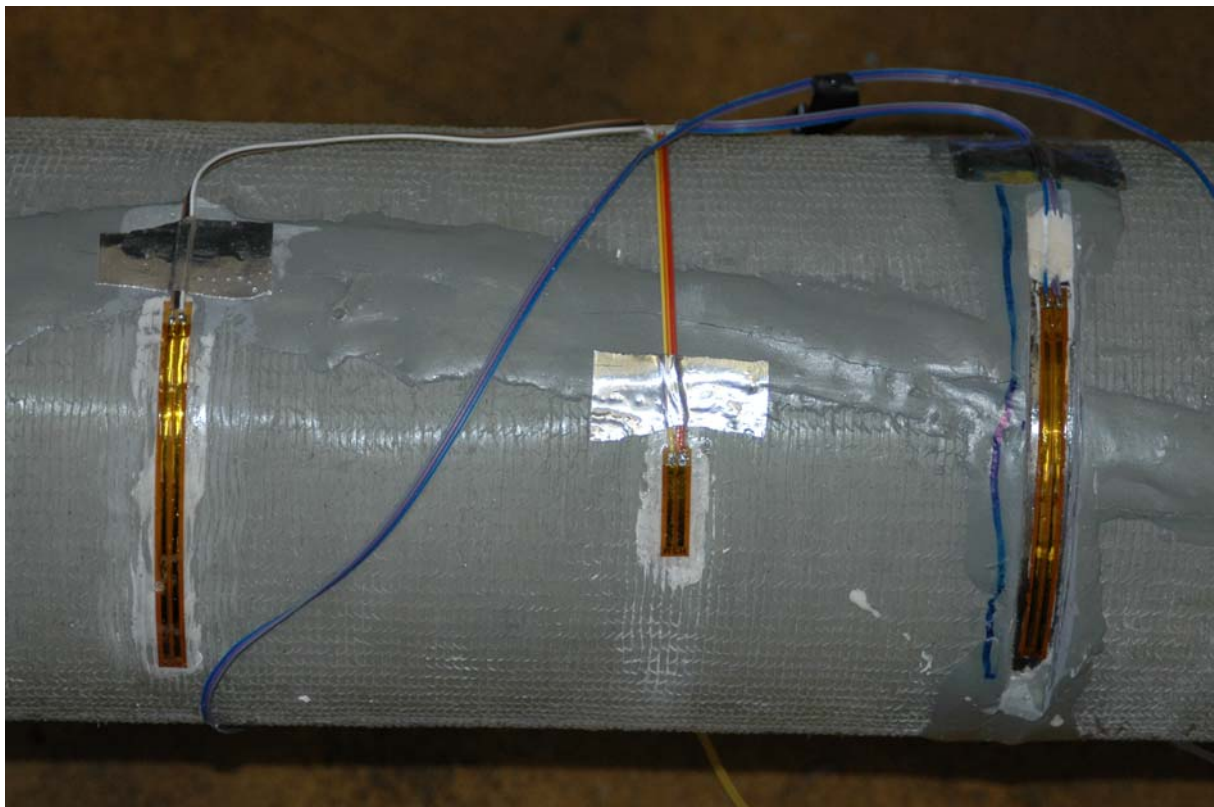
Figure 1-2 *Strain gauge arrangement – test spool*

During burst testing of the testspools, strains in the hoop direction have been measured at (i) virgin steel wall, (ii) external surface of the composite, outside the defect area, and (iii) external surface of the composite at the location of the defect. A photograph showing the strain gauge arrangement is presented in Appendix 1, Figure 2.

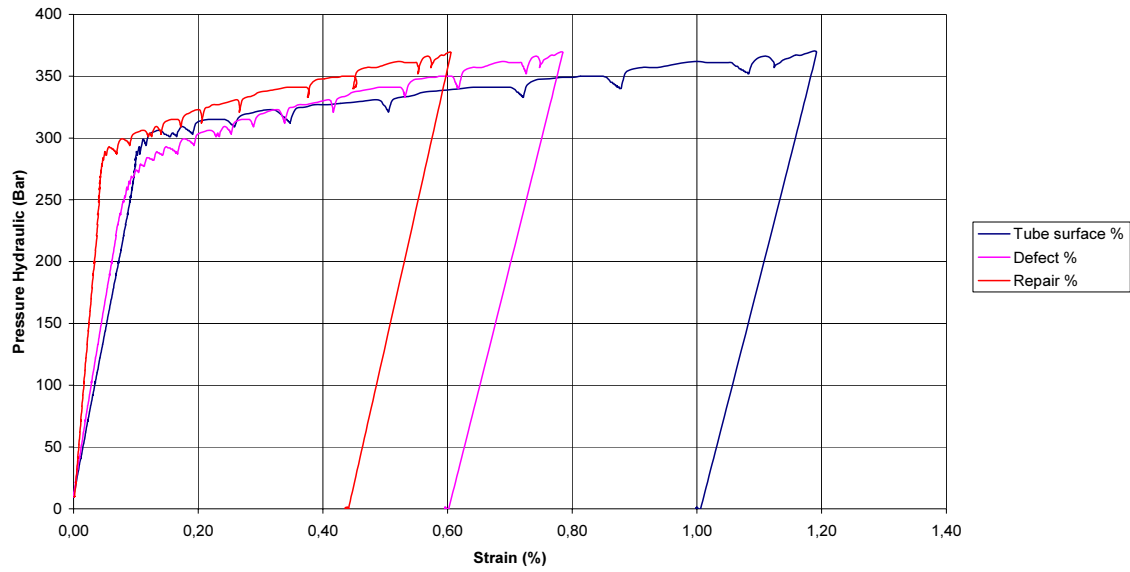
Figure 1-3 Pressure strain curve Armor plate repair (Spool 13)

At the pipe design pressure, 145 bar (Table 8) the composite strain, measured at the location of the defect is 0.04 %. At 180 bar, equivalent to the pipe field hydrotest pressure, the composite strain response at the location of the defect is linear elastic, indicating that yielding at the remaining steel pipe wall at the location of the defect does not occur at 180 bar.

At a pressure of approximately 280 bar onset of non-linear composite hoop strain behaviour at the location of the defect was observed, indicating that yielding of the steel substrate has occurred, at a hoop strain of 0.10 % for both the composite and the “virgin” steel pipe wall. At a pressure of 300 bar significant non-linear strain behaviour was observed at the “virgin” steel pipe wall, i.e. yielding.

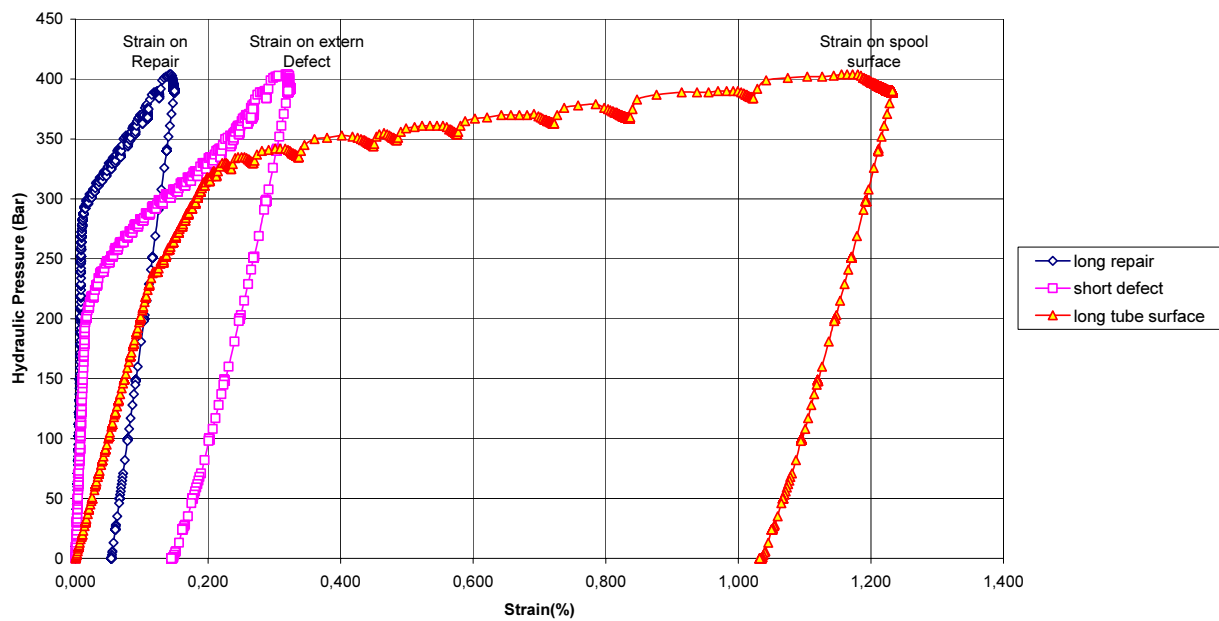
Figure 1-4 Pressure strain curve Clock Spring repair (Spool 11)

At 180 bar, equivalent to the pipe field hydrotest pressure, the composite hoop strain response at the location of the defect is linear elastic, indicating that yielding at the remaining steel pipe wall at the location of the defect does not occur at 180 bar.

At a pressure of approximately 225 bar onset of non-linear composite hoop strain behaviour at the location of the defect was observed for the Clock spring system, indicating yielding of the steel substrate, at a composite hoop strain of 0.03 % and 0.11 % at the “virgin” steel pipe. At a pressure of 325 bar, significant non-linear strain behaviour was observed at the “virgin” steel pipe wall, i.e. yielding.

At a pressure of 400 bar the Clockspring system did not show signs of damage, however, for safety reasons, it was decided to stop further testing. The maximum composite hoop strain was 0.3 % and 1.2 % at the “virgin” steel wall. The maximum pressure of 400 bar is well above the minimum required ultimate pressure strength of 365 bar for the “virgin” pipe.

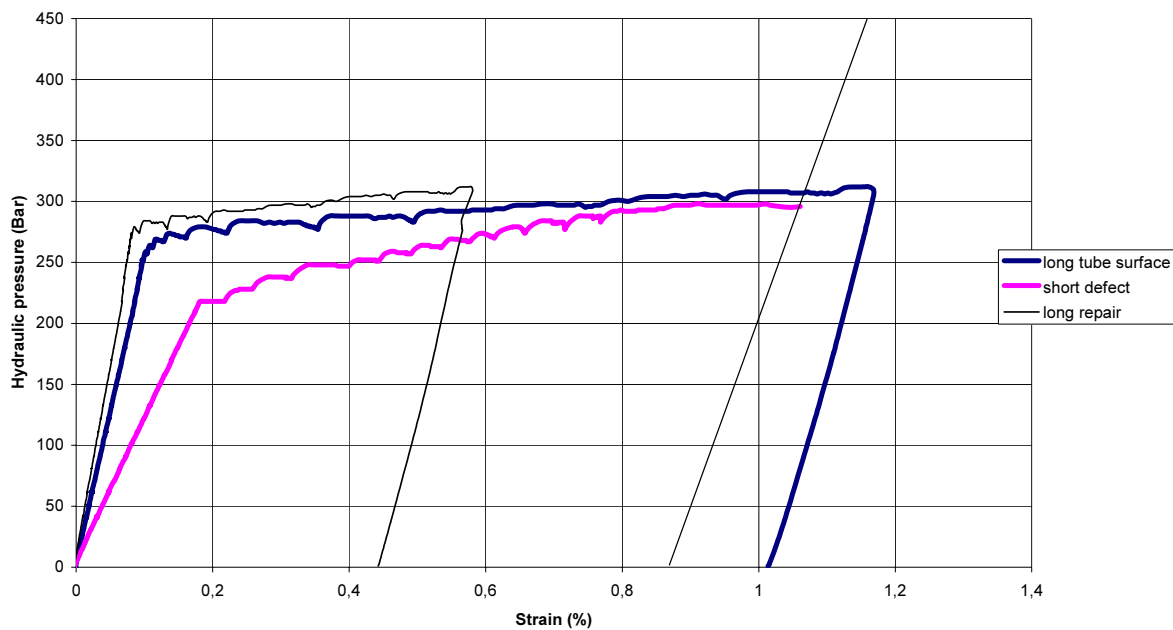
Figure 1-5 Pressure strain curve FIBAROLL repair

At the pipe design pressure, 145 bar the composite hoop strain is 0.12 %. At 180 bar, equivalent to the pipe field hydrotest pressure, the composite hoop strain response at the location of the defect is linear elastic, indicating that yielding at the steel pipe wall at the location of the defect does not occur at 180 bar.

At a pressure of approximately 225 bar, onset of non-linear composite hoop strain behaviour at the location of the defect was observed, indicating yielding of the steel substrate, at a composite hoop strain of 0.18 % and 0.09 % at the “virgin” steel pipe. At a pressure of 270 bar, significant non-linear strain behaviour was observed at the “virgin” steel pipe wall, i.e. yielding.

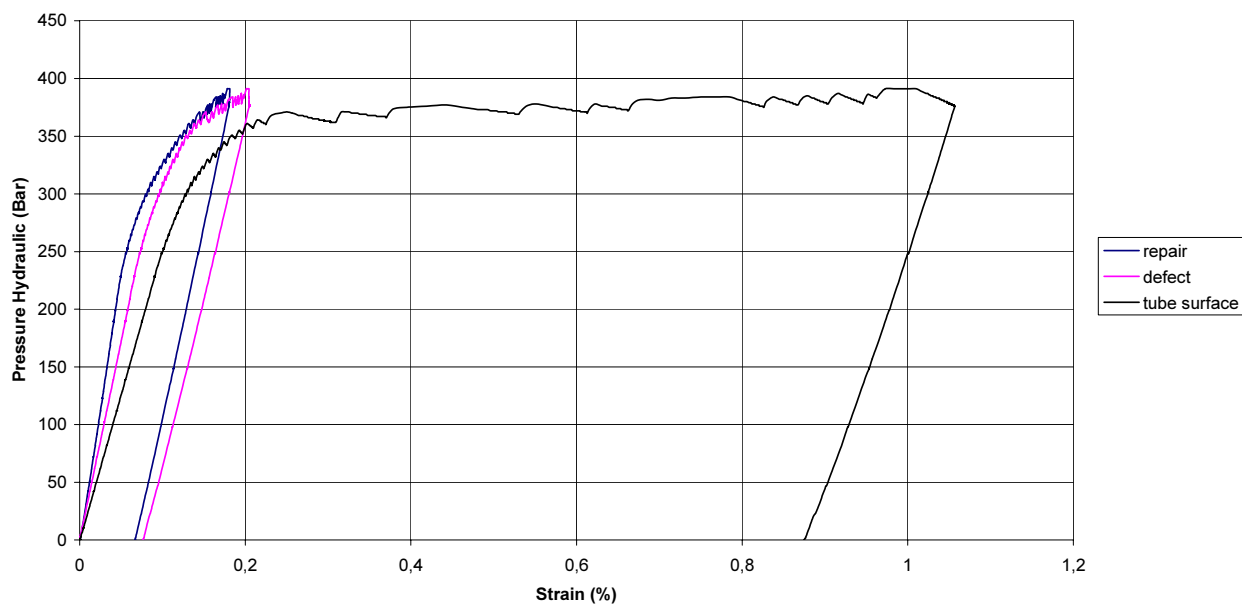
Figure 1-6 Pressure strain curve Nixus repair (Spool 63)

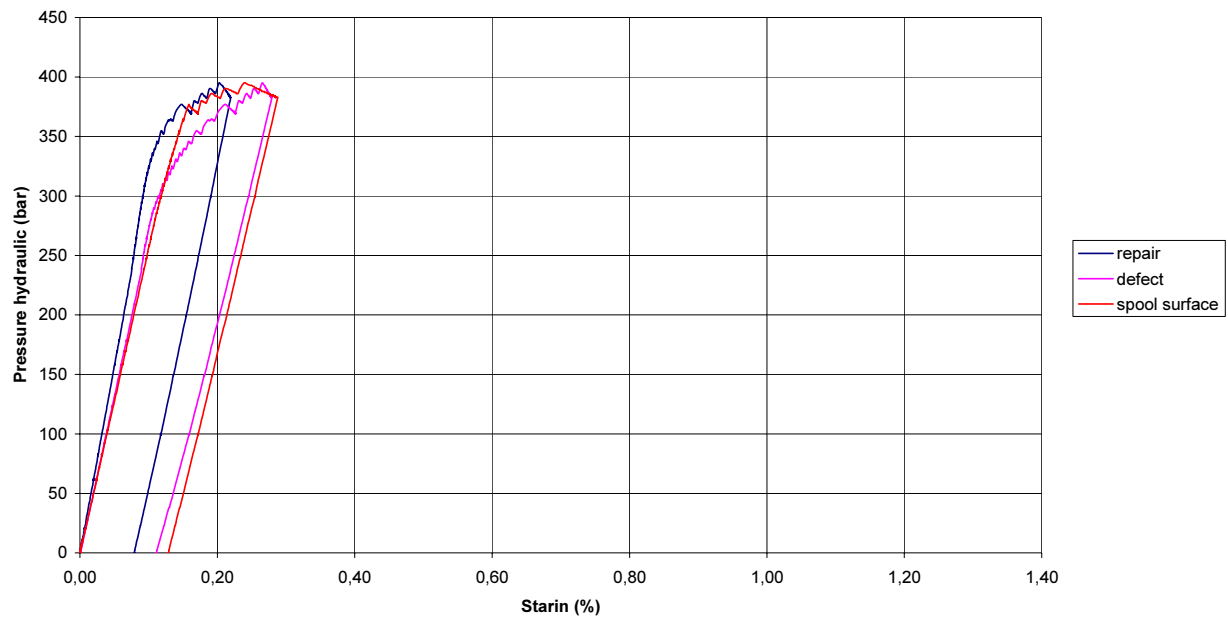
Figure 1-7 Pressure strain curve Synthoglass repair (Spool 71)

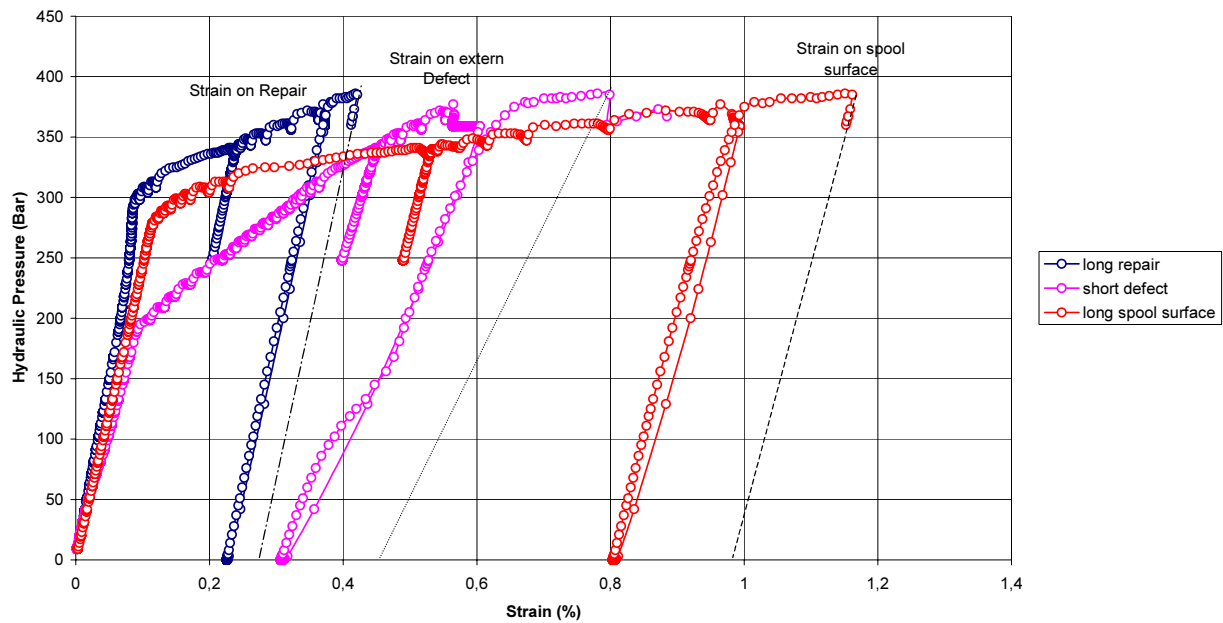
Figure 1-8 Pressure strain curve TDW repair (Spool 06)
