NOTE

| FILE | GSEI/A036/08.pdf | |
| SUBJECT | ASSESSMENT OF A VENTED EXTERNALLY APPLIED GEOMEMBRANE HOSE AS PERMEATION BARRIER FOR TRENCHED SPOOLABLE FIBRE REINFORCED PLASTIC PIPE IN HYDROCARBON SERVICE. 1000 HOUR PRESSURE TEST AT 65 °C | |

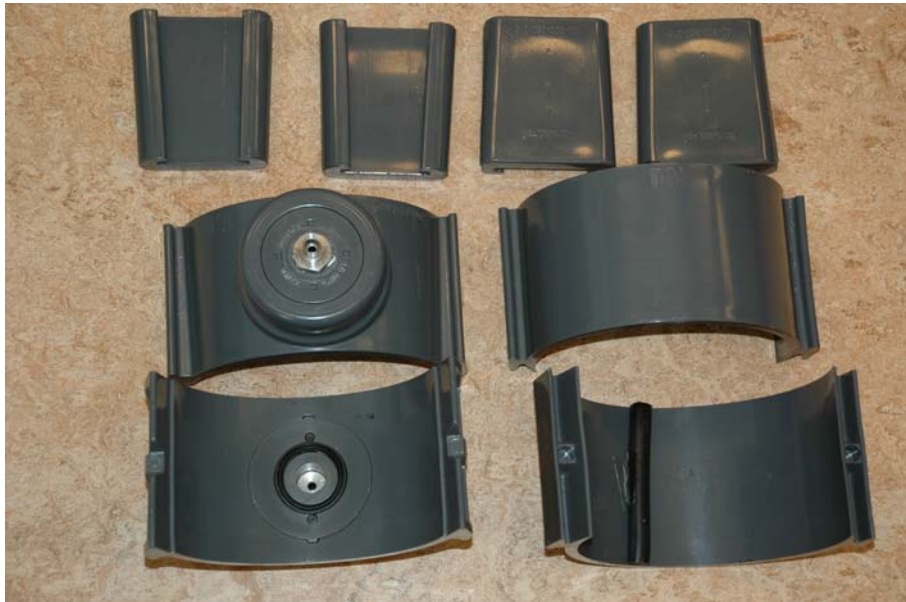
Photo 1 *PVC venting clamps as supplied by the pipe manufacturer*

Steel clamps were placed around the barrier at the polyurethane resin position. Rubber slabs were placed between the steel clamps and the barrier foil to prevent damage of the barrier foil from sharp edges of the clamp. Next to the clamps a Polyvinylchloride (PVC) based venting system was placed according supplier (Pipelife) procedures (Photos 1, 2 and 3).

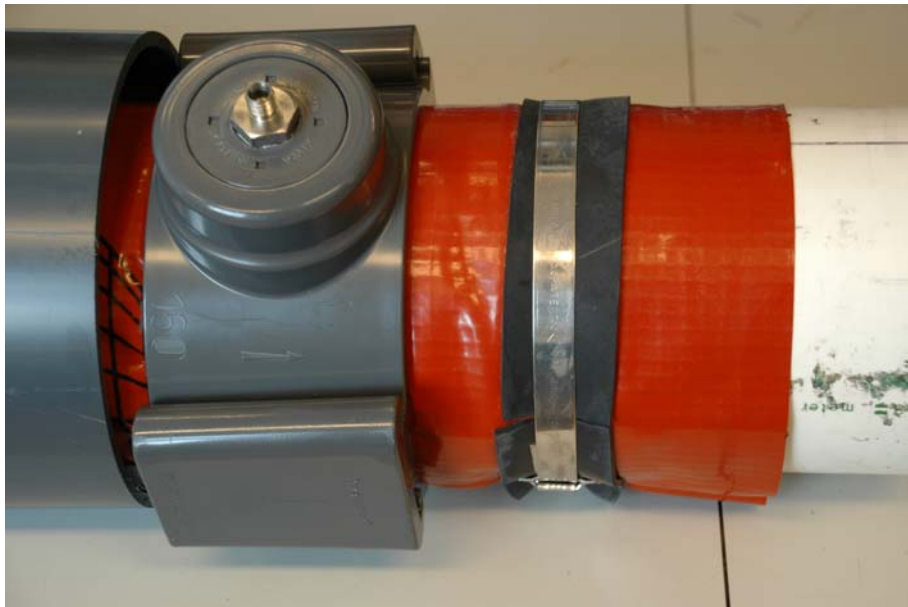
Photo 3 Venting system and metal clamps in position

The specimen started to leak air after 300 hours of 0.45 bar overpressure. Visual inspection showed leakage of air between one of the PVC venting clamps and the barrier foil. The barrier foil itself and its welded areas did not leak.

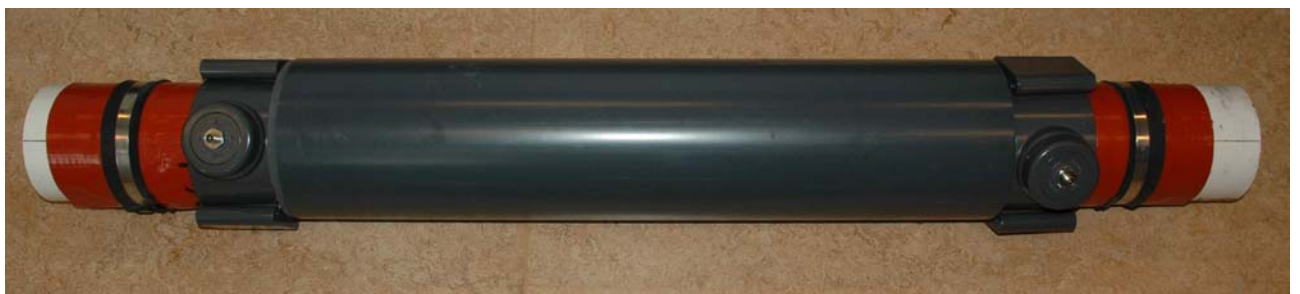
Photo 4 Test sample including anti ballooning PVC pipe

In order to prevent excessive ballooning of the barrier a PCV pipe was used to minimize the expansion of the barrier during pressurisation (Photo 4). This was considered representative for a buried pipe system.
