Corrosion under insulation

June 2019

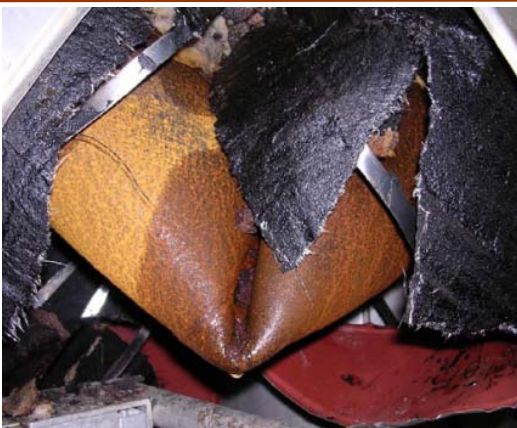
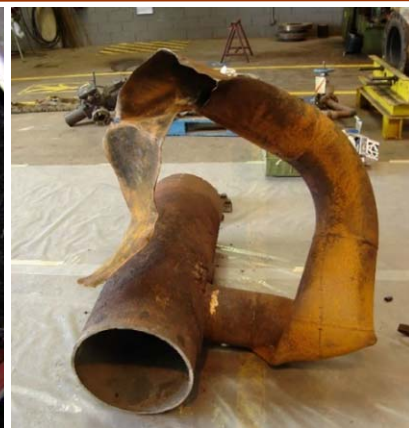
A plant experienced a catastrophic piping failure of an 8-inch (200 mm) insulated steel line containing noncorrosive cracked gas (~ 40% ethylene). The incident started as a pinhole leak that was detected by operators. The pipe failed while the line was being isolated and depressurized. Fortunately, the line folded as it failed, which limited the size of the release. There were no injuries.

The line was 30 years old. It was in a regeneration service where operation alternated among three different temperature conditions:

- Normal operation at 1 °F (–17 °C)
- Regeneration at 428 °F (220 °C)
- Standby at ambient temperature

These changes in operating temperature caused condensation of moisture from the atmosphere on the outside of the pipe, and re-evaporation. This is a well-known high-risk situation for corrosion under insulation (CUI). It can easily be missed if the mechanical integrity team is not aware of the changing operating conditions.

- Understand which equipment in your plant is most susceptible to CUI. Some examples include steel pipe, pipe in cold or cycling service, and pipe containing a corrosive fluid. Your corrosion experts can provide information to help you understand CUI in your plant.

- When you walk through the plant, look for damaged insulation, jackets, or seals where water can enter. These areas should be inspected, and the insulation repaired.

- Immediately report signs of any leak that you observe. Look for signs of liquid inside the insulation jacket such as drips or puddles (even if "only water"), discoloration, rust stains, and blistering. Follow up to make sure the leak is repaired in a timely manner.

- If insulation is removed during maintenance or repairs, use this chance to check the equipment for signs of corrosion. Also, remember that the job is not complete until the insulation is replaced.
