Outline

- Introduction
- Cyclic deformation & Low-Cycle Fatigue
- High-Cycle Fatigue
- Fatigue from Notches
- Fatigue Crack Propagation

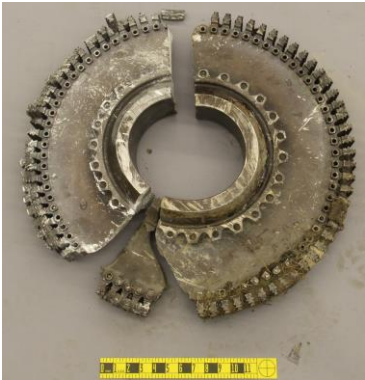
Recovered stage 2 HPT disk pieces

10,984 cycles / life limit of 15,000 cycles

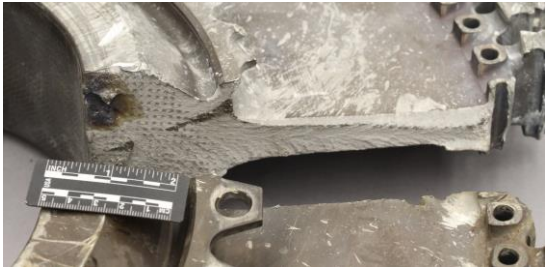
Fatigue crack location on a disk fracture surface

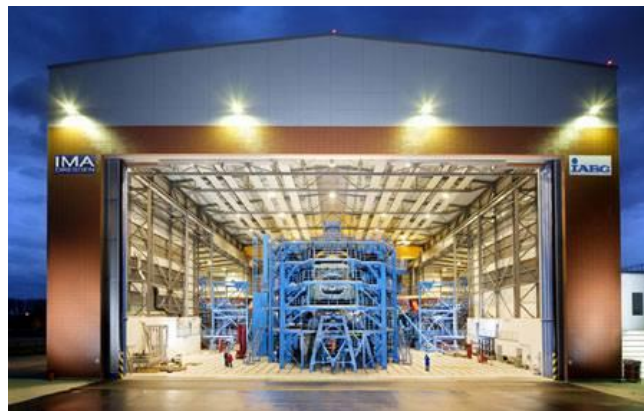
- Accelerated test simulating 47 500 flights, i. e. 25 years of commercial service, in 26 months
- 184 computer-controlled hydraulic rods

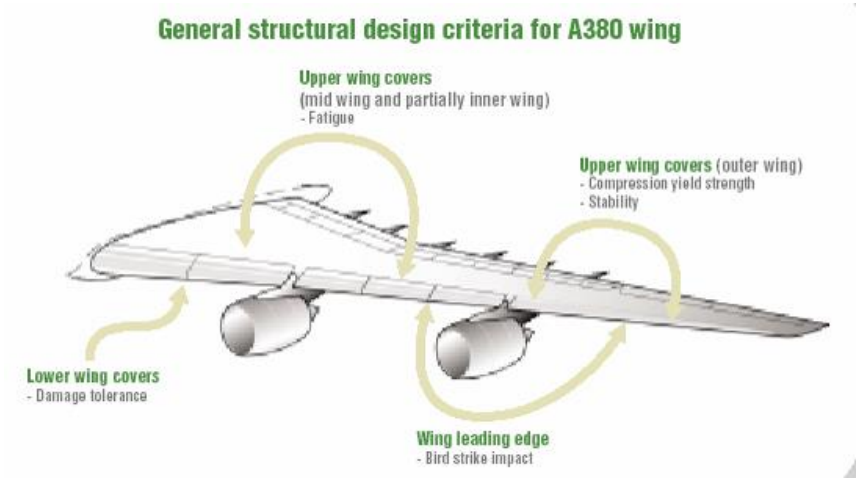
Design criteria for the A380 wing
