Structural metallic materials

5. Failure

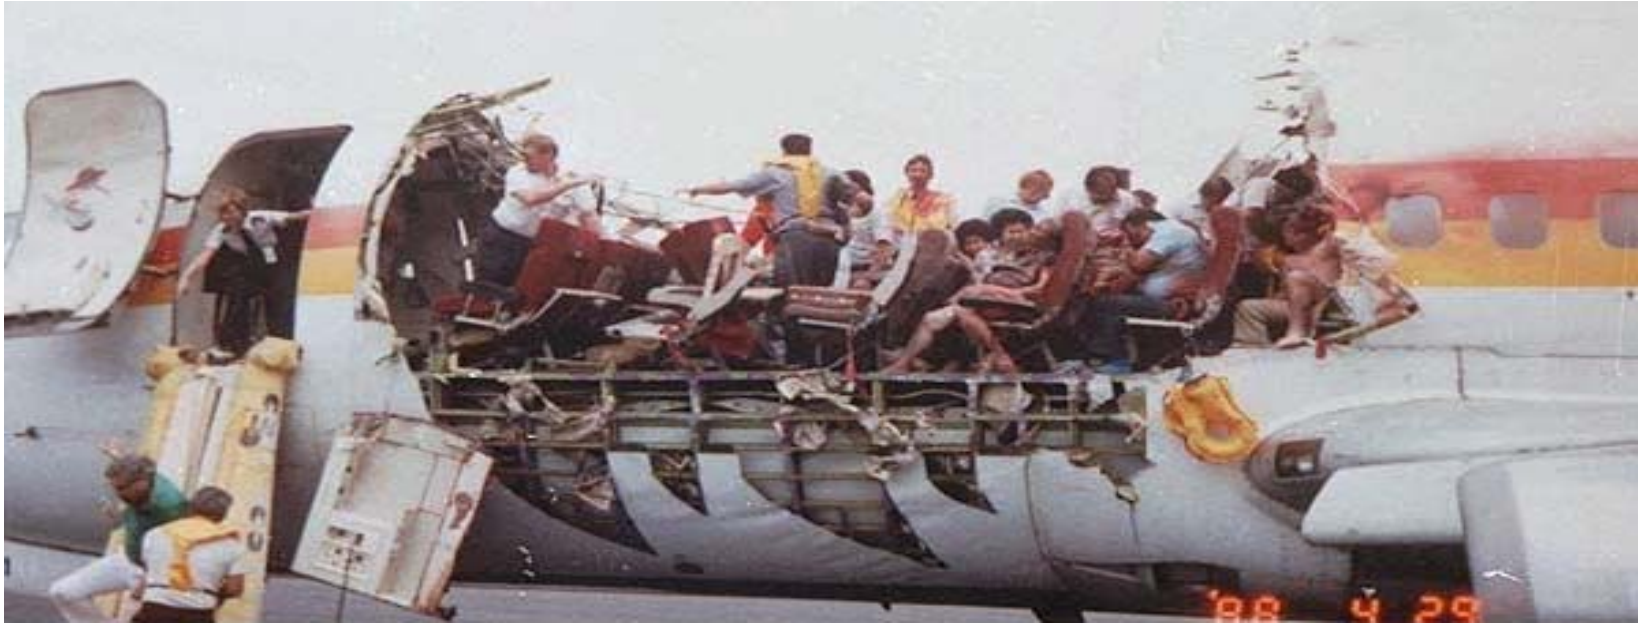
A Boeing 737-200 commercial aircraft(Aloha Airline flight 243) that experienced an explosive decompression and structural failure on April 28,1988.

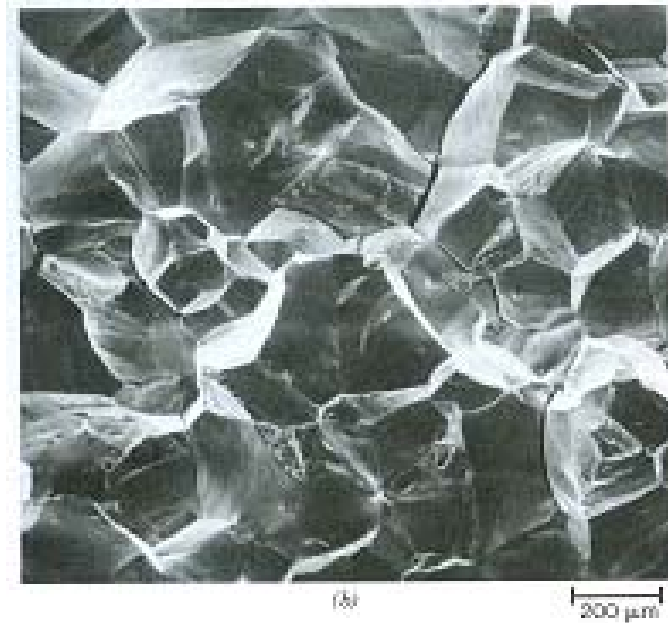
intergranular fracture: fracture of polycrystalline materials by crack propagation along grain boundaries.
