Microsoft Professional Capstone: Data Analysis

April 2015 Nepal Earthquake Building Damage

Key findings from a dataset collected by
The Central Bureau of Statistics of Nepal

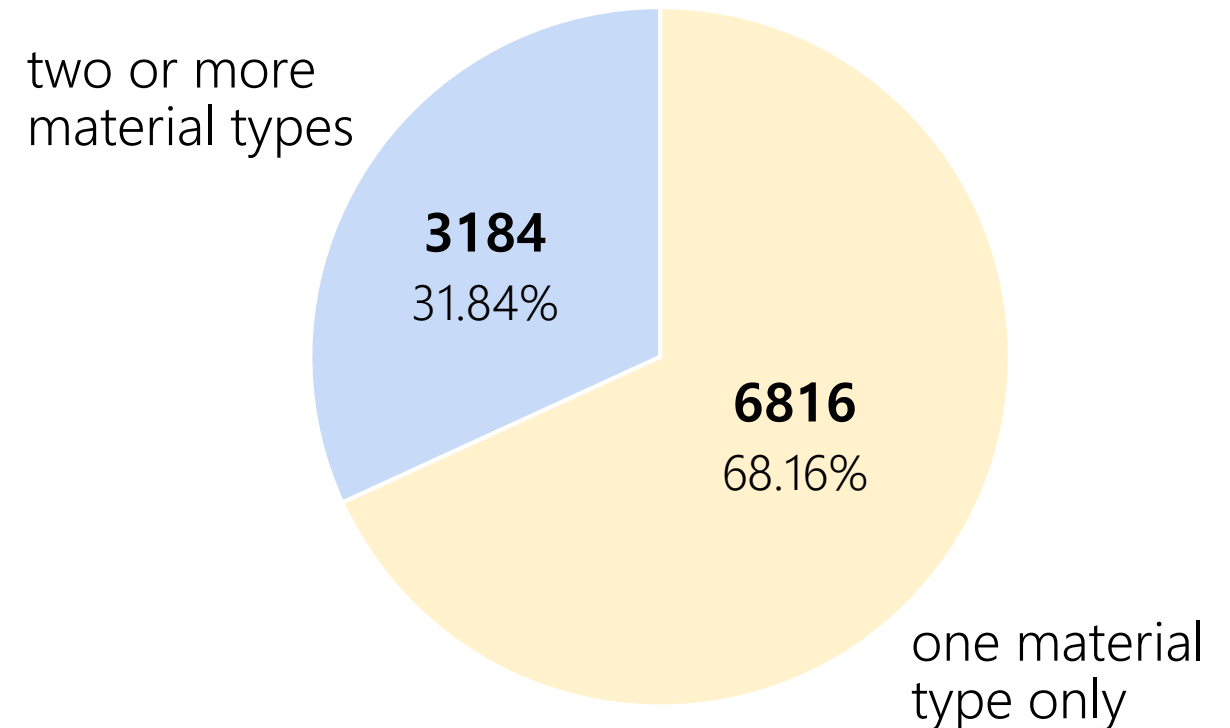
Building Count by Major Split

Material Type wise, buildings can be split into 2 major categories:

- A. Buildings logged with **one material type only**
- B. Buildings logged with **two or more material types**

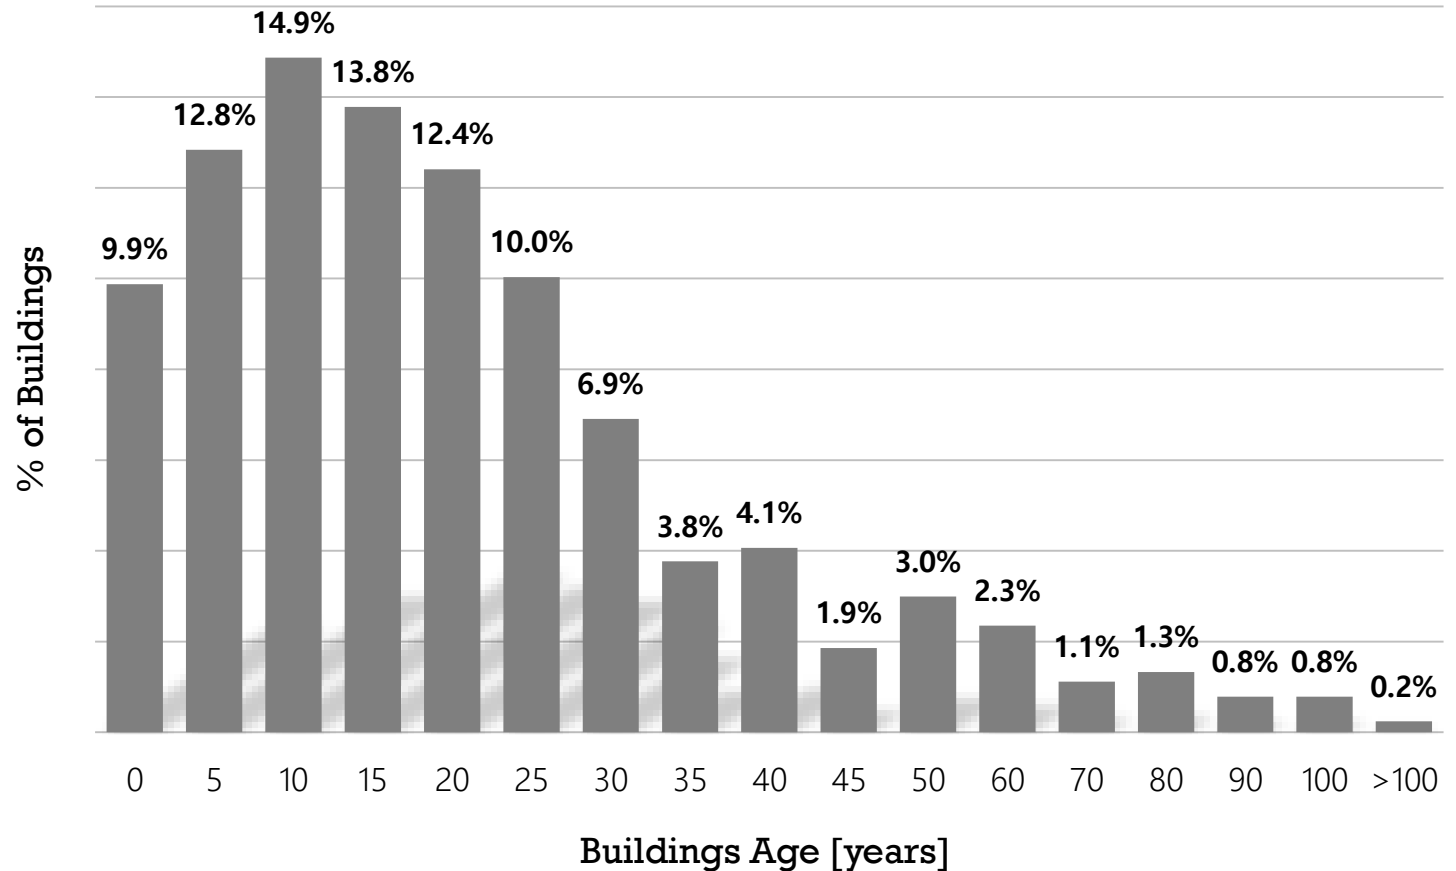
Building Distribution by Age

Descriptive Statistics:

- Sample Range: 0 - 200 years^(*)
- Median: 15 years
- Mode (most freq. age): 10 years
- Mean: 21.5 years
- Std Dev: 19.58 years

(*) Buildings logged with "Age 995" (undefined age) have not been considered here.

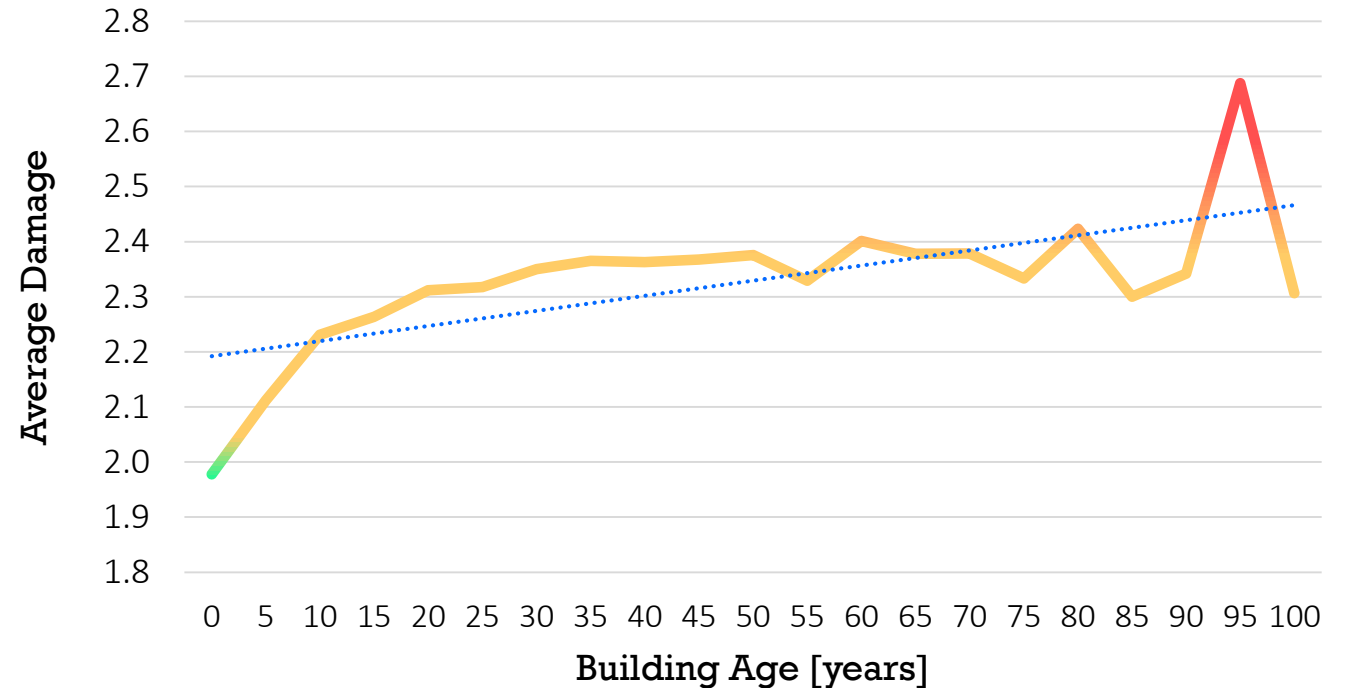
Building Age & Damage Level

Average Damage by Ages:

- Mean: 2.33
- Max: 2.69 (95 years)
- Min: 1.98 (0 years)
- Damage increase with building age
- Accelerated damage decline < 35 years

Note: Sample Range considered: 0 - 100 years (ages >100 years: 'outliers')
