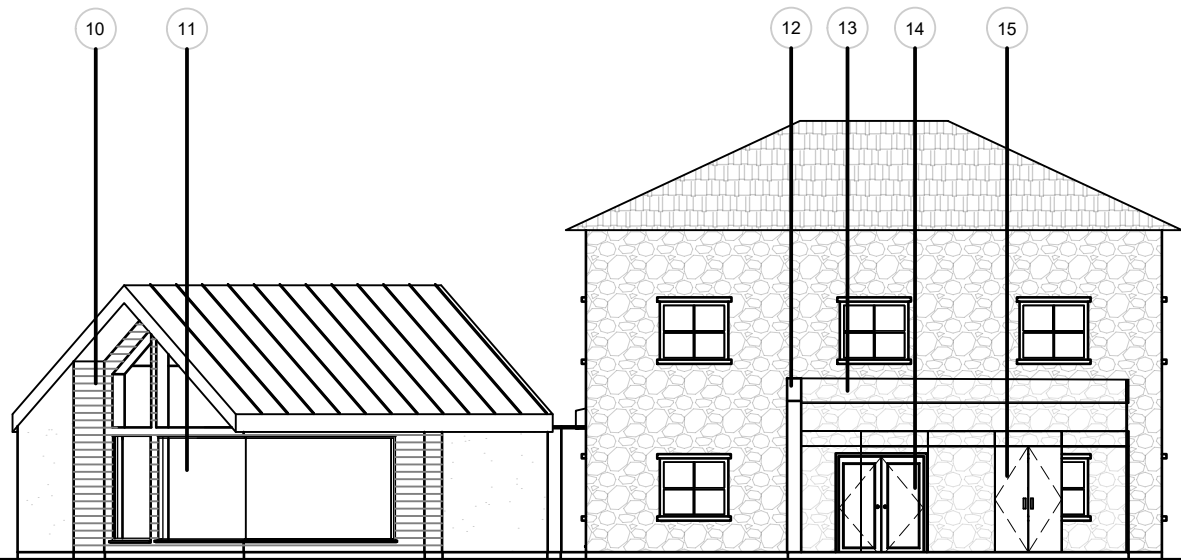
④ South Elevation  
Scale 1:150

1. Existing Sandstone to be surveyed and preserved
2. Existing Sash and Case Windows to be installed with an addition of secondary glazing.
3. Existing Slate Roof to be surveyed and preserved, replacements to match existing as best as possible.

4. Existing Slate Roof at extension to Farmhouse. To be surveyed and preserved. Replacements to match existing as best as possible.
5. Existing Brick cladding at extension, to be surveyed and preserved.

6. Existing window at extension to be converted to an exit door to outdoor area from community cafe.
7. Pilkington Activ Suncool combined with Pilkington Planar for structural glazing to create a walkway between the existing Farmhouse to New Extension.

8. Catnic SSR2 Standing Seam Panel in Anthracite RAL 7016. Fixed to new 30° Pitch Timber Roof.
9. ProWall Rendered Rainscreen Cladding in Uniform- White.

10. SILVALarch Siberian Larch Rainscreen Cladding
11. Large Aluminum clad timber windows in grey finish
12. Separating wall reclaimed from demolished outbuildings finished with Siberian Larch Rainscreen Cladding

13. Pilkington Activ Suncool combined with Pilkington Planar for structural glazing.
14. Existing entrance door at Farmhouse to be converted to a Double door.

15. Double glazing entrance door
