Ball Bearing Data Sets from Two-Disk Balancing Bench

Two-Disk Balancing Bench

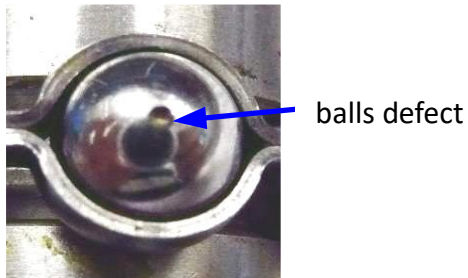
(d) triple fault
bearing

- Balls: \varnothing 1 mm hole
- Cage: \varnothing 1 mm hole

2010_0817_C6_I-C-B

* Bearing faults were all fabricated by electro-discharge machining.

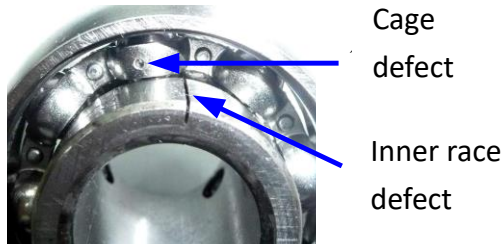
- Inner race: width 0.2 mm and depth 1 mm gap defect
