# Glider Deployment Report: calanus (October 19, 2024)

The Ecosystem Science Division (ESD) at the Southwest Fisheries Science Center (SWFSC) deployed glider **calanus** (unit\_1029) on 2024-10-19 off the coast of **Humboldt, CA** (40.75 ° N, -124.49 ° W) (Figure 1). Sensors deployed on the glider are listed in Table 1.

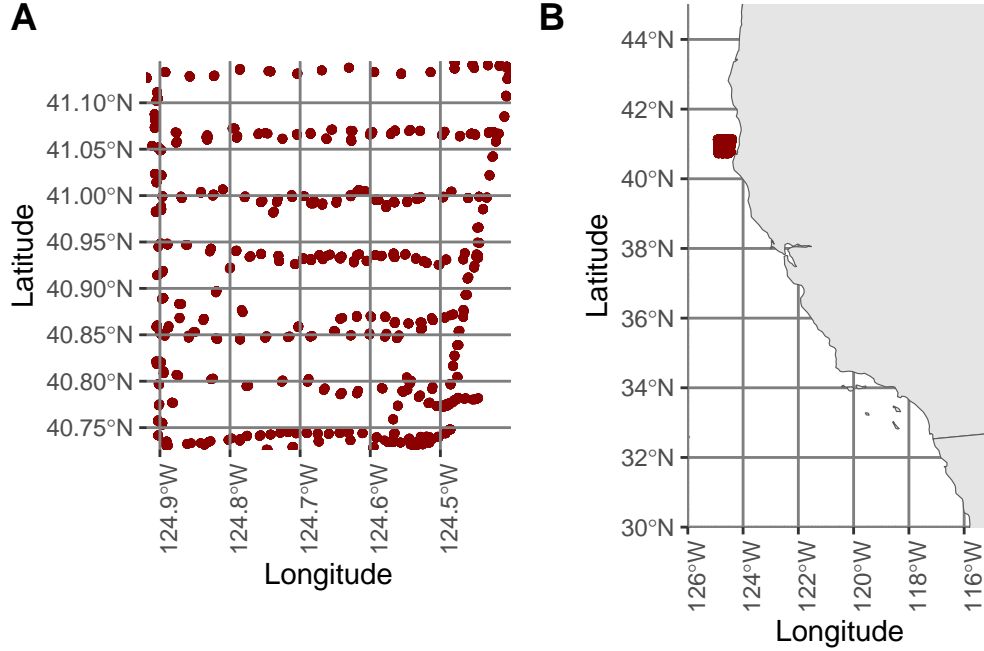
Figure 1: Glider tracklines. A displays close-up tracklines, while B displays the broad deployment area.

Figure 1 (A) displays tracklines of glider during deployment, while (B) displays the broad deployment area. The glider remained deployed for 29 days, performed 334 dives, and traveled a total of 688.39 km while diving to a maximum depth of 958.9 m. The glider was recovered on 2024-11-16.
