**Extended Data Figure 3 | Topography and current map of water-treated SNO thin films.** **a**, Optical image of SNO after applying bias to a selected area, where colour change occurs. **b**, Current map of pristine area, where the current is in the nanoampere range. **c**, The corresponding surface topography of the pristine area. **d**, Current map of water-treated area, which is entirely dark compared with the pristine state (**b**). The current

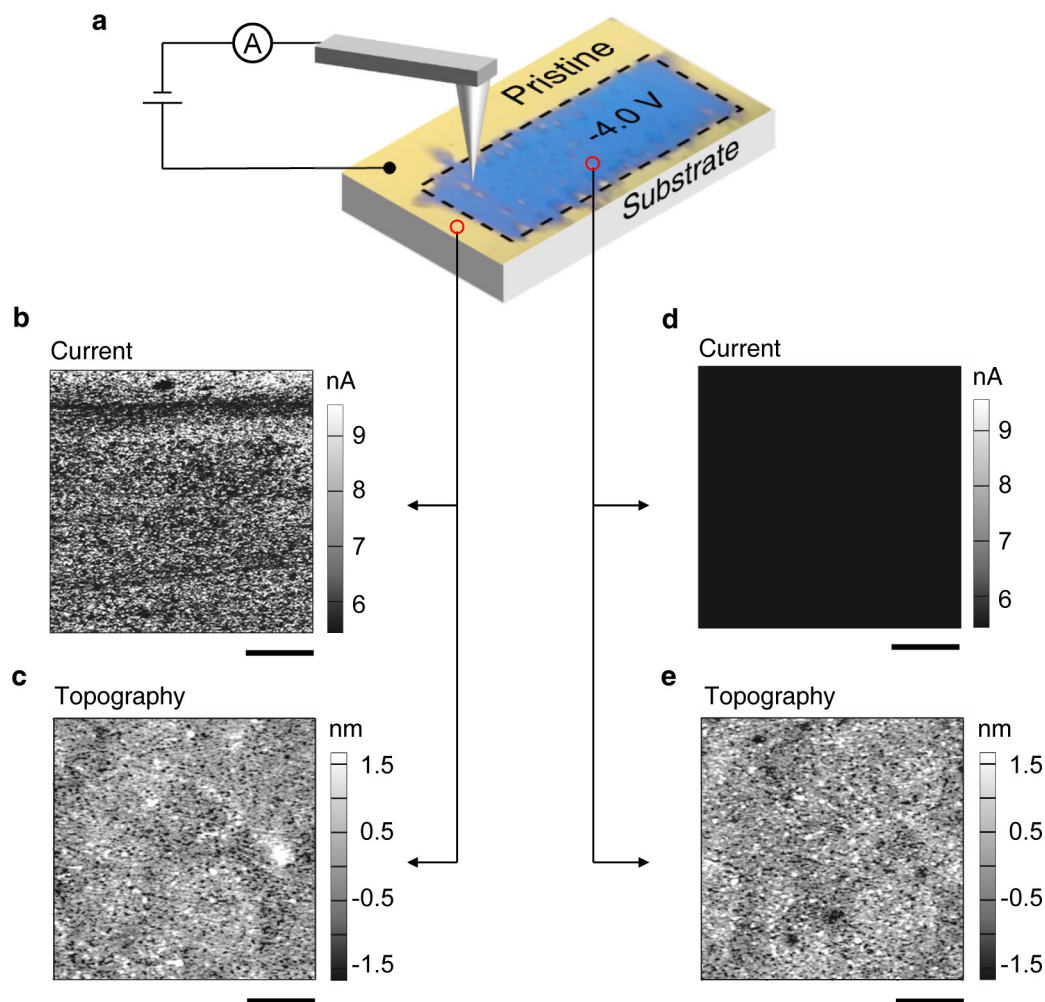
after sensing is decreased to the picoampere range owing to proton uptake. **e**, The corresponding surface topography of SNO after sensing, where no evidence of corrosion was observed compared with the pristine state (**c**). Moreover, almost no variance is observed in the surface roughness of the thin film (Supplementary Information section 3). Scale bars are 0.5 μm.
