Santo Domingo Creek at Rock Lititz

Stream and Floodplain Restoration

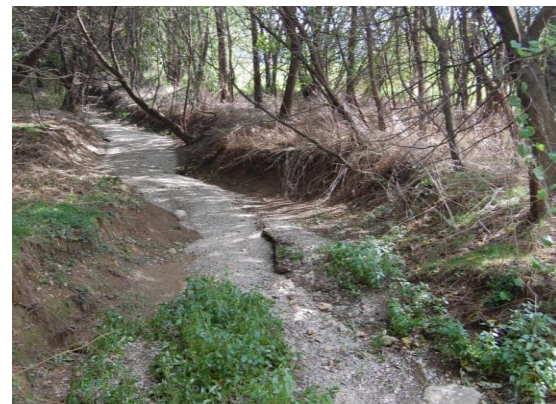
Before Restoration

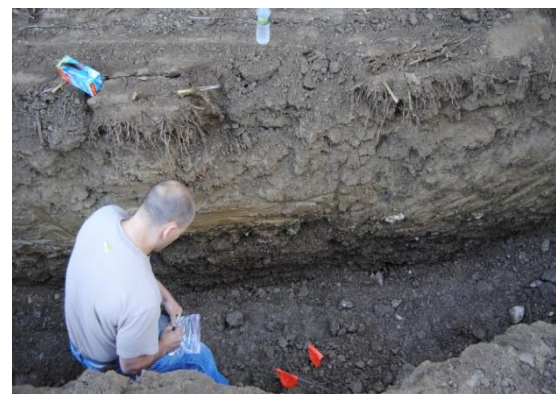
Stormwater Management-Infiltration Evaluation
