Big Spring Run

Stream and Floodplain Restoration

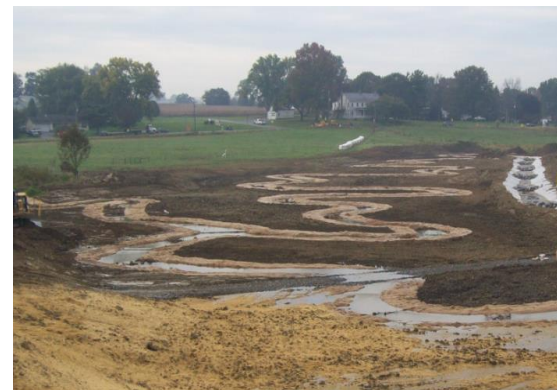
During construction

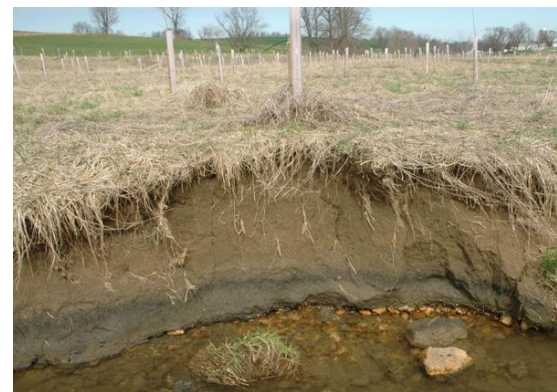
The Big Spring Run tributary is a headwater system that has been impacted by historical human activities. Big Spring Run became characterized by severe streambank erosion and stream bed degradation, with the nutrient-rich sediment released through these erosional processes affecting downstream water quality.

Before construction
