# FIRE WATER TANK 851 A

Vedanta Cairn oil & Gas division			
Project Name	FIRE WATER TANK 851 A	Report number	VOLAT-T-851-A-EMAT
Location	Raageshwari Gas terminal, Barmer	Client representative	Simon Doss

Asset Information			
Asset	FIRE WATER TANK	Inspection date	2024-05-15
Asset type	CARBONSTEEL	Report date	2024-05-24
Asset number	851 A

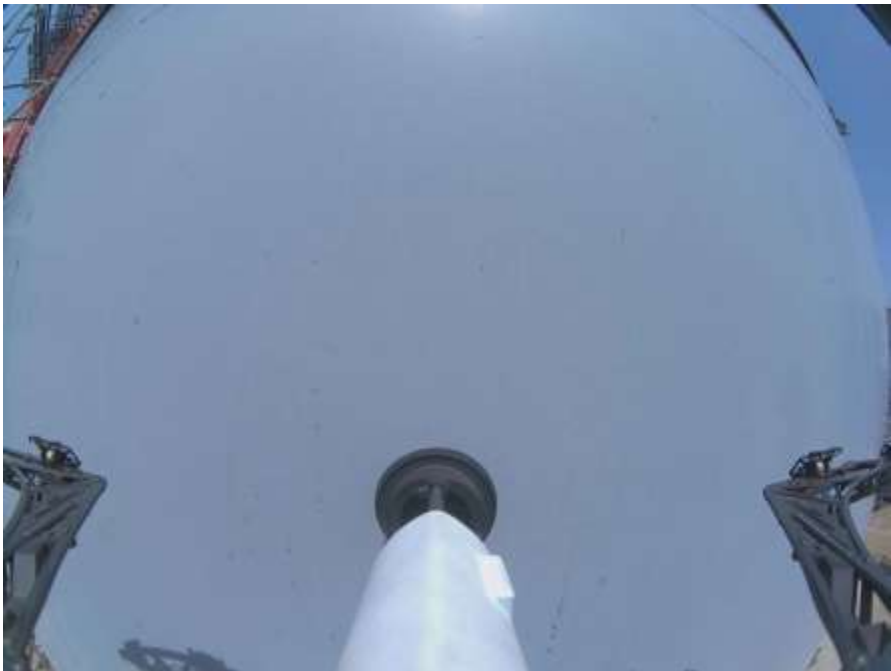
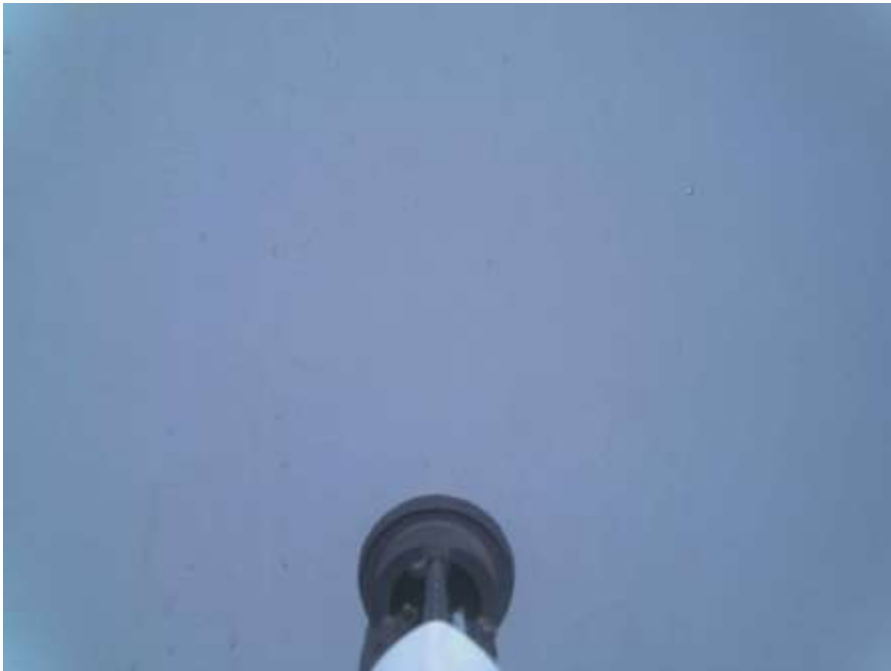
Figure 1: Location - Point 1

Thickness [mm]	10.030	XYZ Coordinates [m]	4.07	0.47	4.80
Rotation	Pitch: -0.8°	Timestamp [s]	15 May 2024, 09:02:17

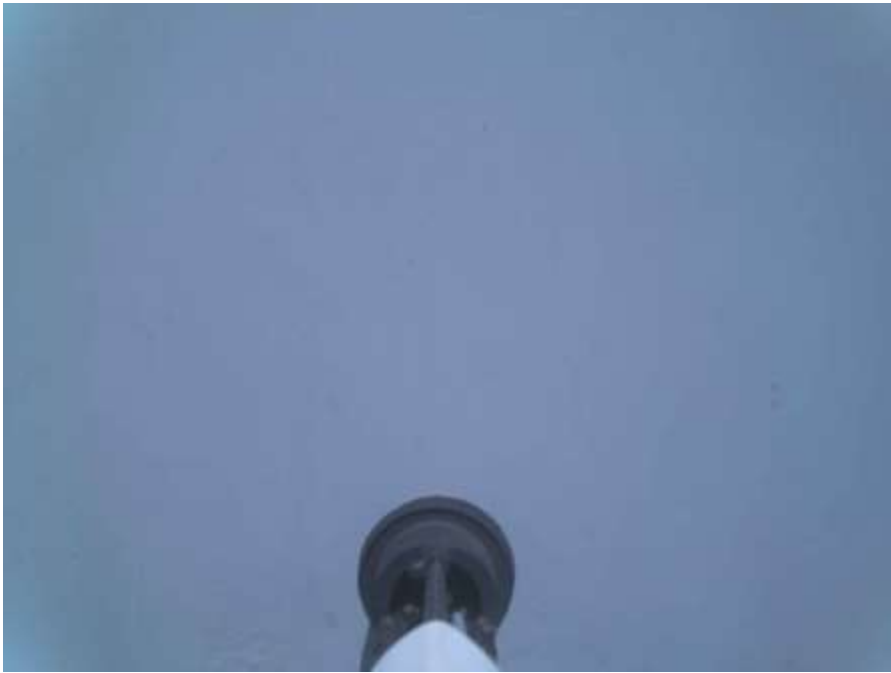
Figure 4: Location - Point 2

Thickness [mm]	10.320	XYZ Coordinates [m]	0.06	6.97	6.75
Rotation	Pitch: -0.0°	Timestamp [s]	15 May 2024, 09:02:38

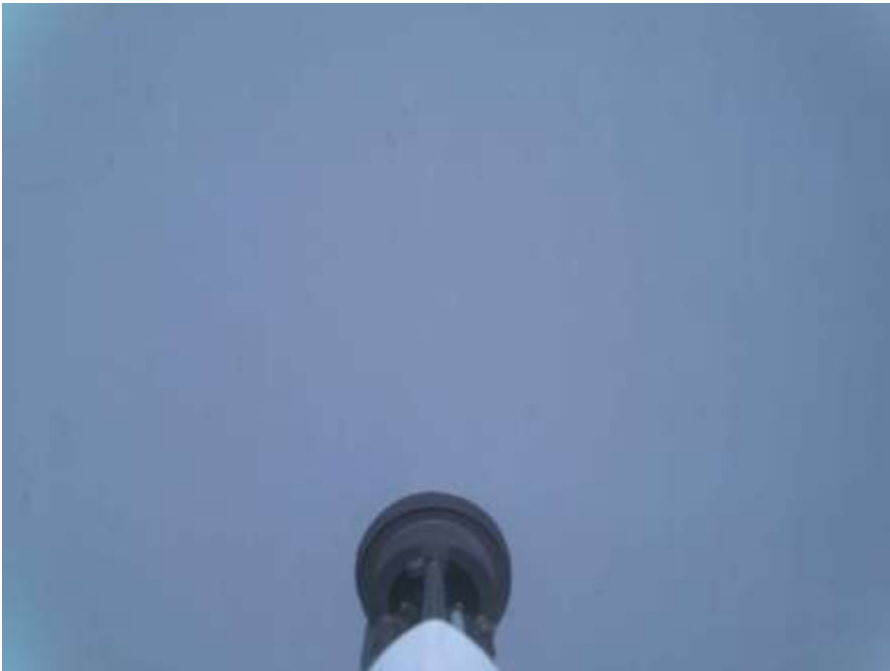
Figure 7: Location - Point 3

Thickness [mm]	8.020	XYZ Coordinates [m]	0.02	6.40	9.10
Rotation	Pitch: -0.5°	Timestamp [s]	15 May 2024, 09:02:59

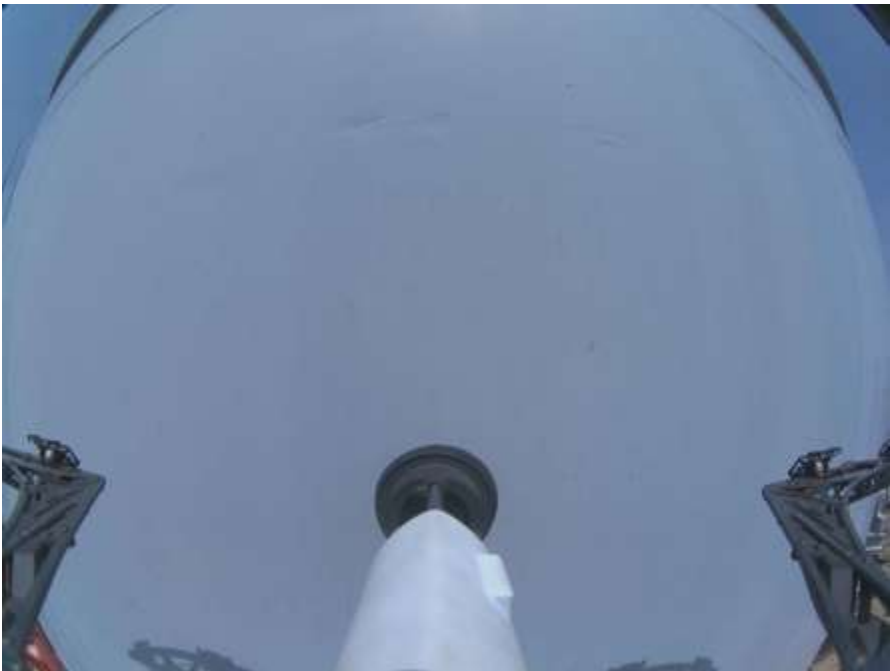
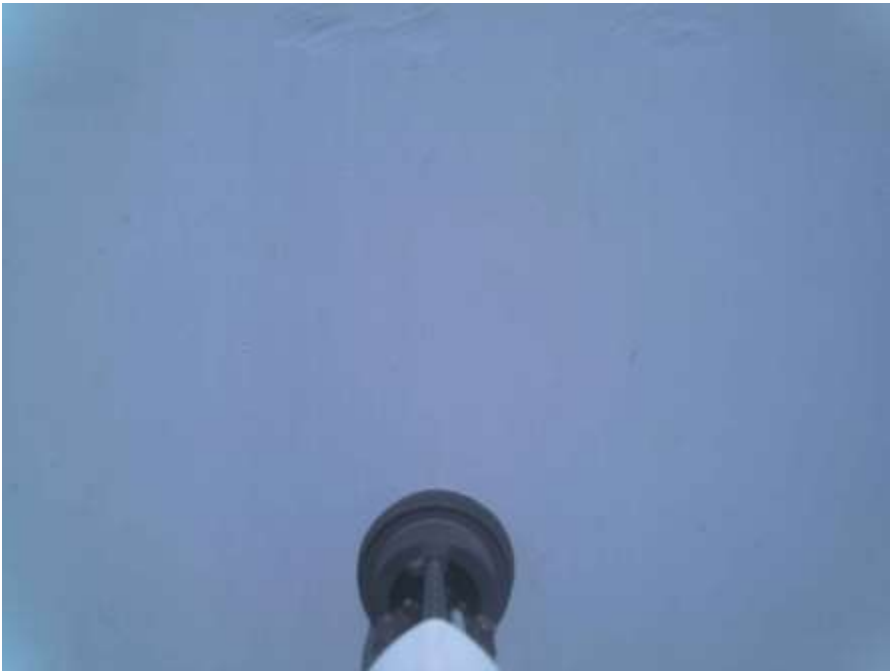
Figure 10: Location - Point 4

Thickness [mm]	8.020	XYZ Coordinates [m]	0.04	5.81	10.88
Rotation	Pitch: -0.2°	Timestamp [s]	15 May 2024, 09:03:18

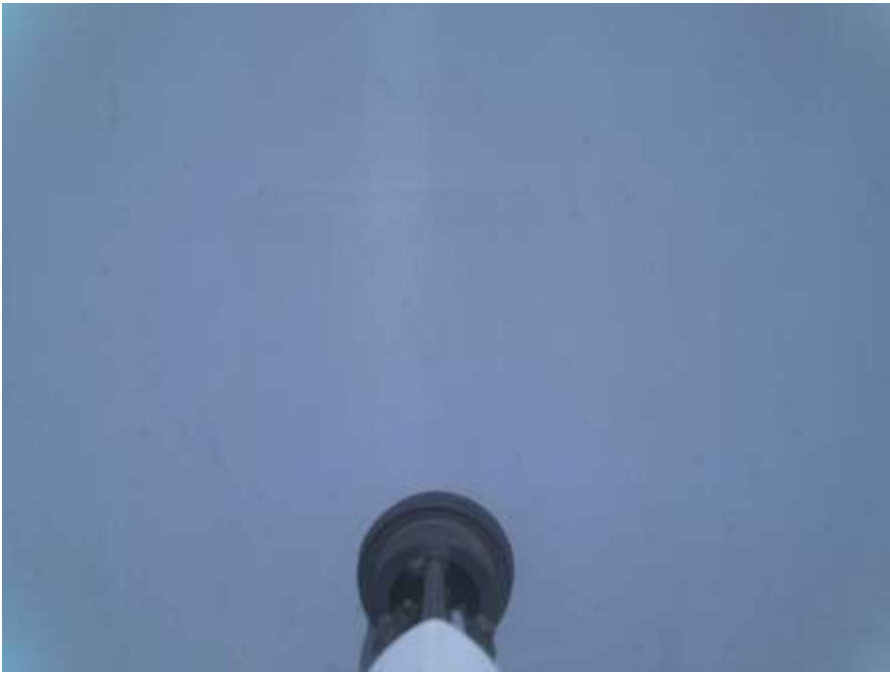
Figure 13: Location - Point 5

Thickness [mm]	8.140	XYZ Coordinates [m]	0.04	5.20	11.78
Rotation	Pitch: -0.2°	Timestamp [s]	15 May 2024, 09:03:44

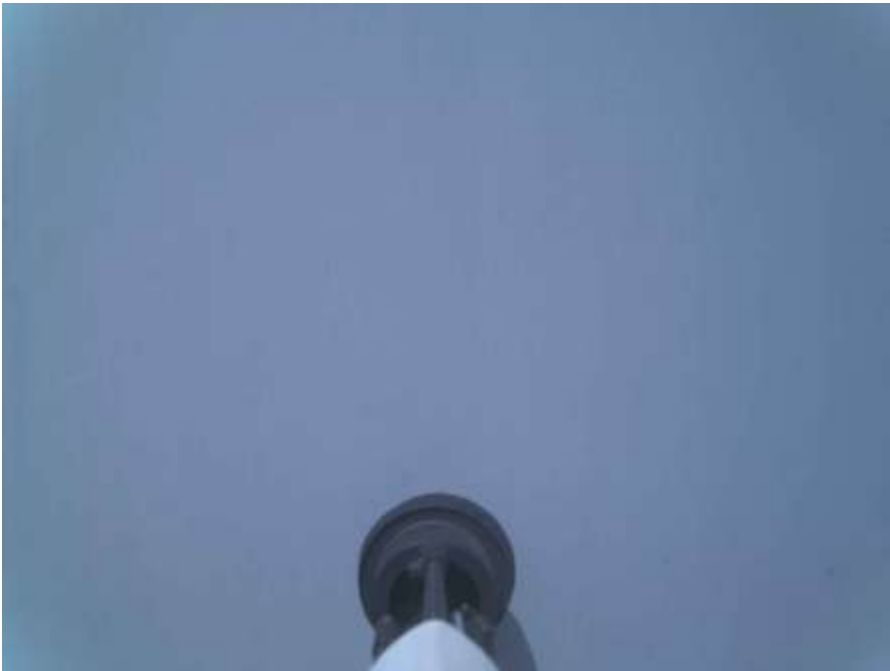
Figure 20: Location - Point 7

Thickness [mm]	8.180	XYZ Coordinates [m]	4.04	5.68	10.26
Rotation	Pitch: -0.3°	Timestamp [s]	15 May 2024, 09:04:34

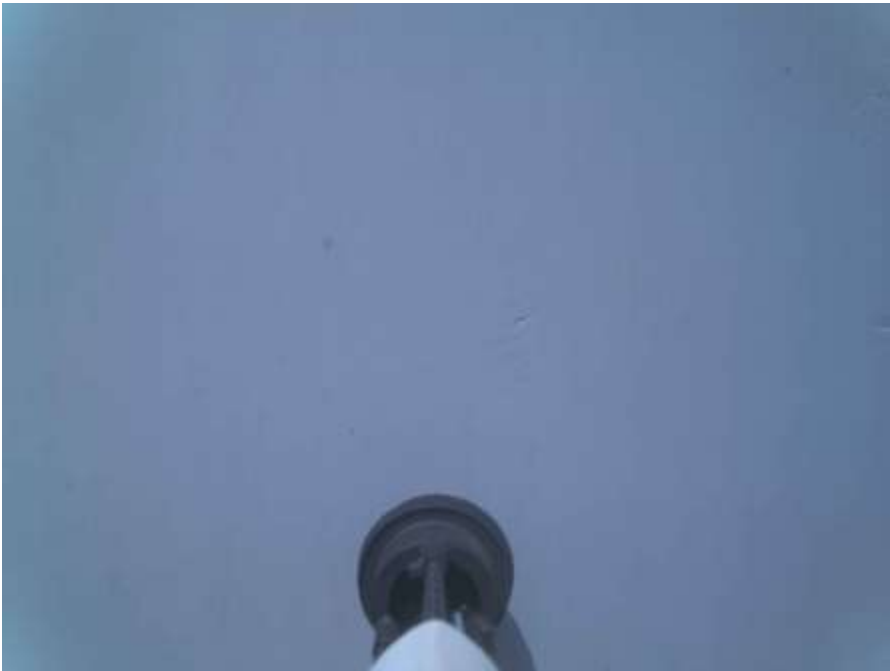
Figure 23: Location - Point 8

Thickness [mm]	8.340	XYZ Coordinates [m]	4.10	5.42	8.67
Rotation	Pitch: -0.1°	Timestamp [s]	15 May 2024, 09:04:53

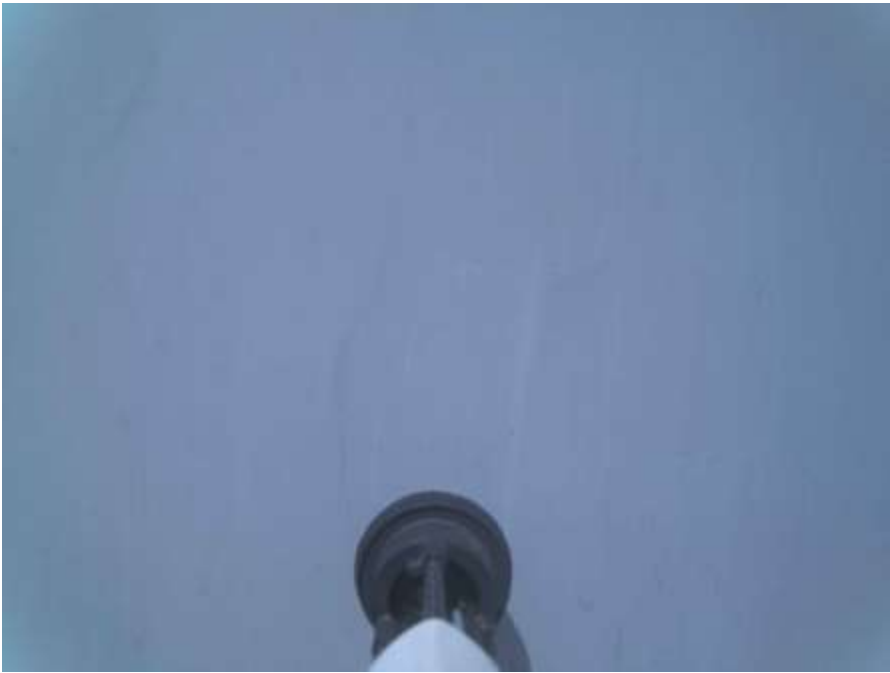
Figure 25: Location - Point 9

Thickness [mm]	10.320	XYZ Coordinates [m]	4.35	4.94	6.88
Rotation	Pitch: 0.1°	Timestamp [s]	15 May 2024, 09:05:13

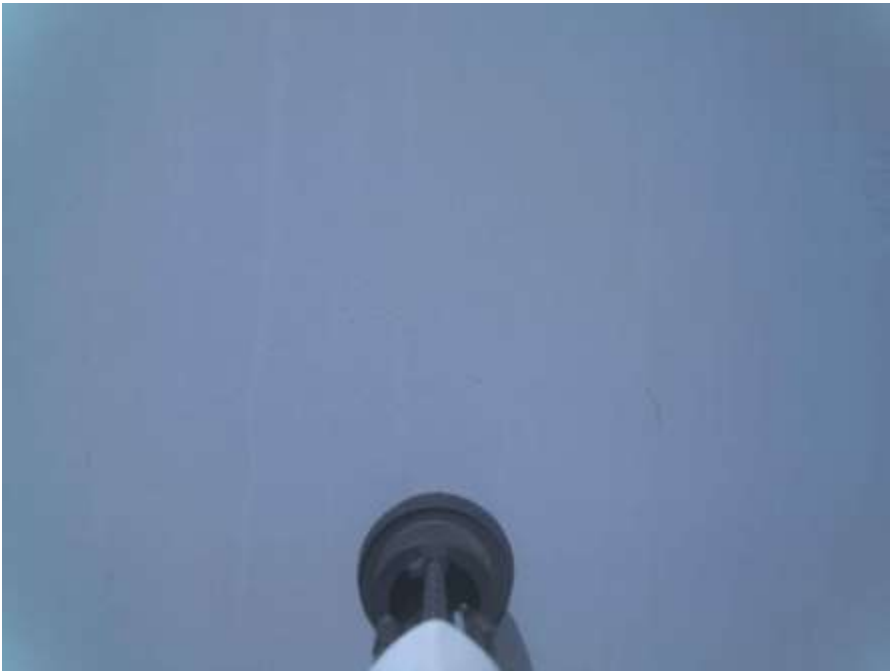
Figure 28: Location - Point 10

Thickness [mm]	10.720	XYZ Coordinates [m]	4.49	4.63	5.64
Rotation	Pitch: -1.4°	Timestamp [s]	15 May 2024, 09:05:39

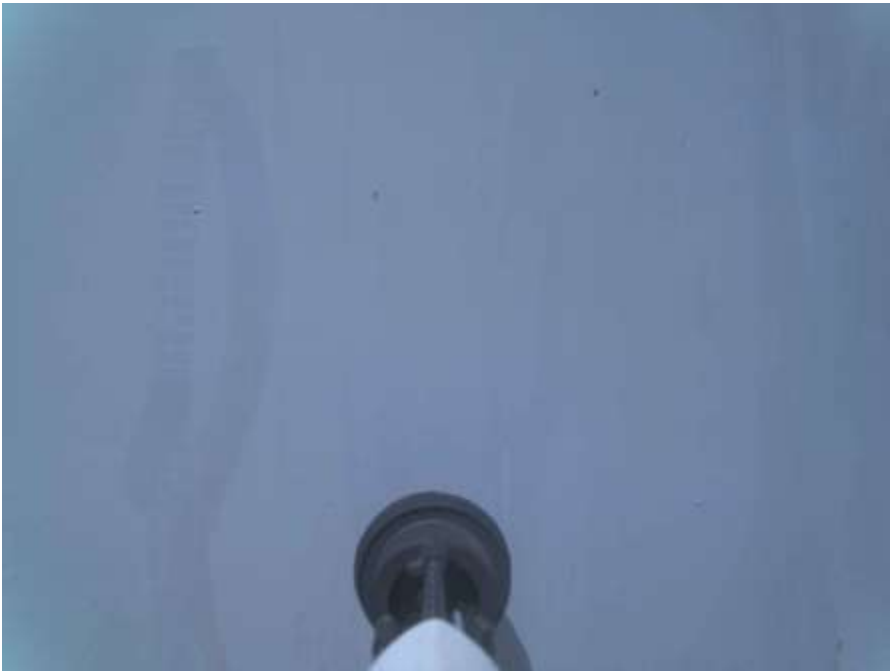
Figure 32: Location - Point 11

Thickness [mm]	10.360	XYZ Coordinates [m]	4.64	4.44	8.62
Rotation	Pitch: -0.2°	Timestamp [s]	15 May 2024, 09:06:06

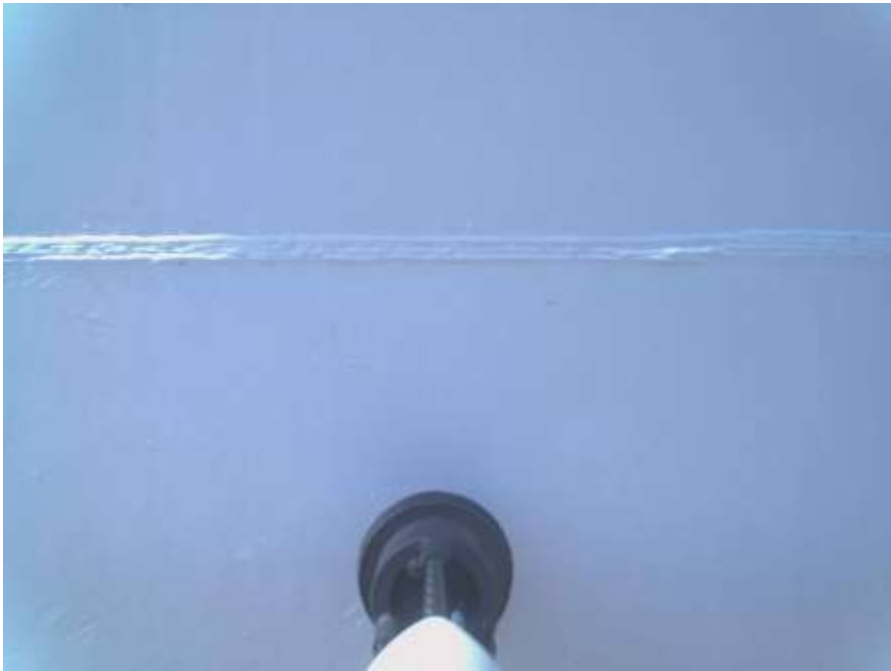
Figure 34: Location - Point 1

Thickness [mm]	14.350	XYZ Coordinates [m]	5.28	1.95	3.54
Rotation	Pitch: -0.5°	Timestamp [s]	15 May 2024, 09:57:56

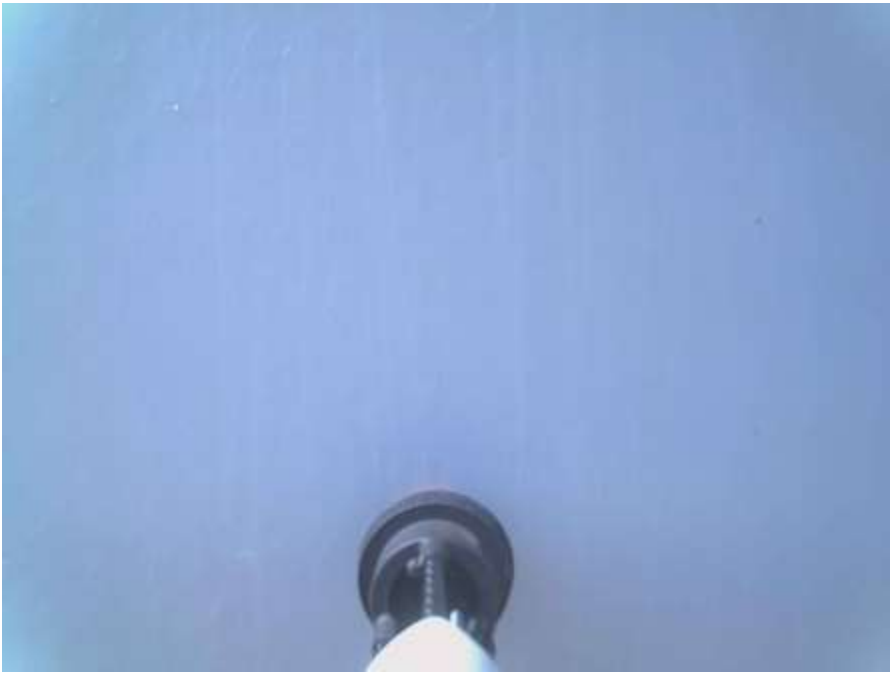
Figure 37: Location - Point 2

Thickness [mm]	10.030	XYZ Coordinates [m]	5.25	1.89	2.38
Rotation	Pitch: -1.0°	Timestamp [s]	15 May 2024, 09:58:17

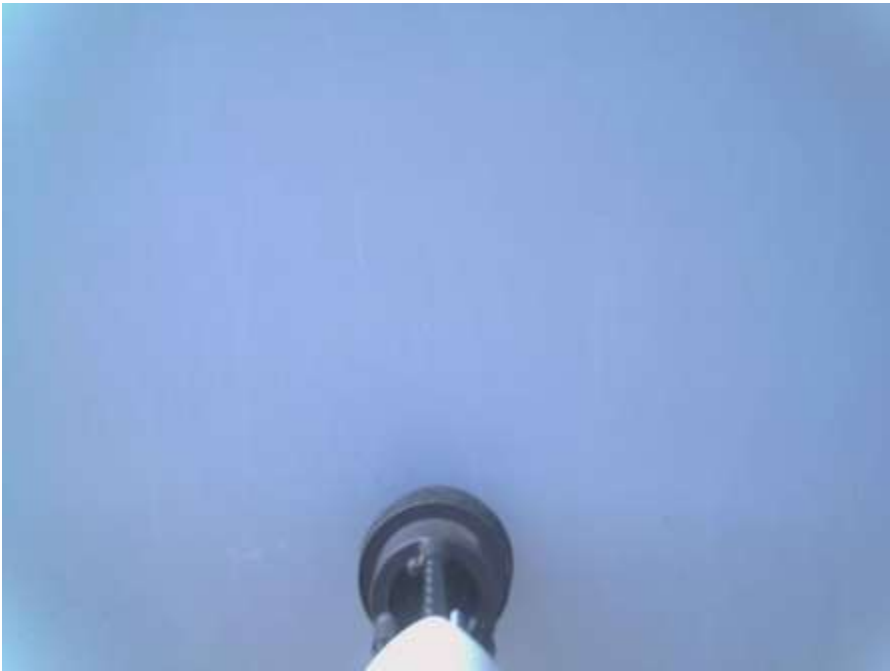
Figure 40: Location - Point 3

Thickness [mm]	9.950	XYZ Coordinates [m]	5.21	1.77	0.69
Rotation	Pitch: -0.2°	Timestamp [s]	15 May 2024, 09:58:39

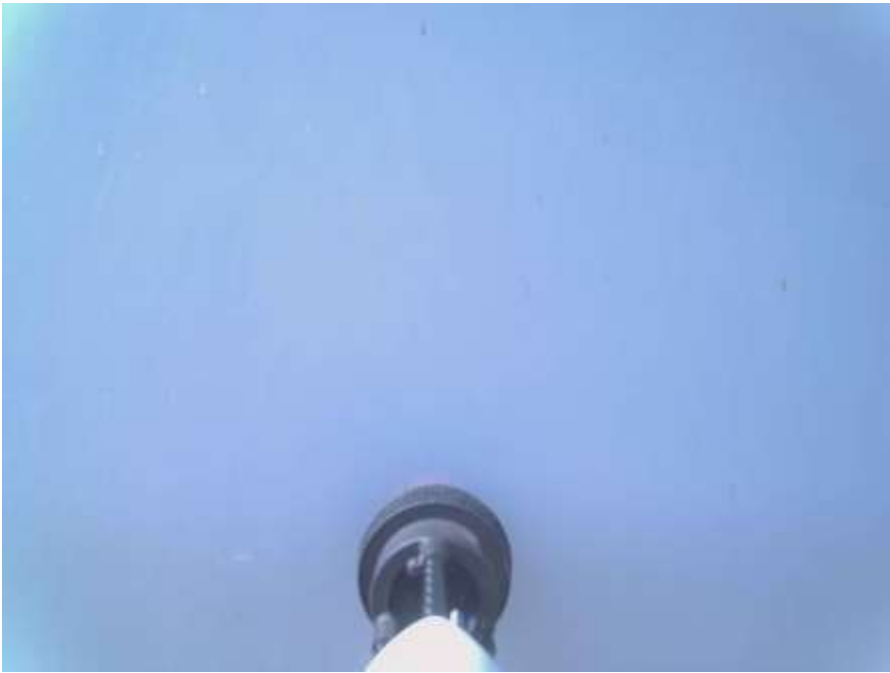
Figure 43: Location - Point 4

Thickness [mm]	8.620	XYZ Coordinates [m]	5.17	1.78	1.46
Rotation	Pitch: -0.4°	Timestamp [s]	15 May 2024, 09:59:00

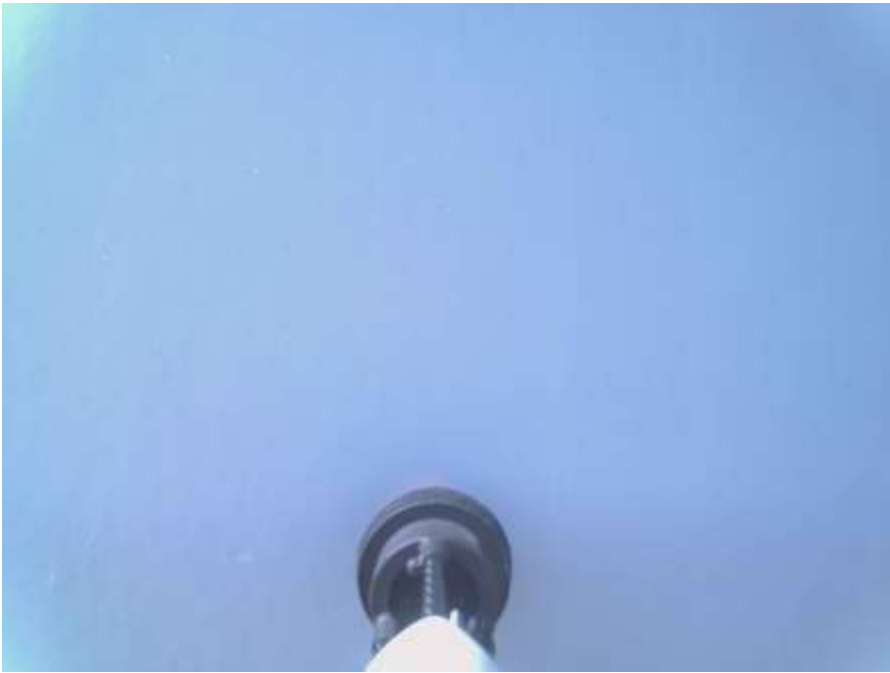
Figure 46: Location - Point 5

Thickness [mm]	7.940	XYZ Coordinates [m]	5.22	1.77	3.40
Rotation	Pitch: -0.5°	Timestamp [s]	15 May 2024, 09:59:21

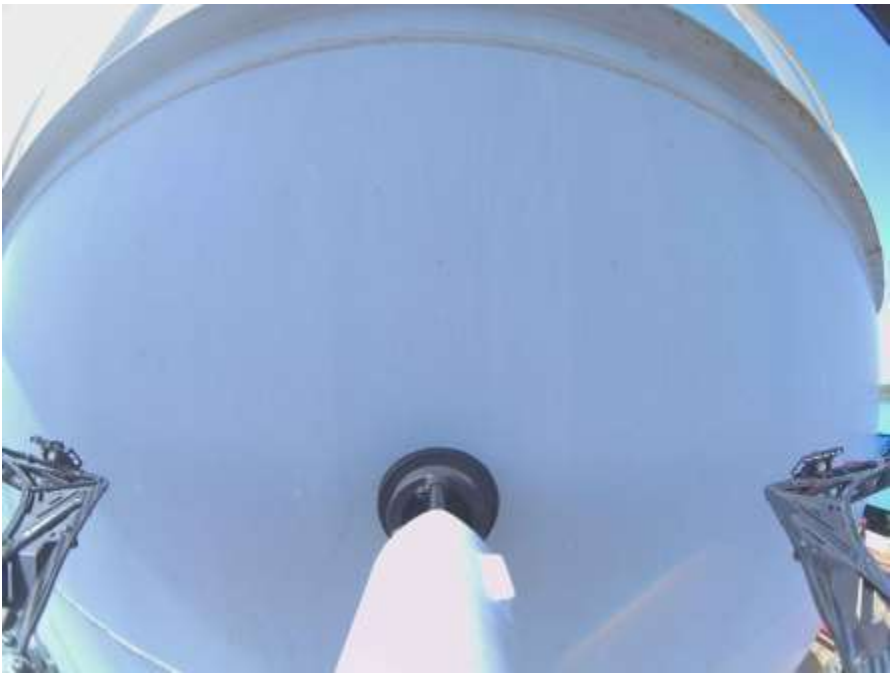
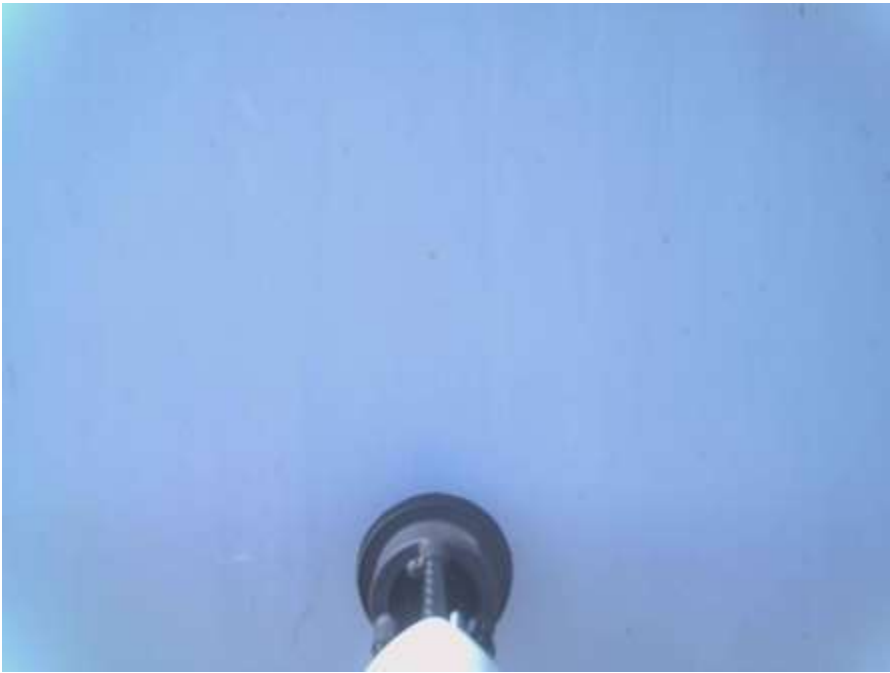
Figure 49: Location - Point 6

Thickness [mm]	7.900	XYZ Coordinates [m]	5.33	1.65	4.58
Rotation	Pitch: -0.5°	Timestamp [s]	15 May 2024, 09:59:42

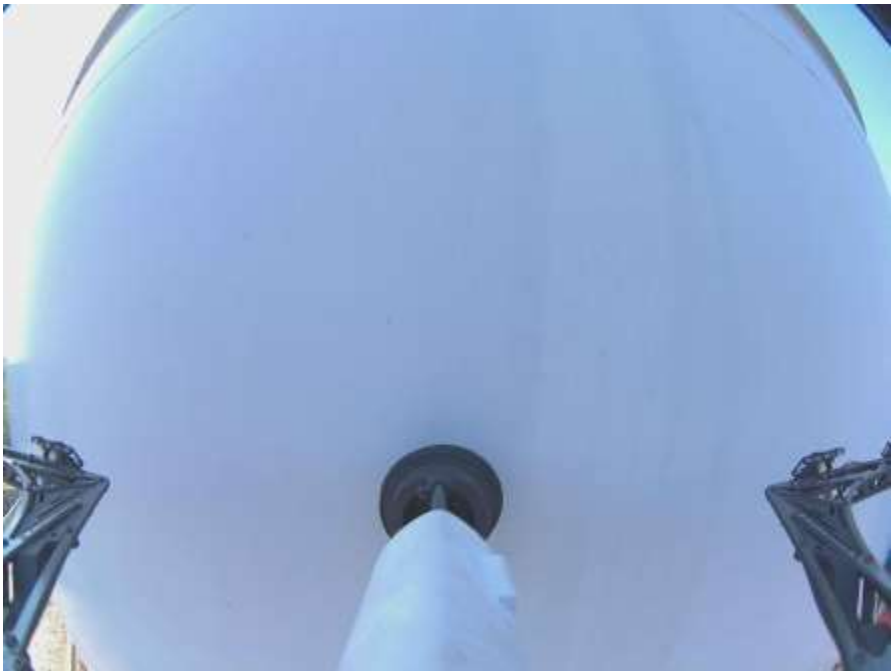
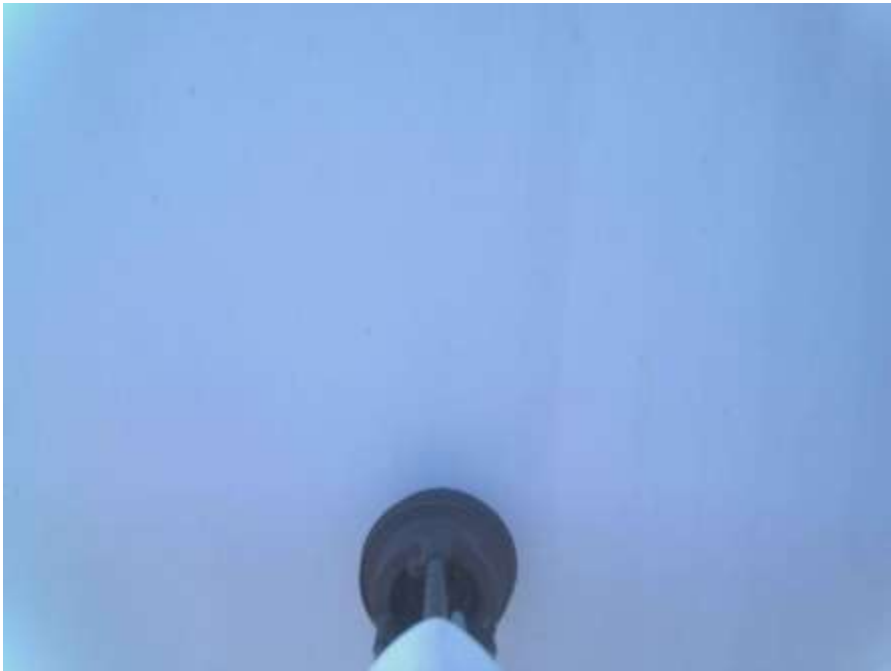
Figure 55: Location - Point 8

Thickness [mm]	8.420	XYZ Coordinates [m]	7.35	5.89	2.57
Rotation	Pitch: -0.9°	Timestamp [s]	15 May 2024, 10:00:40

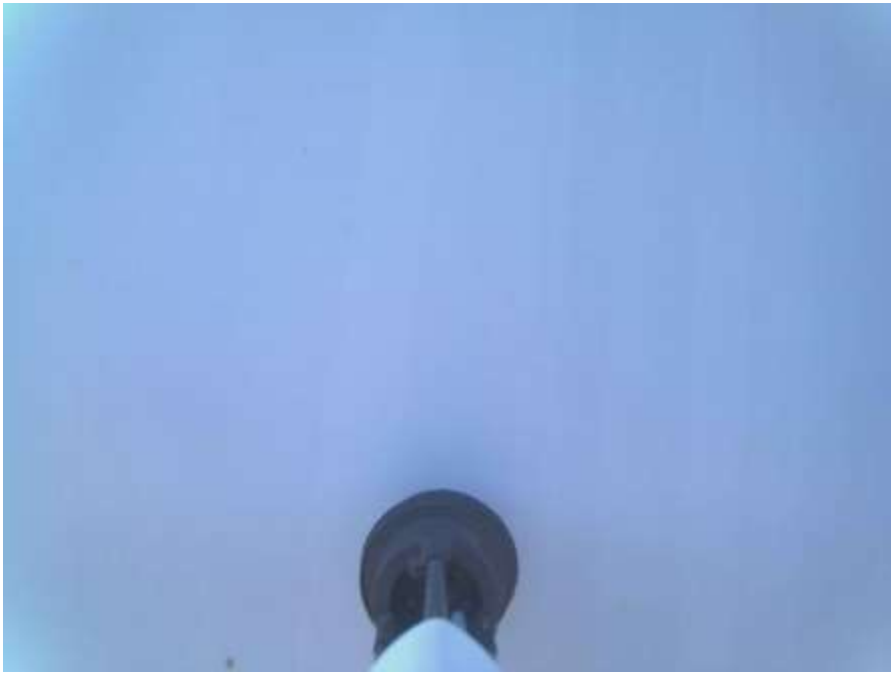
Figure 58: Location - Point 9

Thickness [mm]	8.540	XYZ Coordinates [m]	7.19	6.27	0.71
Rotation	Pitch: -0.6°	Timestamp [s]	15 May 2024, 10:00:59

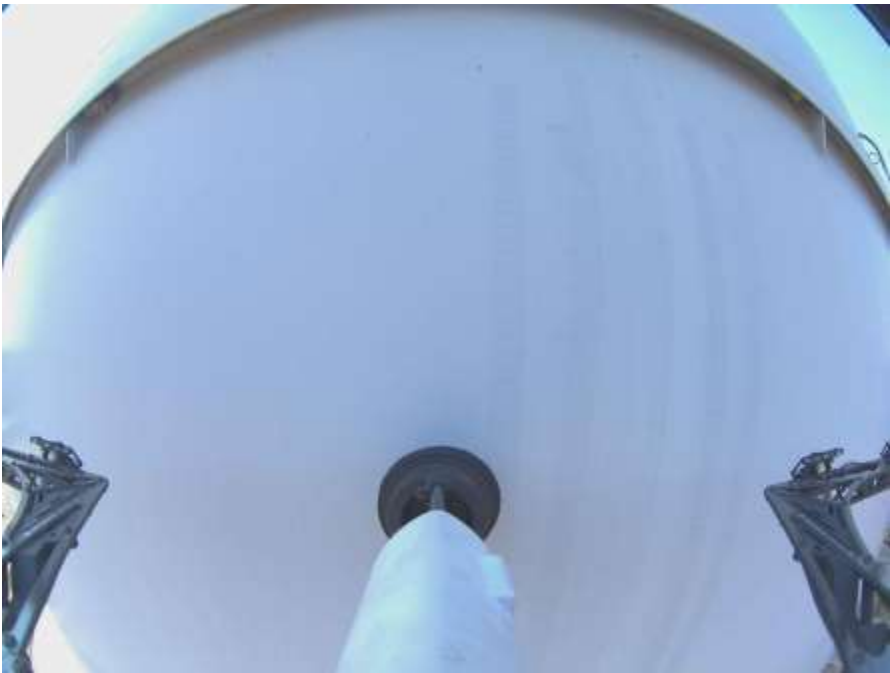
Figure 61: Location - Point 10

Thickness [mm]	9.910	XYZ Coordinates [m]	7.19	6.54	1.87
Rotation	Pitch: -0.7°	Timestamp [s]	15 May 2024, 10:01:19

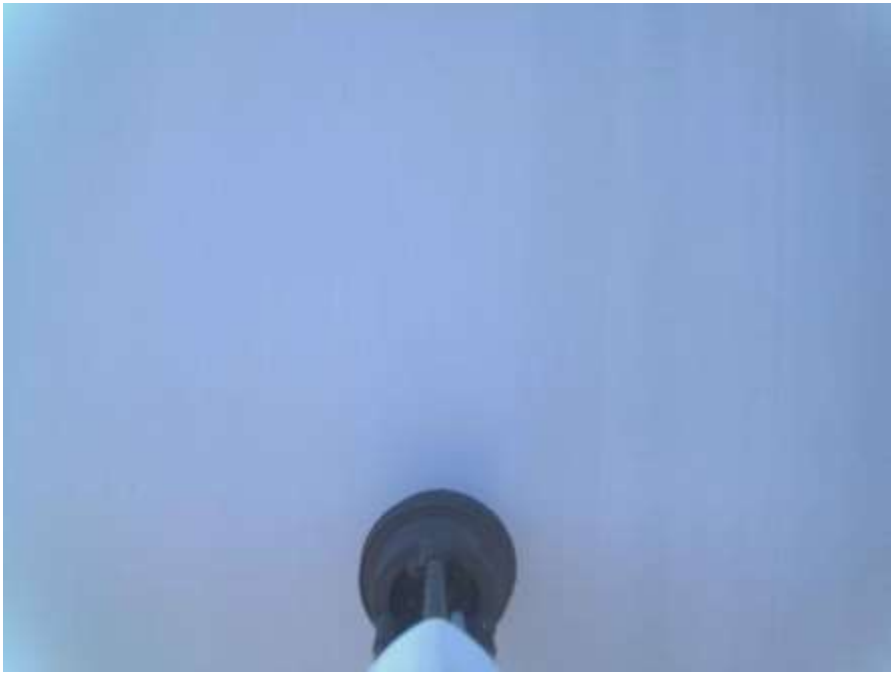
Figure 64: Location - Point 11

Thickness [mm]	10.320	XYZ Coordinates [m]	7.05	6.86	8.80
Rotation	Pitch: -0.4°	Timestamp [s]	15 May 2024, 10:01:41

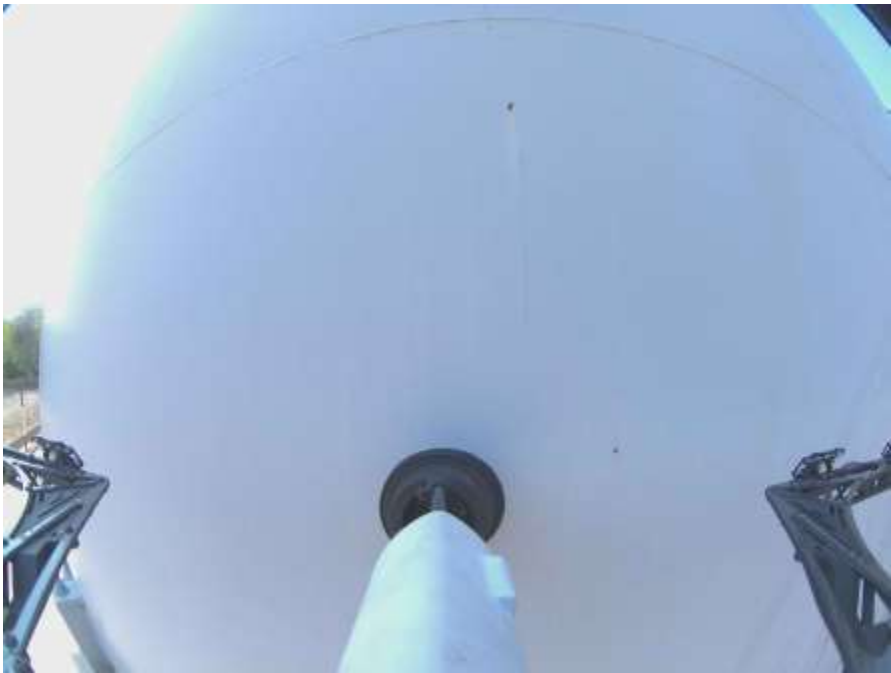
Figure 67: Location - Point 12

Thickness [mm]	10.880	XYZ Coordinates [m]	6.26	6.72	10.95
Rotation	Pitch: -0.4°	Timestamp [s]	15 May 2024, 10:02:04

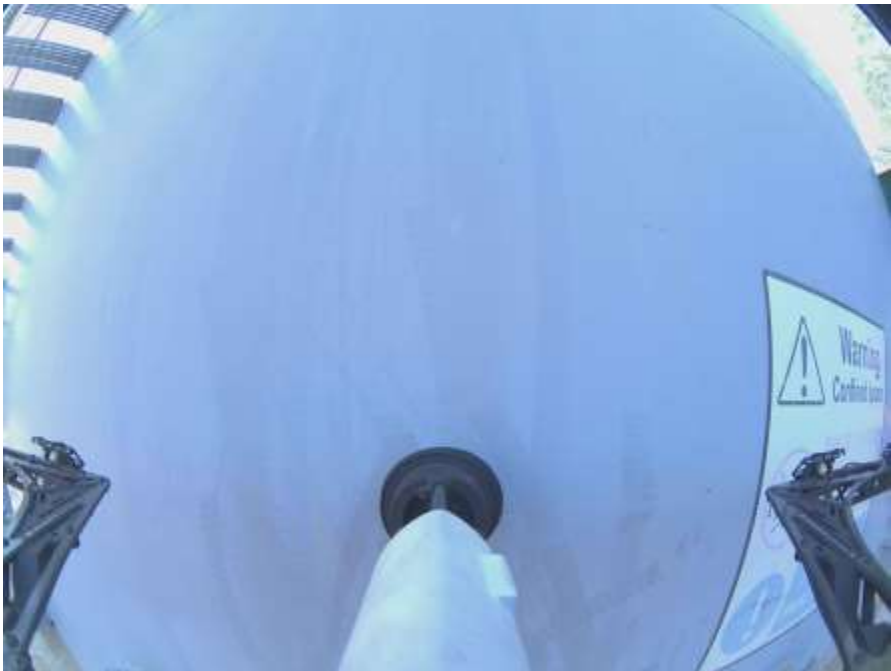
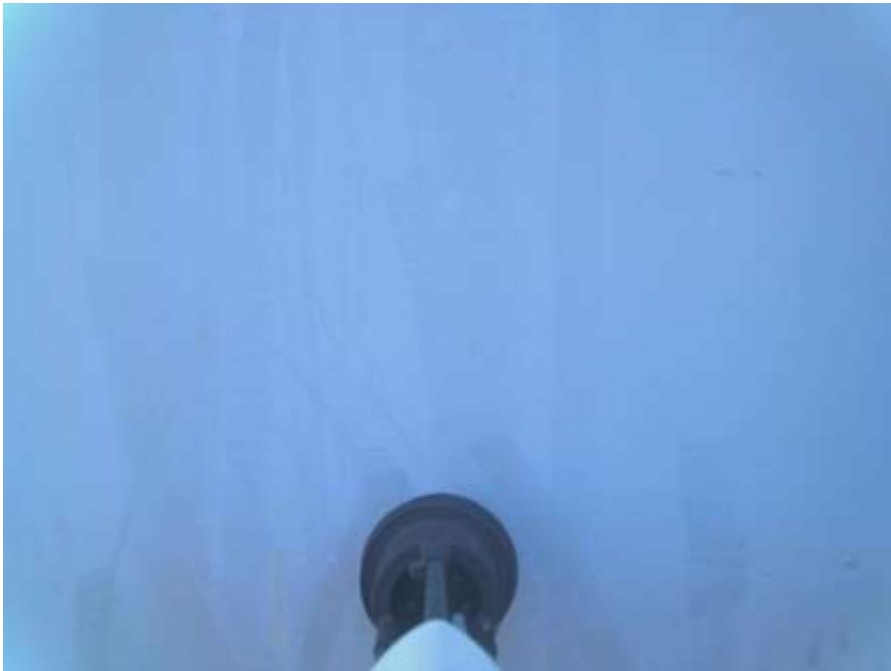
Figure 70: Location - Point 1

Thickness [mm]	10.680	XYZ Coordinates [m]	2.61	2.03	3.39
Rotation	Pitch: 0.2°	Timestamp [s]	15 May 2024, 10:20:27

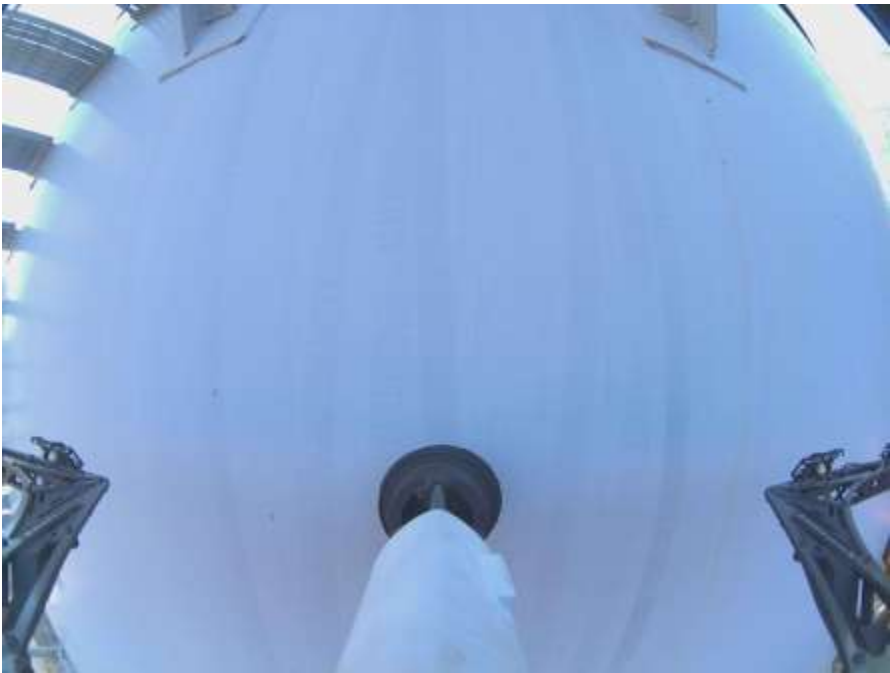
Figure 73: Location - Point 2

Thickness [mm]	10.030	XYZ Coordinates [m]	2.52	2.04	2.42
Rotation	Pitch: -0.3°	Timestamp [s]	15 May 2024, 10:20:52

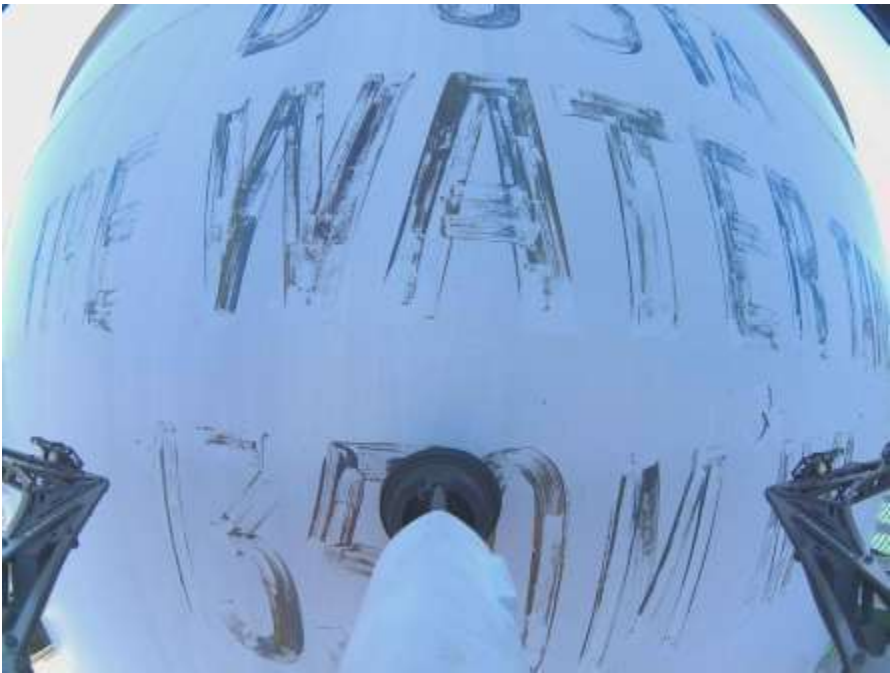
Figure 79: Location - Point 4

Thickness [mm]	8.500	XYZ Coordinates [m]	2.70	2.72	2.79
Rotation	Pitch: -0.5°	Timestamp [s]	15 May 2024, 10:21:42

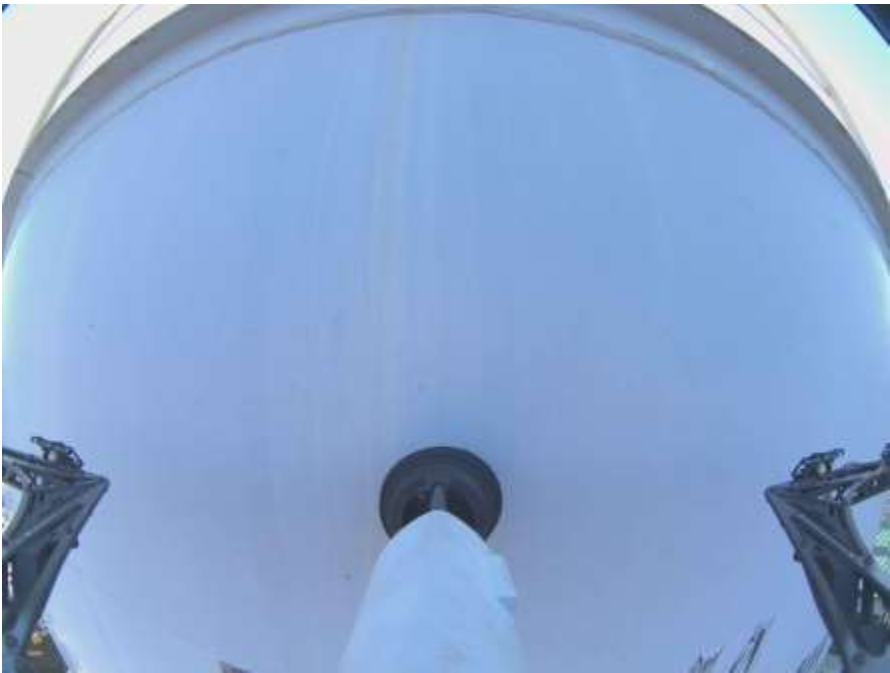
Figure 82: Location - Point 5

Thickness [mm]	8.140	XYZ Coordinates [m]	2.78	3.25	2.42
Rotation	Pitch: -0.4°	Timestamp [s]	15 May 2024, 10:22:06

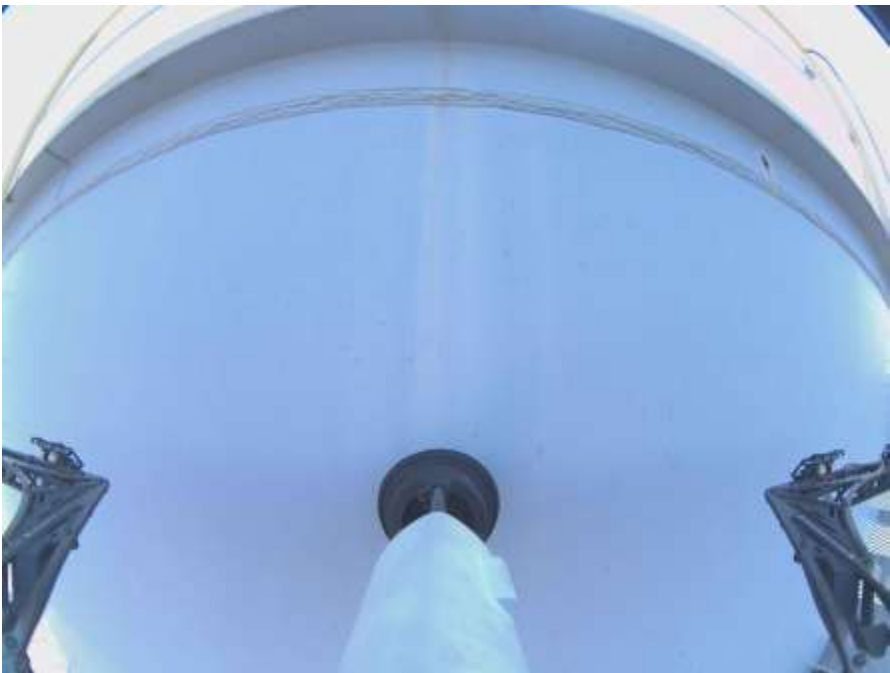
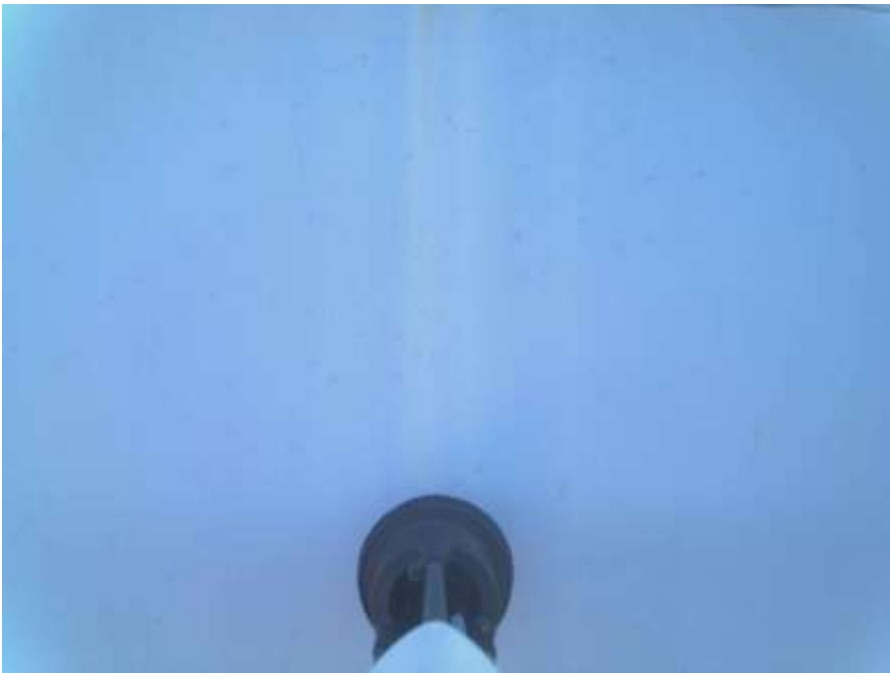
Figure 85: Location - Point 6

Thickness [mm]	8.300	XYZ Coordinates [m]	5.37	4.55	3.86
Rotation	Pitch: -0.5°	Timestamp [s]	15 May 2024, 10:22:39

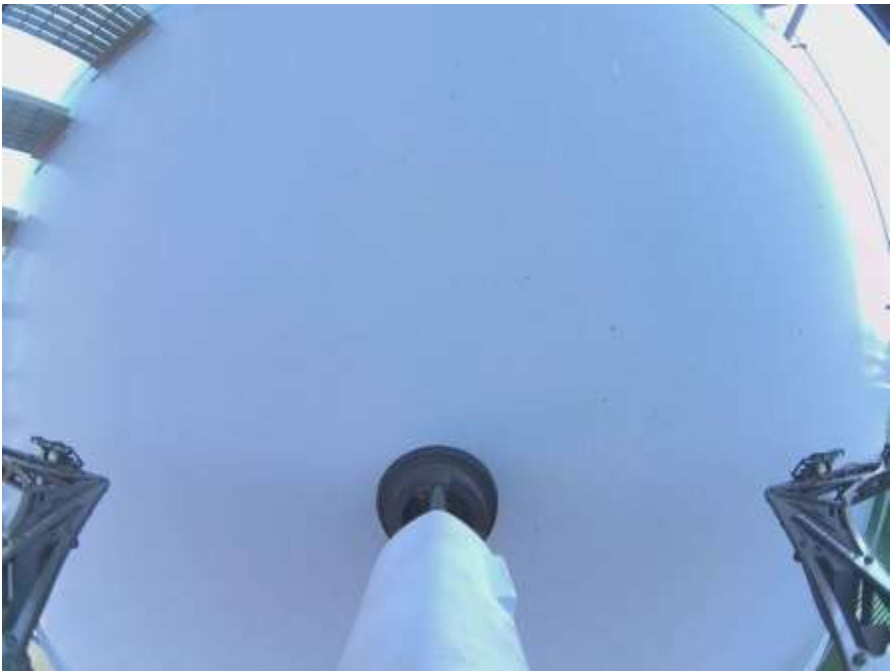
Figure 88: Location - Point 7

Point	Timestamp [s]	Measured [mm]	Ring No	Reference [mm]	Difference [mm]	Comment
6	15 May 2024, 10:22:39	8.300	R6	8	NA	No Reduction
7	15 May 2024, 10:23:22	7.860	R4	8	0.2	Reduction
8	15 May 2024, 10:23:45	10.760	R3	10	NA	No Reduction
9	15 May 2024, 10:24:07	10.030	R2	10	NA	No Reduction
10	15 May 2024, 10:24:29	10.480	R1	10	NA	No Reduction

Thickness [mm]	7.860	XYZ Coordinates [m]	7.87	7.00	9.06
Rotation	Pitch: -0.1°	Timestamp [s]	15 May 2024, 10:23:22

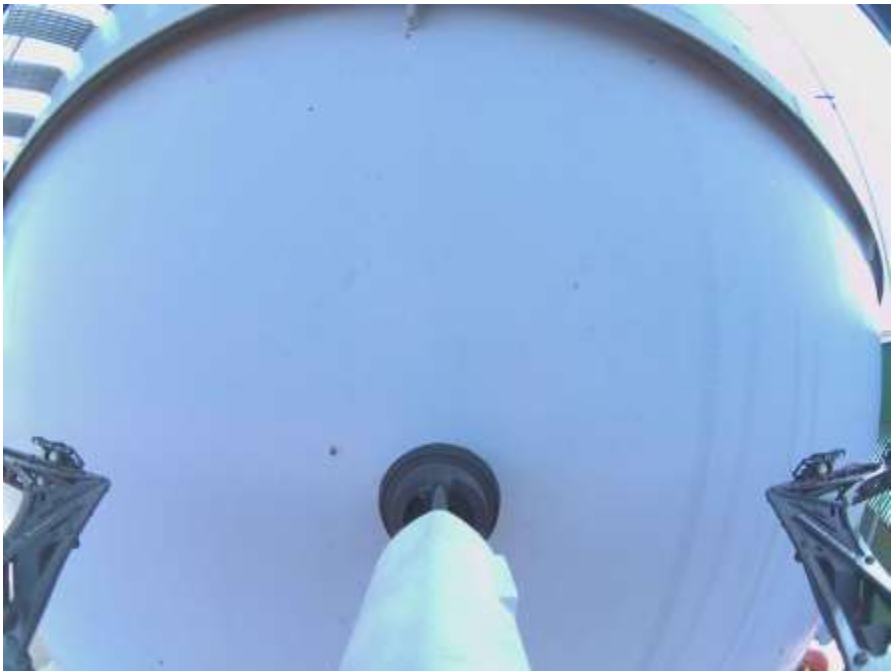
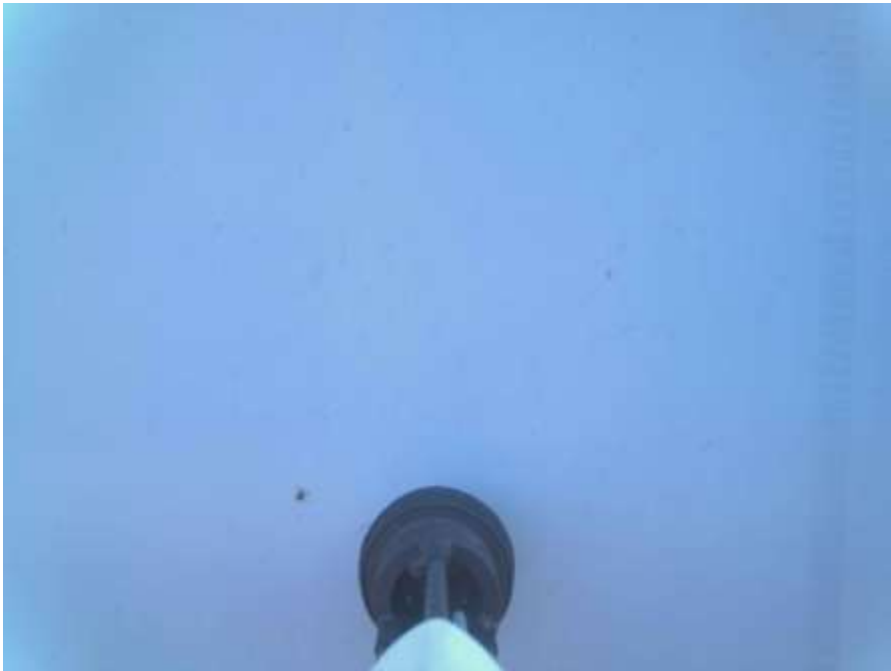
Figure 91: Location - Point 8

Thickness [mm]	10.760	XYZ Coordinates [m]	8.69	7.30	11.56
Rotation	Pitch: -0.9°	Timestamp [s]	15 May 2024, 10:23:45
