# FIRE WATER TANK 851 A

Vedanta Cairn oil & Gas division			
Project Name	FIRE WATER TANK 851 A	Report number	VOLAT-T-851-A-EMAT
Location	Raageshwari Gas terminal, Barmer	Client representative	Simon Doss

Asset Information			
Asset	FIRE WATER TANK	Inspection date	2024-05-15
Asset type	CARBONSTEEL	Report date	2024-05-24
Asset number	851 A

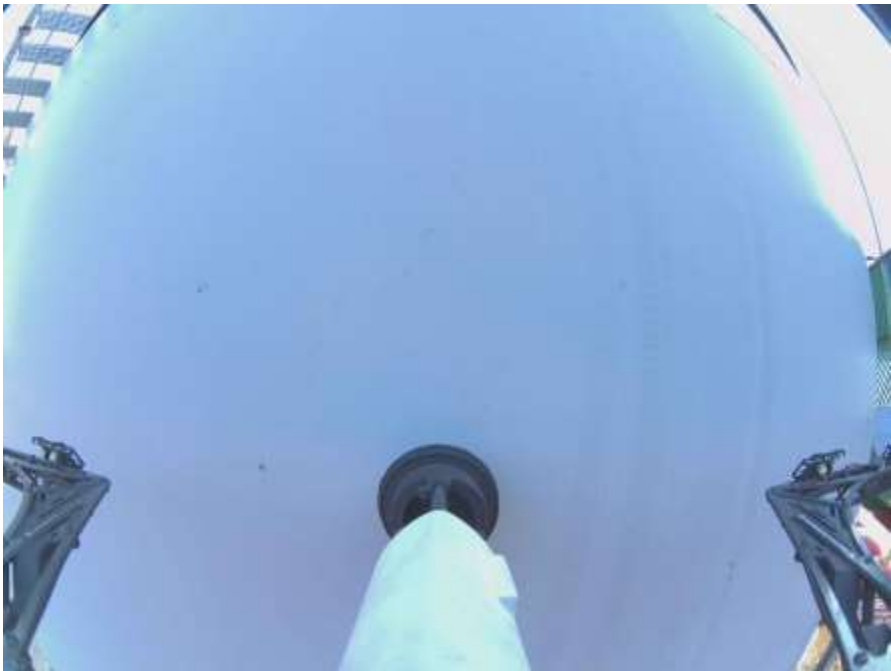
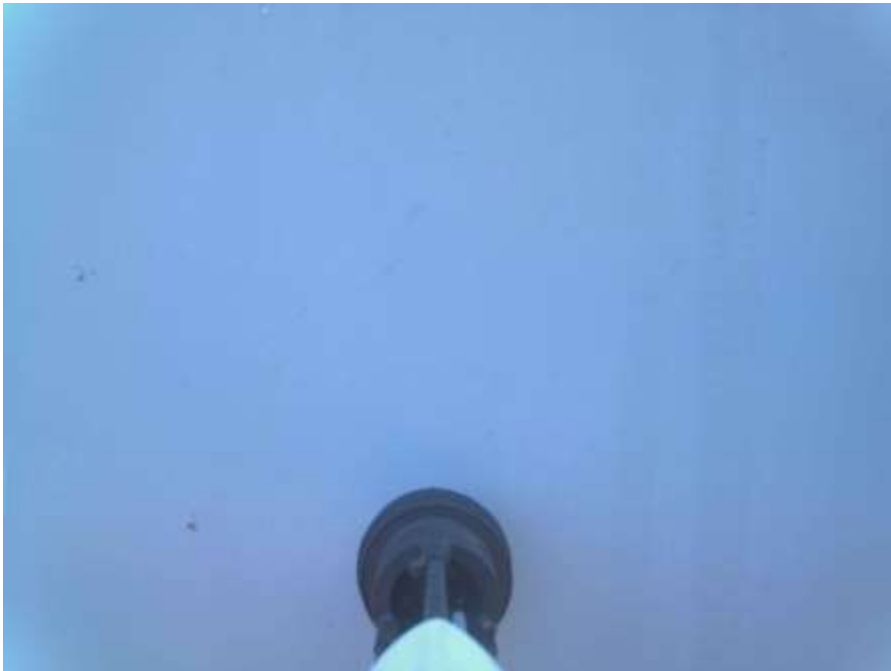
Figure 94: Location - Point 9

Thickness [mm]	10.030	XYZ Coordinates [m]	9.44	7.47	13.39
Rotation	Pitch: -0.2°	Timestamp [s]	15 May 2024, 10:24:07

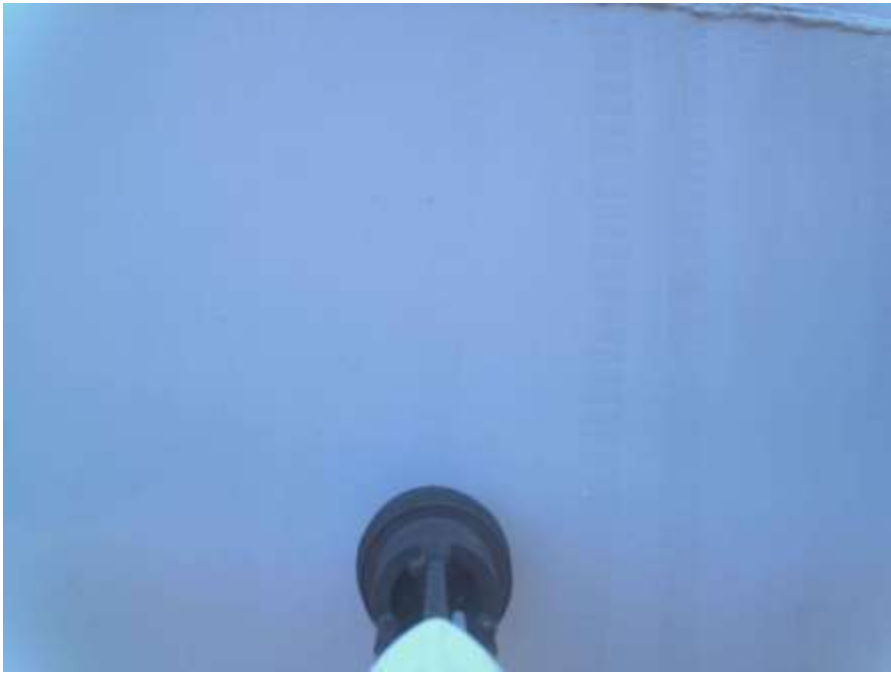
Figure 97: Location - Point 10

Thickness [mm]	10.480	XYZ Coordinates [m]	10.08	7.49	14.56
Rotation	Pitch: -0.5°	Timestamp [s]	15 May 2024, 10:24:29

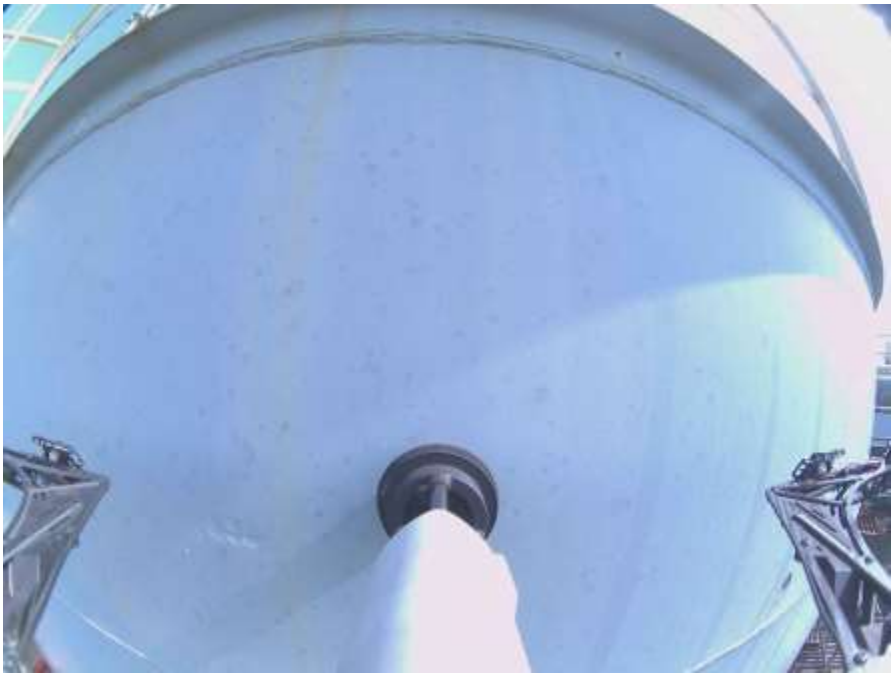
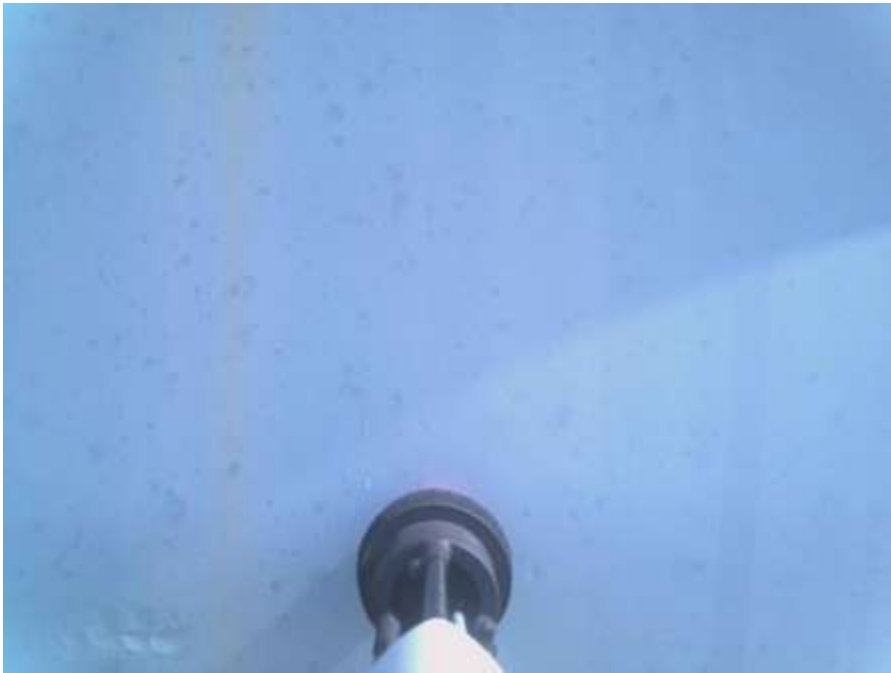
Figure 100: Location - Point 1

Thickness [mm]	7.860	XYZ Coordinates [m]	9.78	9.10	4.13
Rotation	Pitch: -0.3°	Timestamp [s]	15 May 2024, 10:38:08

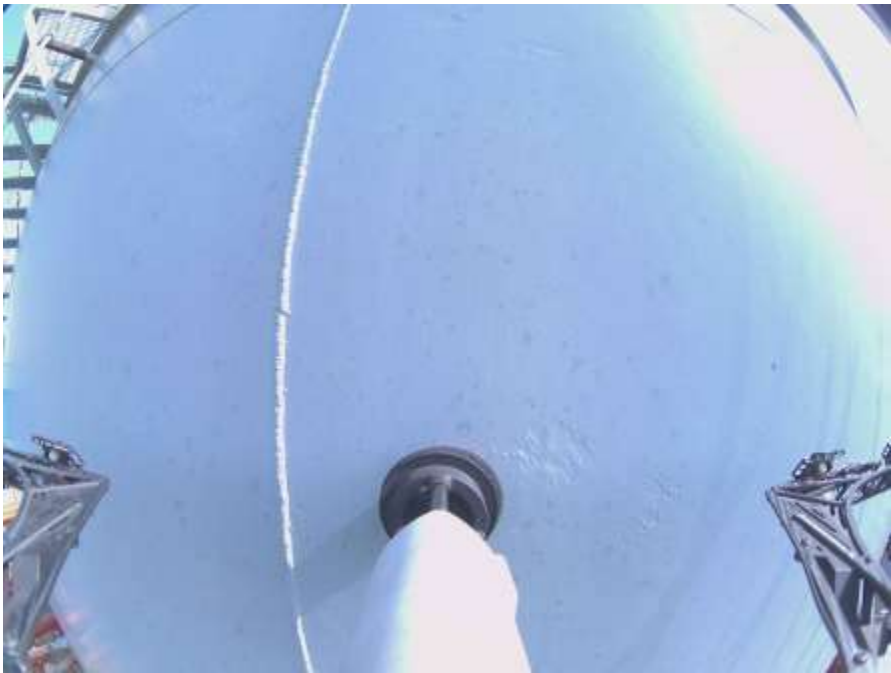
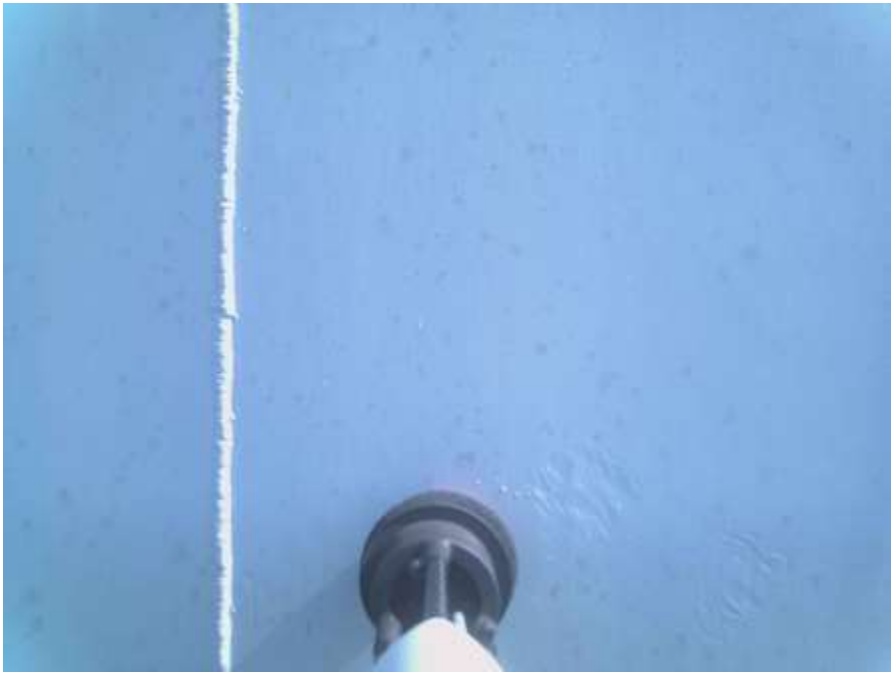
Figure 103: Location - Point 2

Thickness [mm]	7.900	XYZ Coordinates [m]	10.31	9.57	2.00
Rotation	Pitch: -0.1°	Timestamp [s]	15 May 2024, 10:38:36

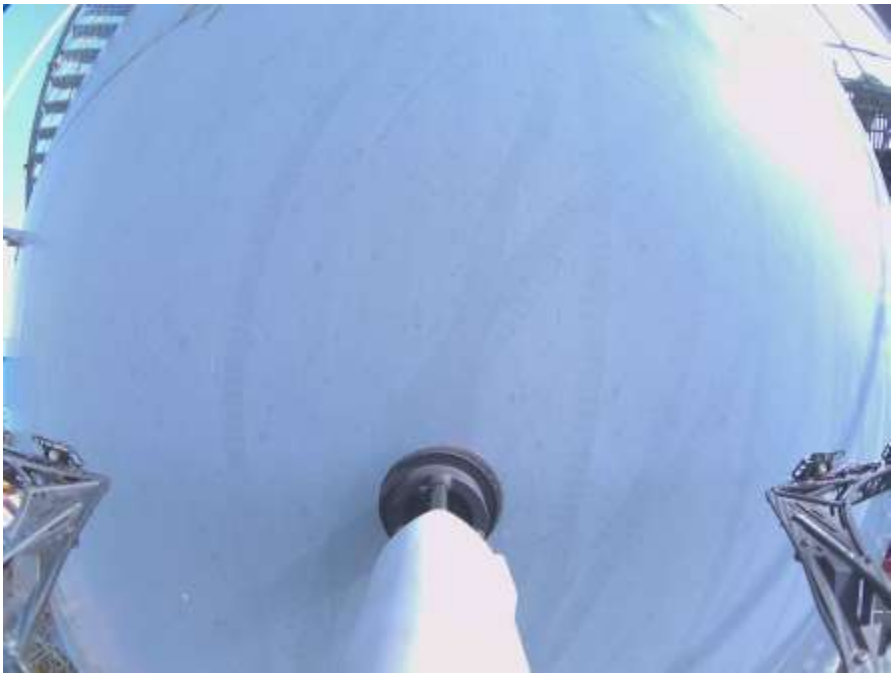
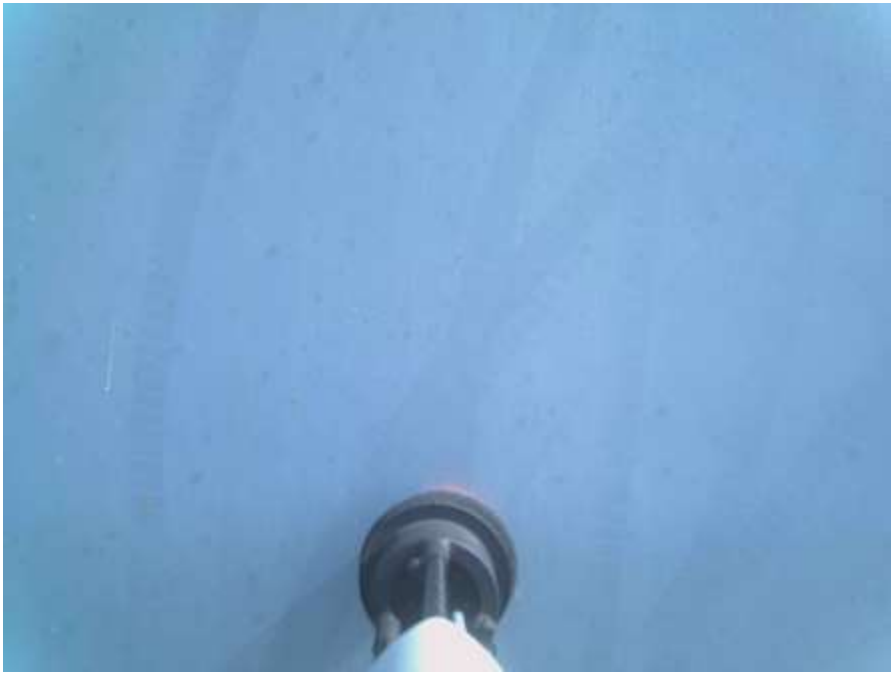
Figure 106: Location - Point 3

Thickness [mm]	8.140	XYZ Coordinates [m]	10.73	9.91	0.34
Rotation	Pitch: -0.4°	Timestamp [s]	15 May 2024, 10:38:55

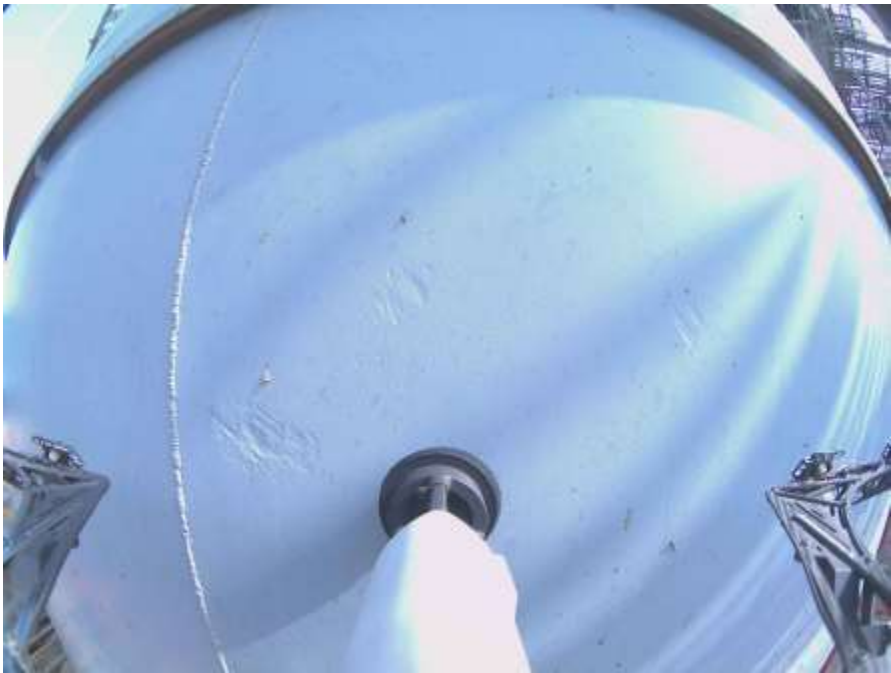
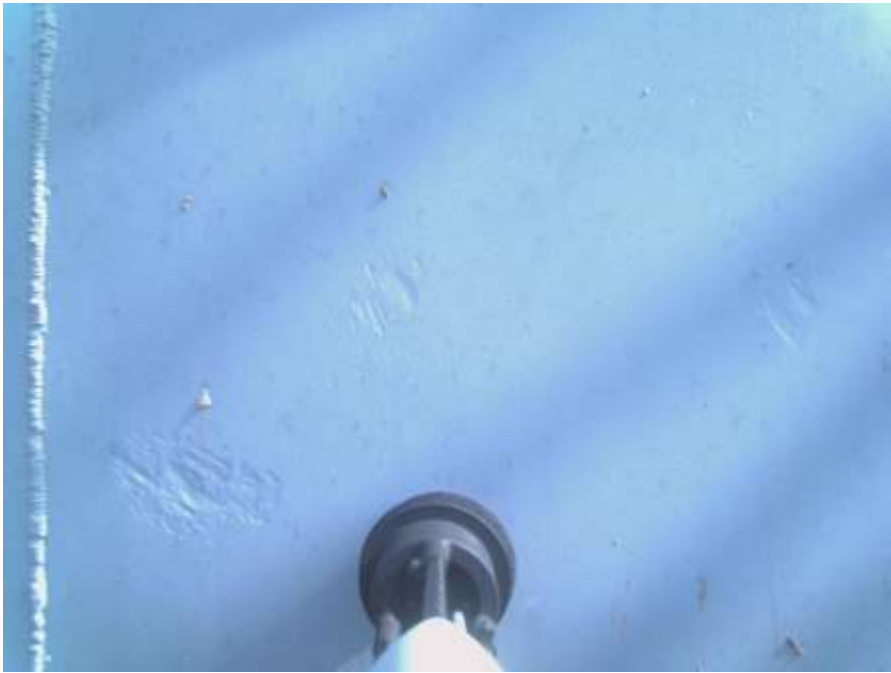
Figure 109: Location - Point 4

Thickness [mm]	10.720	XYZ Coordinates [m]	11.44	10.59	3.23
Rotation	Pitch: 0.1°	Timestamp [s]	15 May 2024, 10:39:22

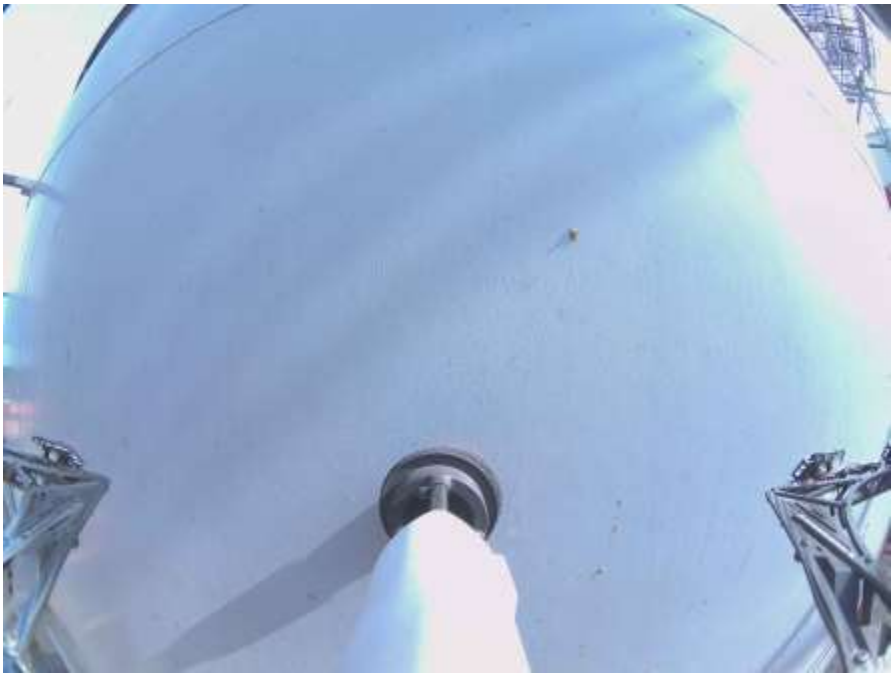
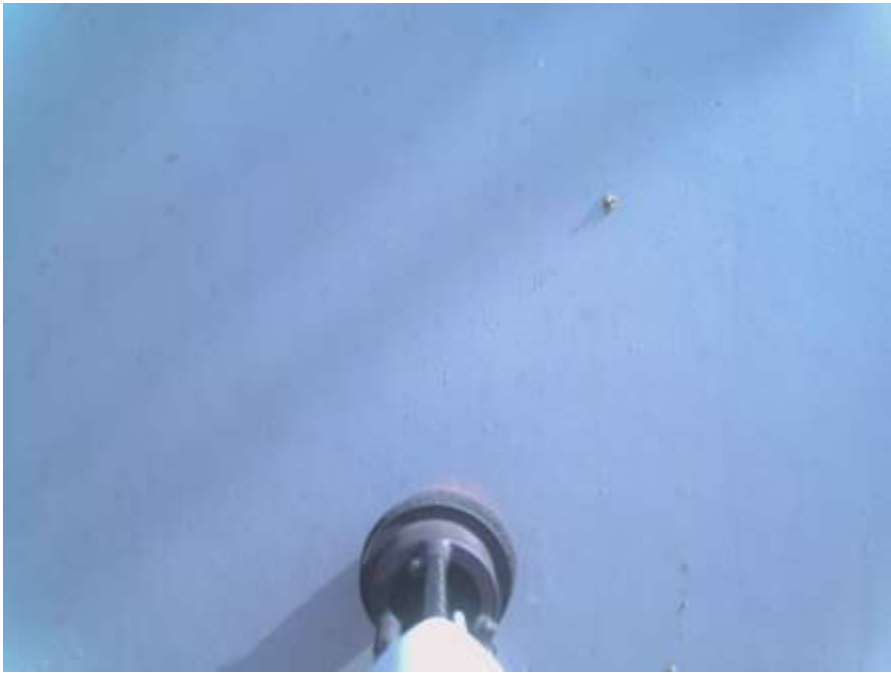
Figure 112: Location - Point 5

Thickness [mm]	10.560	XYZ Coordinates [m]	11.97	10.80	4.73
Rotation	Pitch: 0.2°	Timestamp [s]	15 May 2024, 10:39:48
