Construction and Testing of an Inexpensive PAR Sensor

Ministry of Forests Research Program

Fielder, P. and P. Comeau. 2000. Construction and testing of an inexpensive PAR
Sensor. Res. Br., Min. For., Victoria, BC. Work.—Pap. 53/2000.

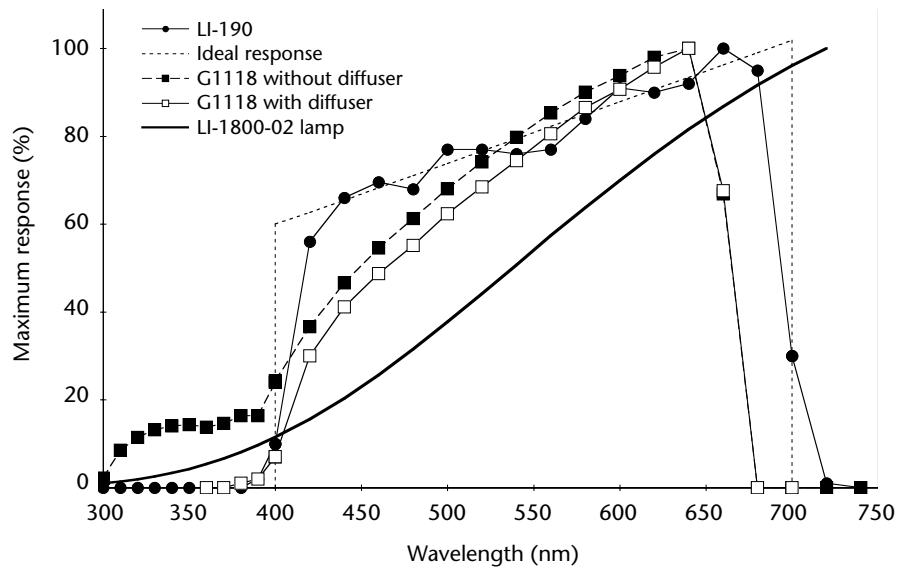
FIGURE 1 Spectral responses of the LI-190 quantum sensor, the ideal quantum response, and the GaAsP planar diffusive type photodiode (G1118) with and without the influence of the diffuser material. The spectral output of the quartz tungsten halogen lamp of the LI-1800-02 Optical Radiation Calibrator is also shown for comparison. Sources of data shown: LI-190 quantum sensor and ideal quantum response (LI-COR 1986), halogen lamp calibration data (LI-COR, Lincoln, Nebr.), G1118 photodiode (Hamamatsu Corp. 1995), Acrylite GP 015-2 diffuser material (Cyro Canada Inc., Mississauga, Ont.).

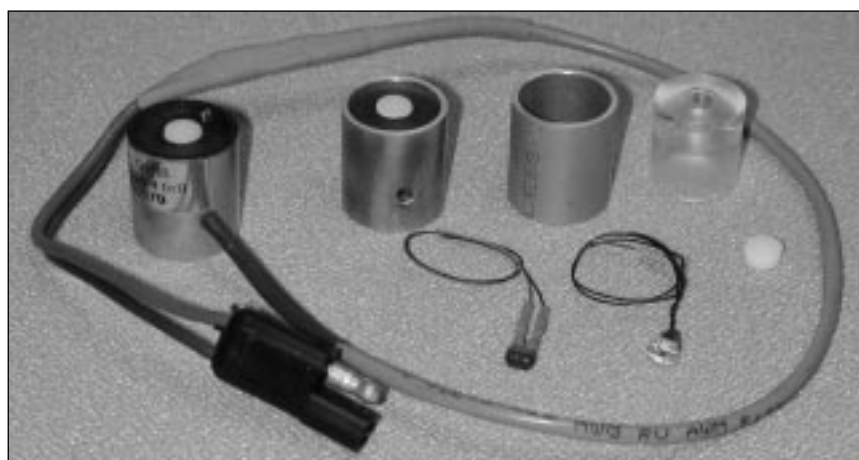
FIGURE 2 GaAsP sensors in various stages of assembly. From right to left in the foreground: the translucent acrylic diffuser, the G2711-01 and G1118 photodiodes with 30-gauge leads. From right to left in the background: the clear acrylic sensor housing with machined port for the photodiode, an aluminum sleeve, a complete sensor showing lead port, and the complete sensor with lead, plug, and label.

Materials and construction Components of the GaAsP sensor are shown in Figure 2 and in cross-section in Figure 3 (see Appendix 1 for detailed assembly procedures).

Photodiode The recommended photodiode is the GaAsP G1118 or G2711-01 manufactured by Hamamatsu Corporation (Figure 2). The G1118 is round (cut flat on two sides), 5.93 mm in diameter, with two long pins arising from the back. The negative pin is marked with a tiny hole in the resin package. The G2711-01 is rectangular, 5.98 by 6.61 mm (6.75 mm diagonally) with two common negative pins diagonally opposite each other and a single positive pin (the fourth is non-functional).

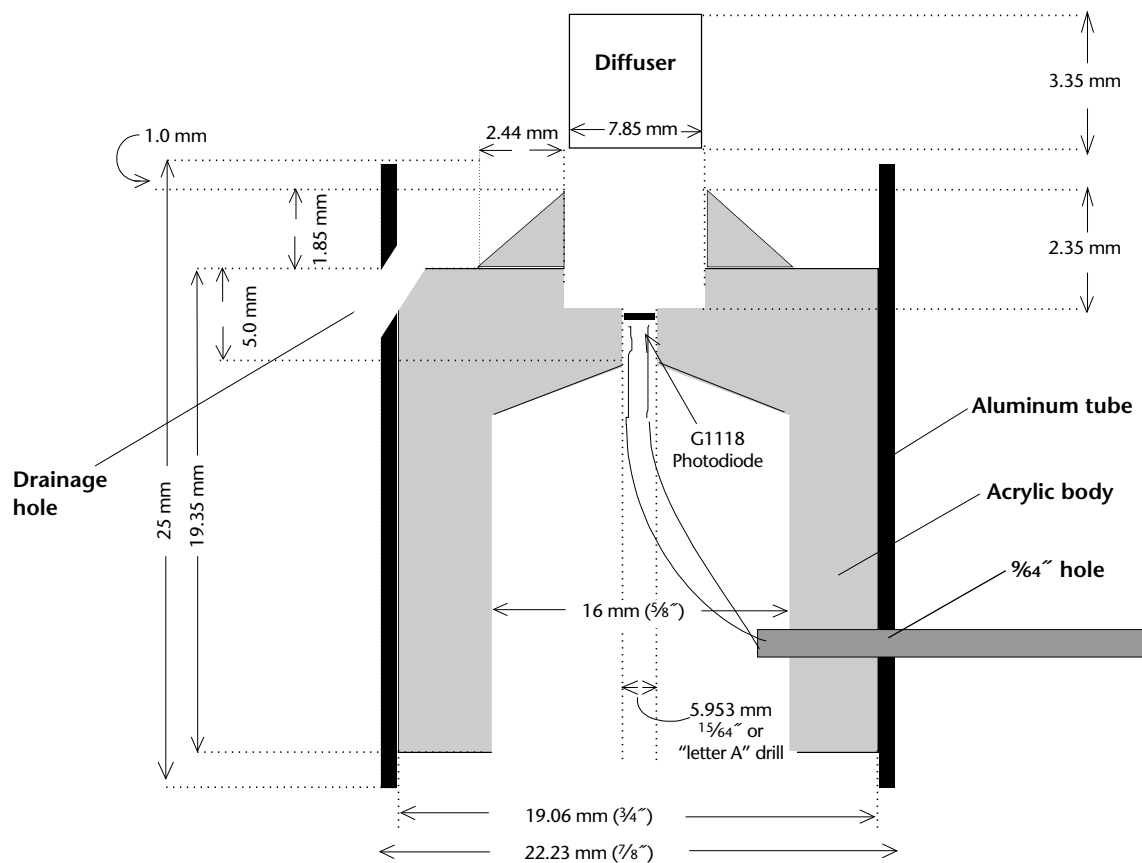
FIGURE 3 Cross-section of GaAsP sensor showing assembly and dimensions.

Cast 19.06 mm ($\frac{3}{4}$ ") diameter clear acrylic round stock was used for the body and 3.34 mm ($\frac{1}{8}$ ") thick cast translucent ("sign-white") acrylic sheet (Acrylite GP 015-2, Cyro Canada, Inc., Mississauga, Ont.) for the diffuser. The diffusers were cut from sheet material by laser. Diffuser and sensor body were bonded together using methylene chloride to reduce the possibility of delamination and subsequent moisture penetration into the photodiode. The aluminum outer sheath (outer diameter 22.23 mm [$\frac{7}{8}$ "], internal diameter 19.06 mm [$\frac{3}{4}$ "]) provided rugged protection and a level base, and created the rim necessary for the cosine-correcting head without extra machining of the acrylic. The aluminum sheath also prevented light from penetrating the side of the clear acrylic sensor body, eliminating the need to paint to maintain opacity (opaque cast acrylic round stock is very hard to find). Aluminum sheath and acrylic body were cemented together using a slow-curing epoxy resin. Several applications of matte-black enamel model paint (Testors) were used to prevent light penetration through the top surface of the acrylic body. An exterior-grade matte-black vinyl was also used to exclude light, with good results. The G1118 and G2711-01 were the two GaAsP photodiodes used in subsequent variations on the basic design.

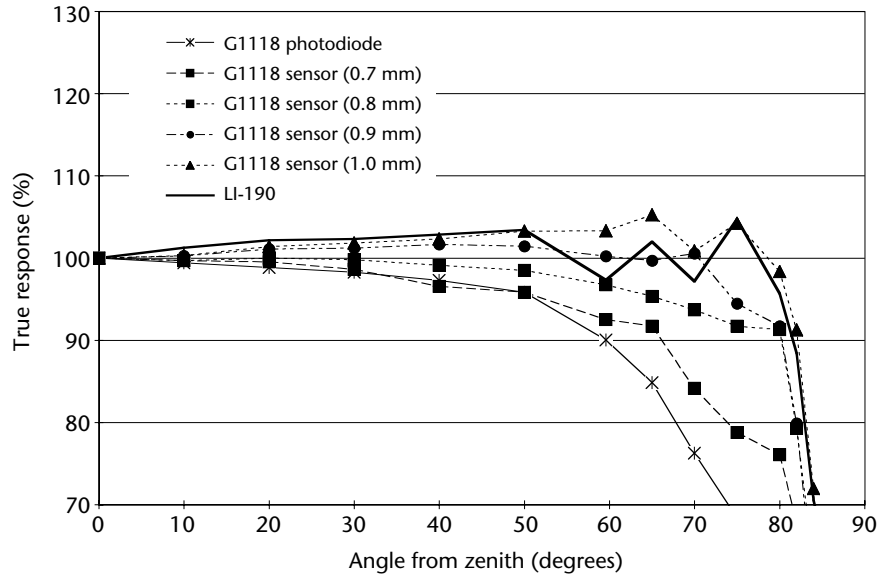
FIGURE 4 Response curves for the G1118 sensor with different diffuser heights. Shown are curves for a bare G1118 photodiode with no cosine correction, and sensors with the diffuser recessed to four depths, resulting in diffuser heights of 0.7, 0.8, 0.9, and 1 mm. The response of an LI-190 was measured using the same apparatus.

Figure 4 shows how changing the height of the diffuser edge can affect the cosine correction compared with that of a bare photodiode (G1118). The GaAsP sensors were a considerable improvement over the bare photodiode at angles larger than 50 degrees. These sensors were within 5% of the true response for angles from the zenith of 50, 65, 75, and 80 degrees, for diffuser heights of 0.7, 0.8, 0.9, and 1.0 mm, respectively. Empirical evidence from the test sensors shows that a height of 1.0 mm (rather than the theoretical 0.8 mm) would have resulted in a better cosine response, in that it mimics that of the LI-190. Using the same equipment, the LI-190 was within 5% of the true response for angles up to 80 degrees. These test findings have been incorporated into the recommended design.

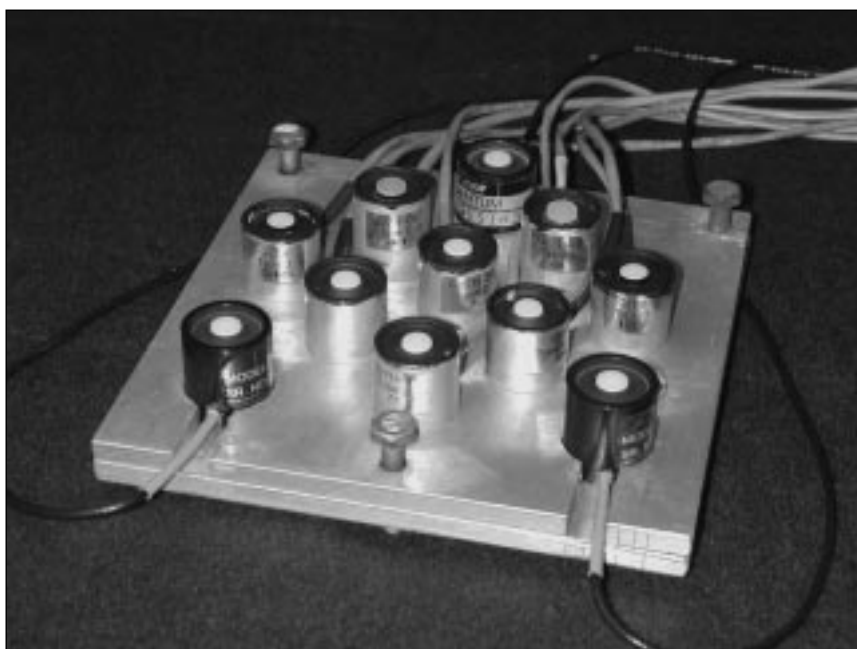
FIGURE 5 Calibration plate used for open-sky calibrations of GaAsP sensors using the LI-190 quantum sensor. Shown are eight silver-coloured GaAsP sensors arranged inside a triangle of three LI-190 sensors (black), two in the foreground and one in the centre in the background.

Calibration under solar radiation To calibrate a GaAsP sensor for solar radiation, we mounted it on a calibration plate (Figure 5) beside at least two calibration standards (LI-190), and collected data under open skies for a full day, typically 04:00–22:00 h. The array was made up of two square 6.35 mm ($\frac{1}{4}$ ") aluminum plates (15×15 cm). The top plate was drilled with three 23.60 mm ($\frac{60}{64}$ ") holes to accommodate the LI-190 sensors and eight 22.23 mm ($\frac{7}{8}$ ") holes with equidistant centres (34 mm) to accept the test sensors. The two plates were screwed together so that the bottom plate provided a flat base for each sensor. A 15.875 mm ($\frac{5}{8}$ ") hole was drilled in the lower plate beneath each sensor to allow water to drain and to make sensor installation and removal easier. Three threaded holes were drilled in the form of an equilateral triangle and bolts were threaded through the holes (Figure 2). The bolts were used to level the array and each sensor was checked individually using a bubble level. A small bubble level distributed by LI-COR was found to be ideal for this purpose, as it was the correct diameter to rest on the rim of the LI-190 and GaAsP sensor.

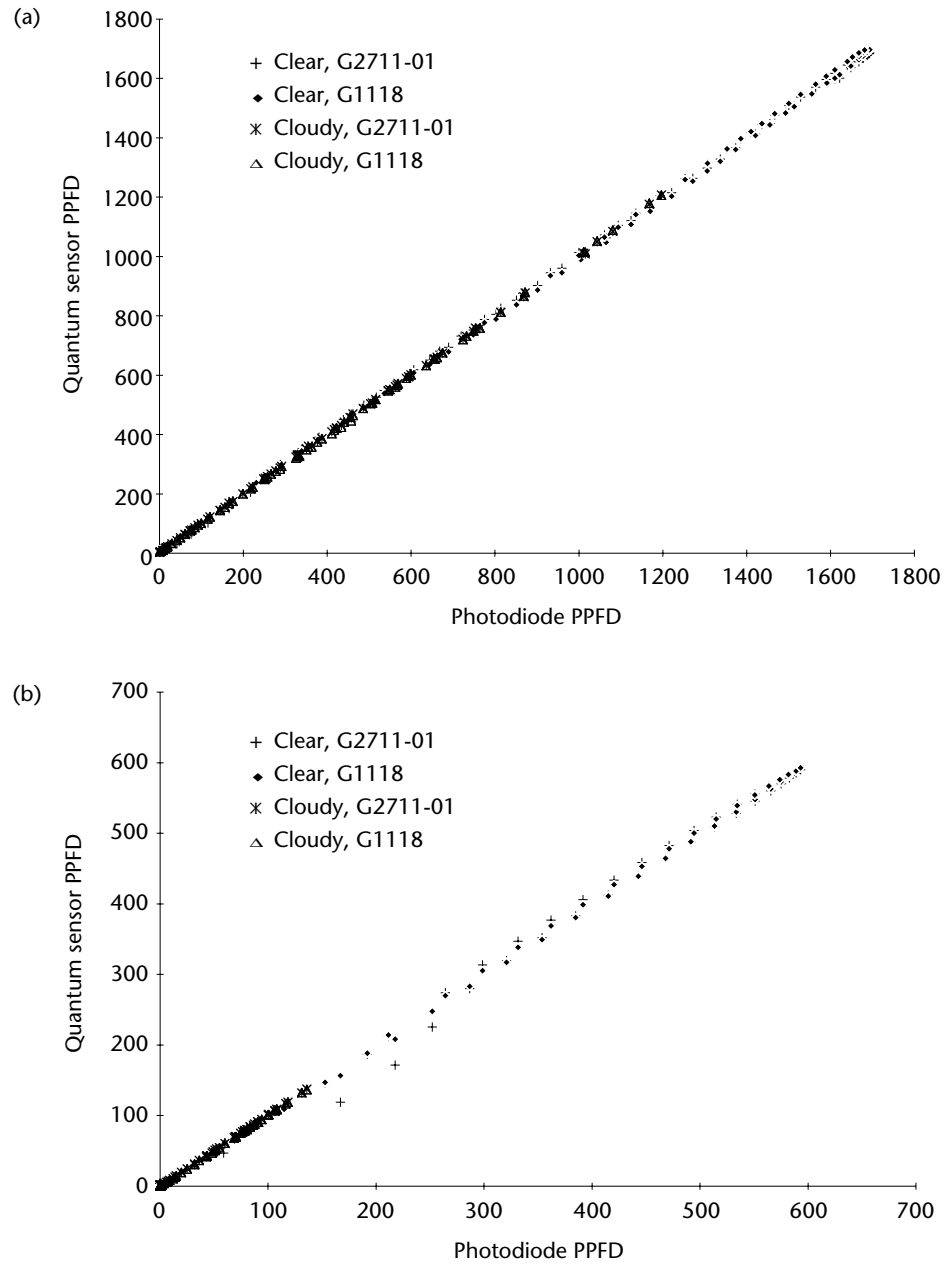
FIGURE 6 PPFD obtained from two GaAsP sensors on 2 clear and 2 cloudy days compared with an adjacent LI-190 quantum sensor. The two GaAsP sensors contain different photodiodes, G2711-01 and G1118. (a) Clear day, August 7, 1998; cloudy day, August 17, 1998. (b) Clear day, December 20, 1998; cloudy day, December 21, 1998.

Figure 6 shows the relationship between the output of two GaAsP sensors and an LI-190 on 2 summer days and 2 winter days under clear and cloudy conditions. The GaAsP sensors incorporate all the features of the recommended basic design, with one sensor type containing a G2711-01 (Type 2 sensor) and the other a G1118 (Type 4) photodiode.

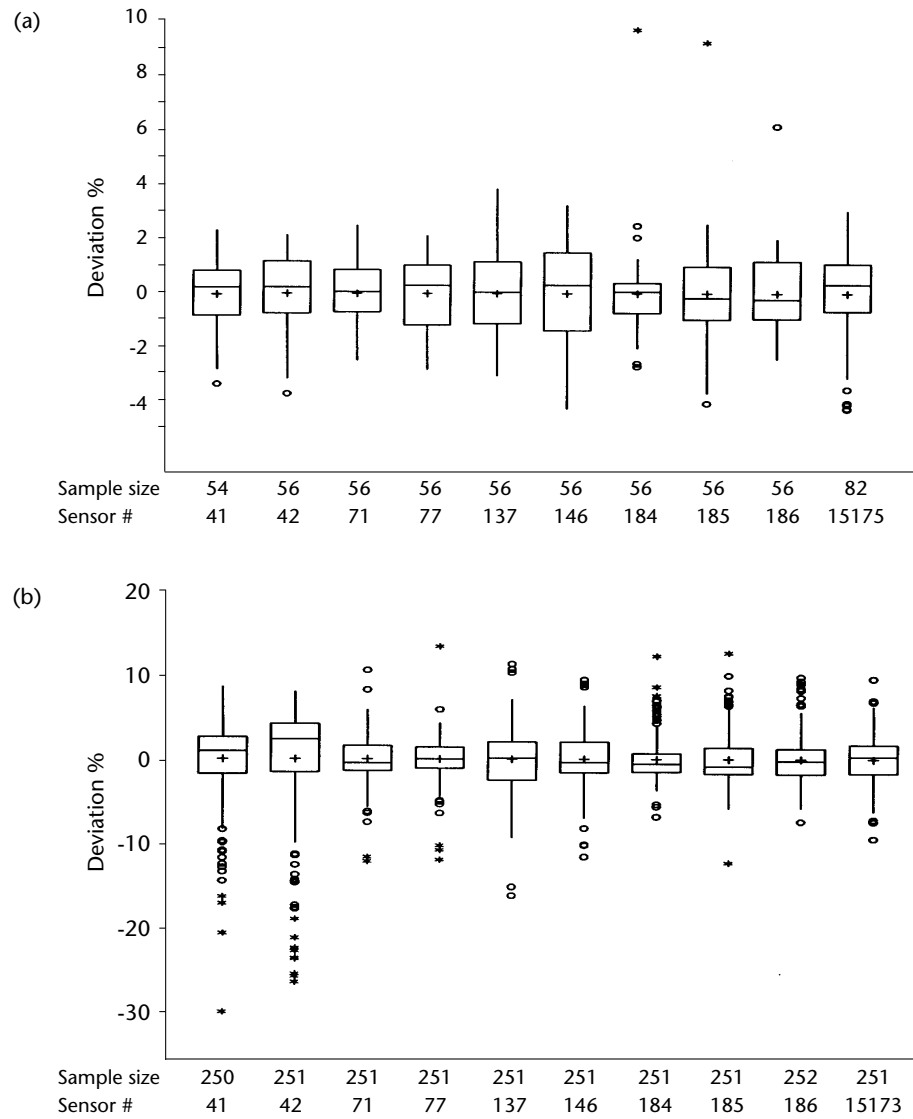
FIGURE 7 Daily calibration coefficients of nine GaAsP sensors. GaAsP sensors include two different photodiodes and four construction "Types." Sensors with the G2711-01 photodiode include #41, #42 (Type 1), #71, and #77 (Type 2), and sensors with the G1118 include #137, #146 (Type 3), and #184–186 (Type 4). Plotted data are the percentage deviation of each daily calibration coefficient from the mean calibration coefficient for (a) June to September 1998 calibrated with LI-190 quantum sensors Q15175 and Q9594, and (b) January to November 1999 calibrated with Q15173 and Q15176 (only Q15176 was used for regressions). The two LI-190 sensors were calibrated against each other for each test period. Sample size = Number of data points (days).

Seasonal variation in daily open-sky calibrations (vs. LI-190) Figure 7 shows box plots of the daily calibration coefficients for the nine GaAsP and LI-190 sensors over 18 months under an open sky (see Glossary for explanation of box plots). Each daily calibration coefficient has been subtracted from, and divided by, the mean to yield the percentage deviation from a zero value for each sensor. Data show the distribution of the daily calibration coefficients during summer 1998 (June to September) (Figure 7a) and for summer, fall, and winter 1999 (January to November) (Figure 7b). Data for the period December 1999 to June 2000 are not shown because that part of the year was calibrated in 1999 and the pattern was similar in 2000. The data indicate that the photodiode (either G1118 or G2711-01) did not result in a consistent difference in sensor performance. Differences in data distributions for the four sensor types were consistent over the 2 years. However, consistent differences in data distribution also occurred within the same design Type (i.e., #184, 185, and 186).

The magnitude of the data spread doubled from 1998 to 1999. This increase was a result of more variable data from the late fall, winter, and spring months in 1999 when rainfall was more frequent and of longer duration, resulting in cosine error differences between test and calibration sensors. On

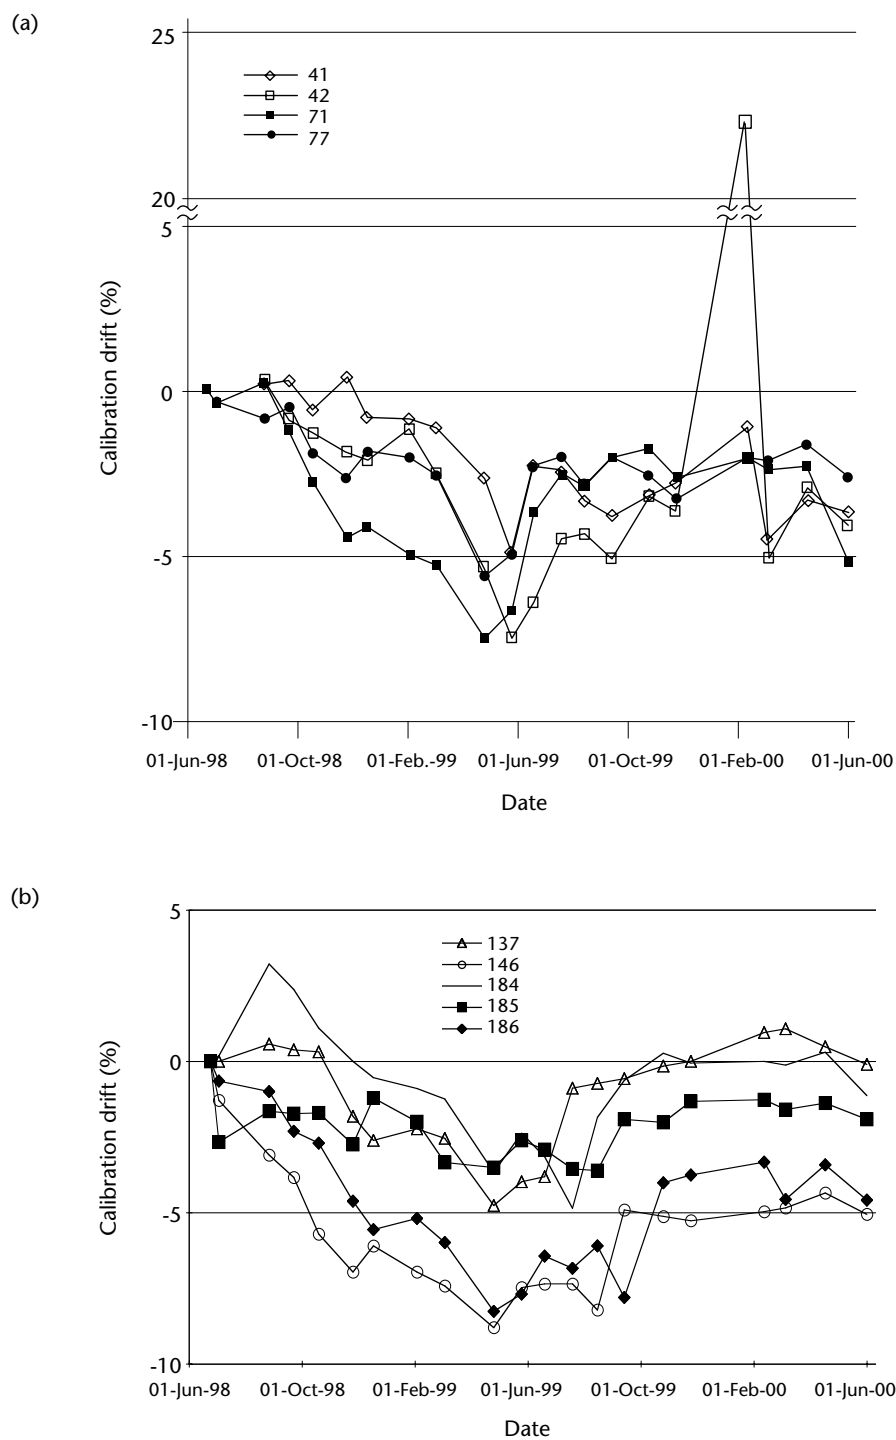
FIGURE 8 Sensor drift of nine GaAsP sensors calibrated with the LI-1800-02 Optical Radiation Calibrator, June 1998 to June 2000. (a) Sensors (G2711-01), #41, #42 (Type 1), #71, and #77 (Type 2), (b) Sensors (G1118) #137, #146 (Type 3), and #184–186 (Type 4). See Figure 9 for LI-190 data.

the first complete year (spring to spring), followed by a recovery. The reason for the gradual drift is not clear, but it could be due to diffuser weathering or to changes in the photodiode (the GaAsP sensor requires no filters, so filter deterioration can be ruled out). Weathering of the acrylic diffuser is a possibility, because the slow recovery of signal exhibited from May to November 1999 coincided with a change in cleaning procedure. From May 1999 onwards, readings were made before and after spraying and wiping using Electrosolve® contact cleaner, safe for plastics. This cleaning activity may have gradually removed a sun-damaged layer from the surface of the acrylic, but we have not tested this hypothesis. Another explanation for the drift of the GaAsP sensors is that newer sensors have not had a chance to “burn in.” Pontaller (1990) mentions that newly made GaAsP (i.e., Type 4) slowly reach relative stability, but does not indicate how long such a process takes. Hamamatsu Corp. provided no data on long-term stability or on how stability might be affected by weathering.

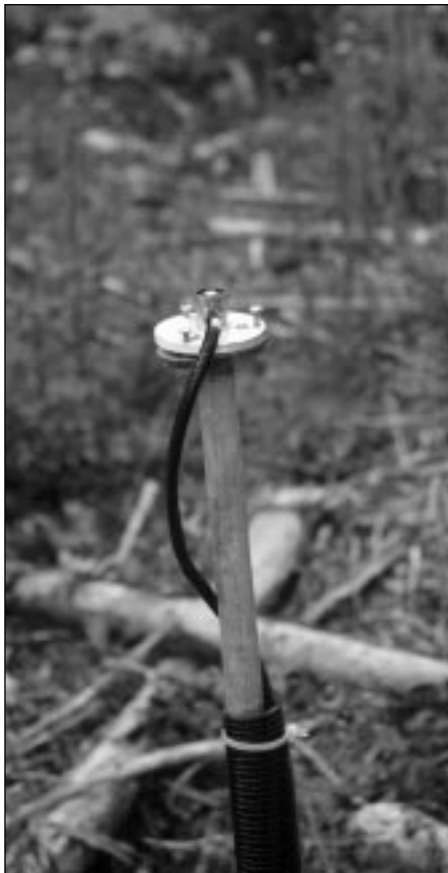
FIGURE 10 GaAsP sensor mounted on a steel post with levelling fixture.

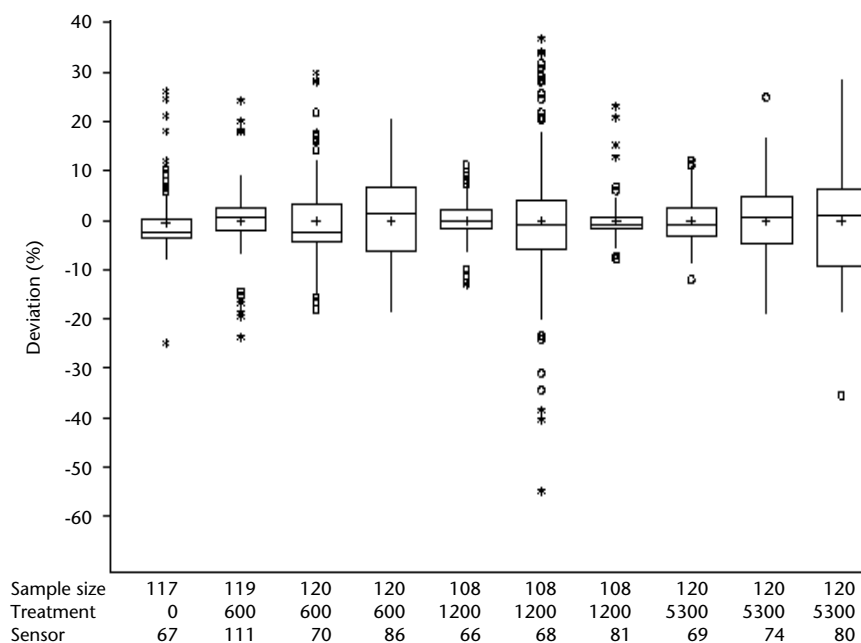
FIGURE 11 Daily calibration coefficients for 10 LI-190 and GaAsP sensor pairs under a birch canopy of various densities of 0, 600, 1200, and 5300 (uncut) st/ha, July 25 to November 12, 1998. Plotted data are the percentage deviation of each daily calibration coefficient from the mean calibration coefficient for the measurement period. Sample size = Number of data points (days).

Box plots in Figure 11 show the distribution of the daily calibration coefficients for the whole season. The magnitude of drift in the three sensor pairs exhibiting the greatest change (Table 6) was not reflected in the daily variation, indicating that the change most likely took place as soon as the sensors were deployed. The percentage deviation from the mean calibration coefficient is lowest in the open plot and is comparable to data presented for calibration tests under open-sky conditions. For all the treatments under a birch canopy, most data points were between 5 and 30%, with outliers as far as 54%, but half the data varied by only 1–10%. The data distribution is generally broader under the canopy than in the open, but was very variable within and between treatments. The greatest data spread occurred in the two most dense treatments, 1200 st/ha (#68) and 5300 st/ha (#80). The heterogeneity of the light environment beneath the canopy most likely contributed to the variability of these data. The outliers were most likely the result of rainfall events, but this could not be confirmed because of lack of rainfall data for the site. These data suggest that below-canopy calibration of sensors should be done over more than 1 full day.
