# Flood Analysis Using Remote Sensing Techniques: A Case Study in Valencia, Spain

Author: Claudia Isabela Saud Miño

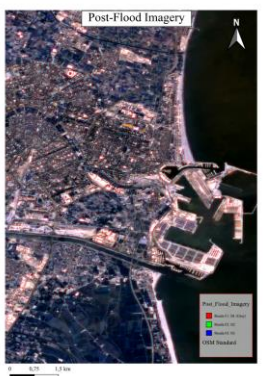
Figure 1. Post-Flood Image

- **Pre-Flood Imagery:** A clear representation of the study area before the flood, highlighting the distribution of vegetation, water bodies, and urban areas.
- **Post-Flood Imagery:** The extent of water coverage and changes in vegetation post-flood were evident. Urban areas and vegetation showed noticeable impacts from the flood event (Figure 1).

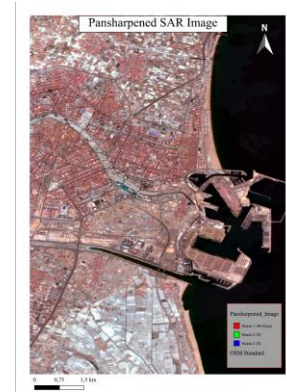
Figure 2. Pansharpened Imagery

The pansharpened imagery demonstrated improved spatial detail for RGB visualization, aiding in identifying subtle flood impacts. The increased spatial resolution enabled better detection of water pooling and changes in urban and vegetated areas (Figure 2).
