## Recovery of Rotorua geothermal field, New Zealand: Progress, issues and consequences

Bradley J. Scott<sup>a,\*</sup>, Dougall A. Gordon<sup>b</sup>,  
Ashley D. Cody<sup>c</sup>

### Abstract

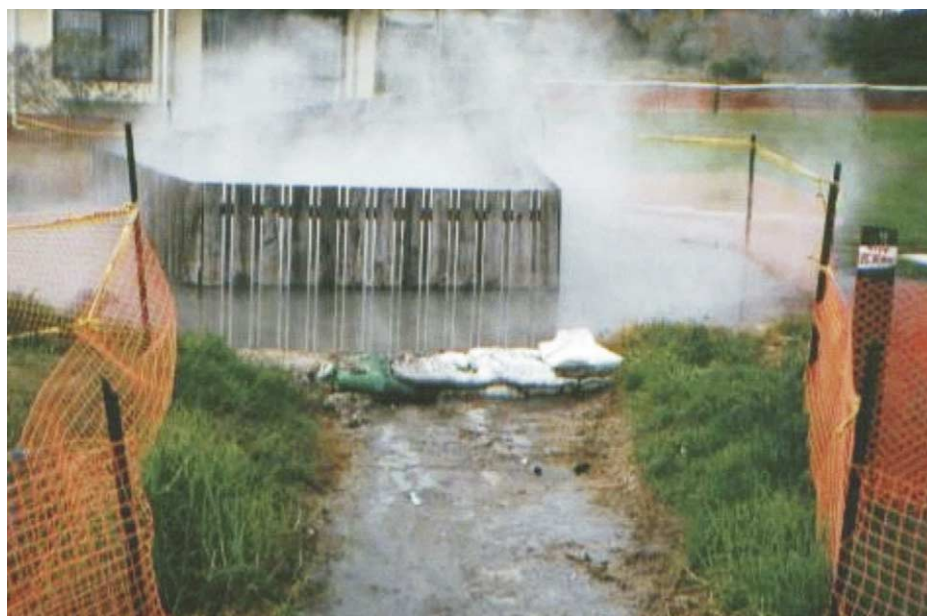
Fig. 3. Spring 657 overflowing strongly in March 1998. Originally the spring was contained behind the wooden fence (photo: A.D. Cody). This figure, and others in this article, can be viewed in colour online at the ScienceDirect website: <http://www.sciencedirect.com/>.

In early 1998, there was a resumption of hot spring activity beneath and between residential housing at 14–24 Tarewa Road. In March 1998, springs S657 and S649 were boiling and overflowing onto the street (Figs. 3 and 4); this was the first such boiling or overflow from either of these two springs for over a decade. However, during subsequent months these two boiling and flowing springs and others nearby became more troublesome. On 8 May 1998, the adjacent (5 m) spring S657/1 re-opened its vent with hydrothermal eruptions 7–8 m high that continued for several days. In July 1998, geysering occurred in S657 and also from underneath the garage at 20 Tarewa Road. In May 1999, spring S657 resumed

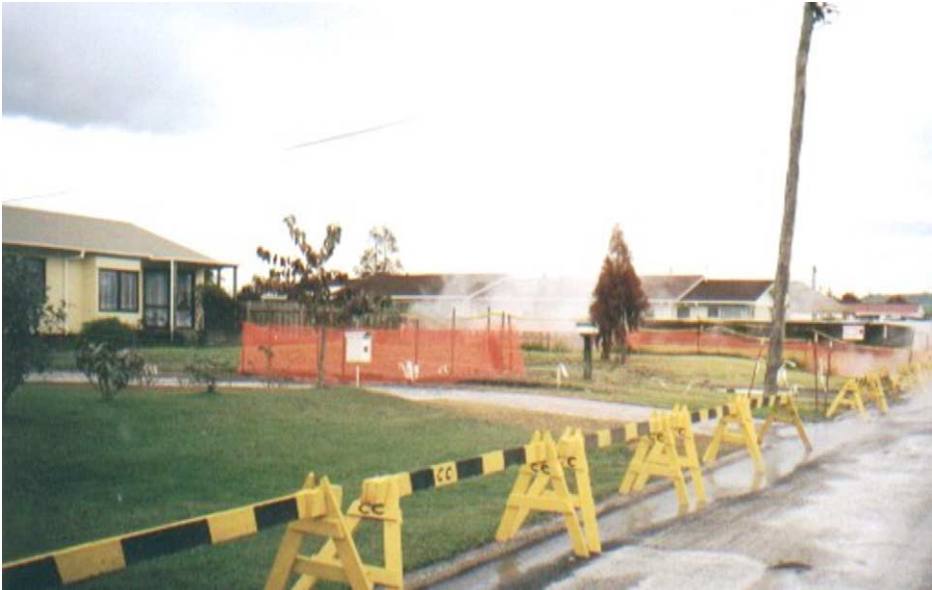
Fig. 4. View looking south along Tarewa Road, Rotorua, showing spring overflow onto the roadway as a result of spring recovery in March 1998 (photo: A.D. Cody).

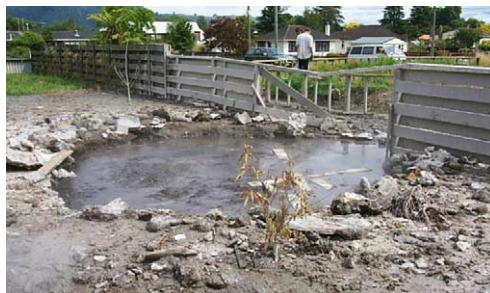
Fig. 5. Spring 652 after the hydrothermal eruption on 19 January 2000. Note the section of fence destroyed and the debris surrounding the feature (photo: B.J. Scott, GNS).

overflowing and S649 boiled and flooded its surrounding area. During 1–14 May 1999, the nearby spring S715 geysered 3–5 m high every 40–50 min. In November 1999, the large western-most pool at 22 Tarewa Road (S653) briefly erupted, killing a dog kennelled alongside; prior to that date this had been a calm, cool pool without overflow for many years. On 19 January 2000, hydrothermal eruptions occurred from a long-dormant, cold and in-filled dry spring vent (S652) (Fig. 5), which had been described and mapped by Thompson (1953) as an active spring. Between 24 and 26 January 2000, nearby S649 erupted in spectacular style at least six times and caused large overflows of boiling waters across the land at 20 Tarewa Road (Cody, 1998a; Scott, 2000a, 2000b). Intermittent vigorous boiling and over-

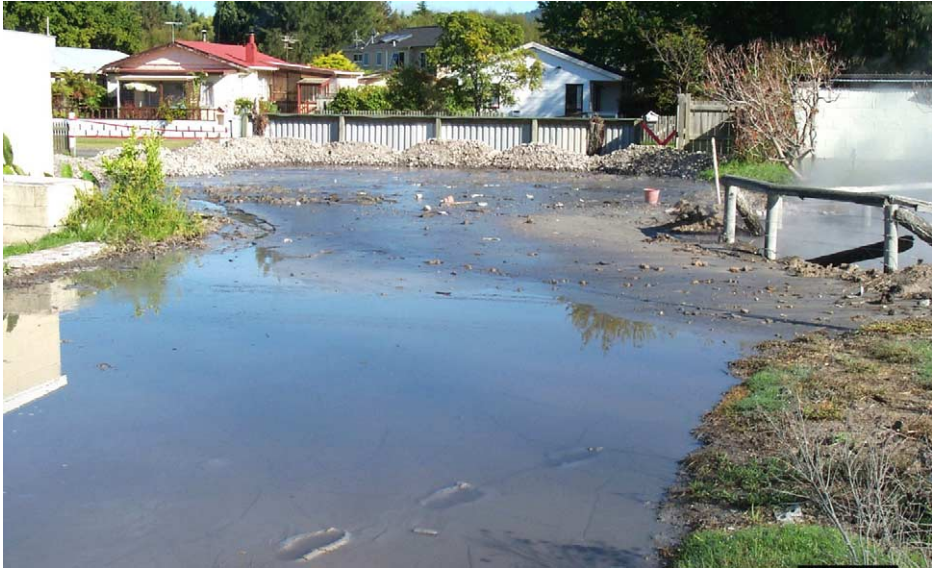
Fig. 6. Spring 653 after a vigorous boiling and overflow event in April 2000. Note the water and debris covering the surrounding area and the bund constructed in front of the fence to prevent water flowing onto Tarewa Road (photo: B.J. Scott, GNS).

flow events continue to date (Figs. 6–9). The resumption of activity in the Tarewa Road area resulted in several houses being damaged or forced to be relocated.

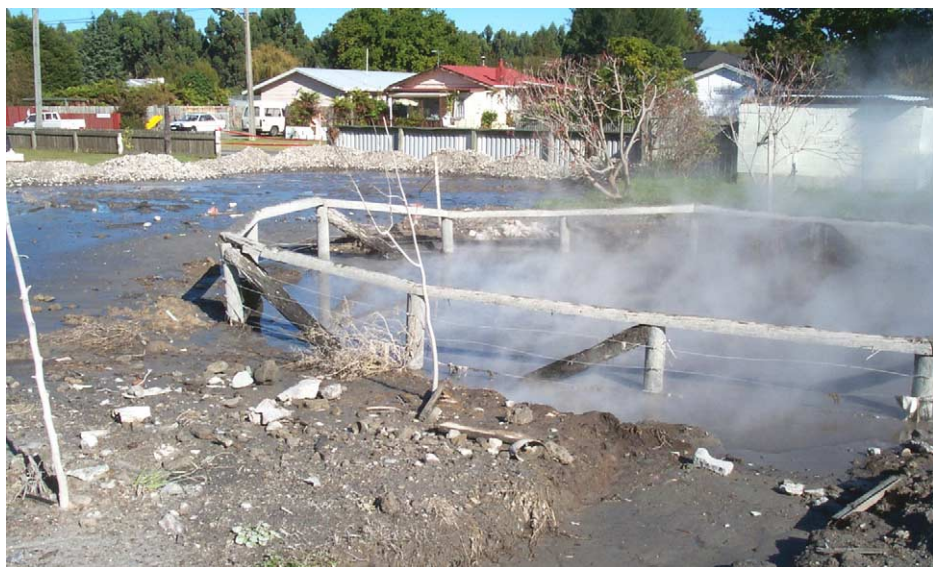
Fig. 7. Vent area of Spring 653 following a vigorous boiling and overflow event in April 2000. Note the ejecta from previous eruptions and flooding around the spring (photo: B.J. Scott, GNS).

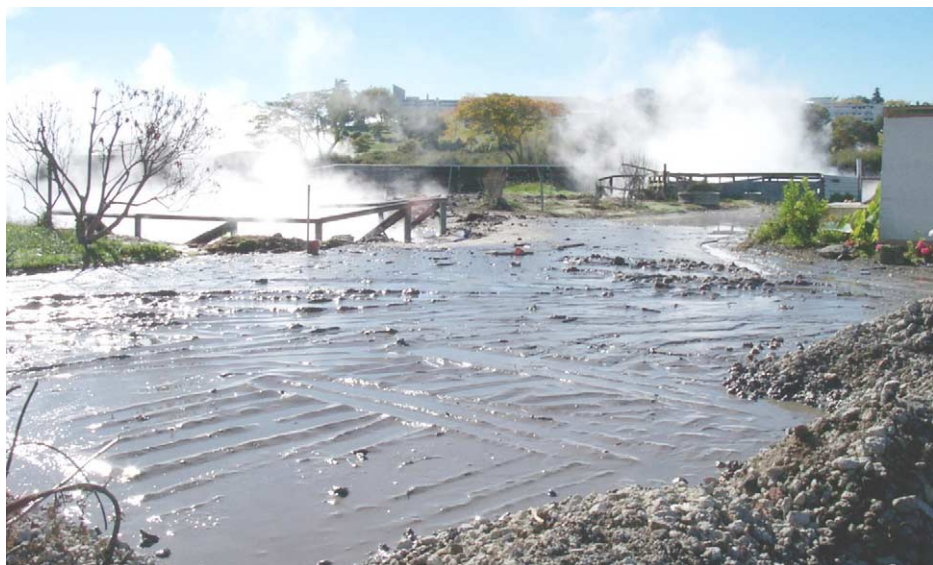
Fig. 8. Springs 653 (left) and 649/650 (right). These springs were the sources of several hydrothermal eruptions and strong overflow events in 1999 and 2000. Photograph taken on 13 April 2000 (photo: B.J. Scott, GNS).

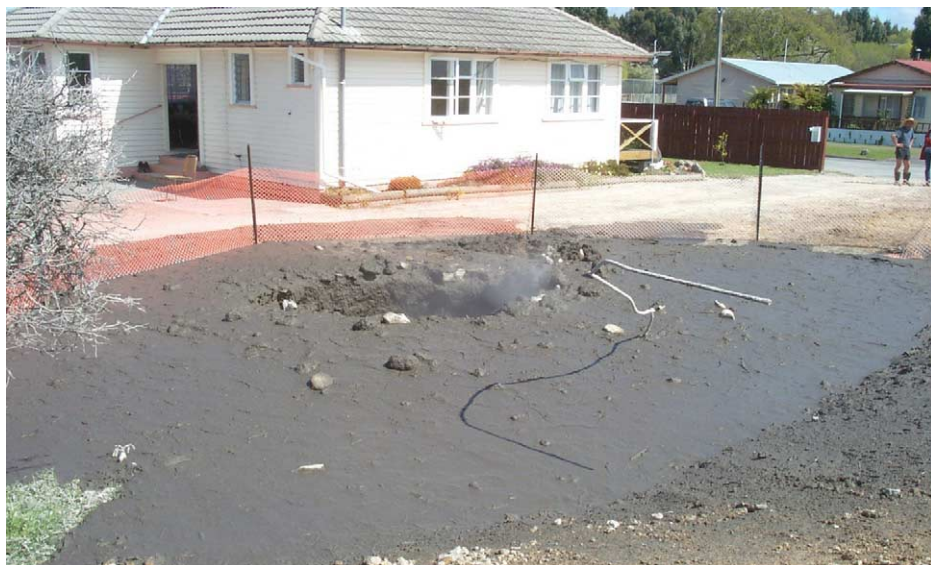
Fig. 9. View of a small scale overflowing event on 18 September 2000 in Tarewa Road. This event followed removal of the shallow concrete foundations of a rotary clothesline (photo: B.J. Scott, GNS).

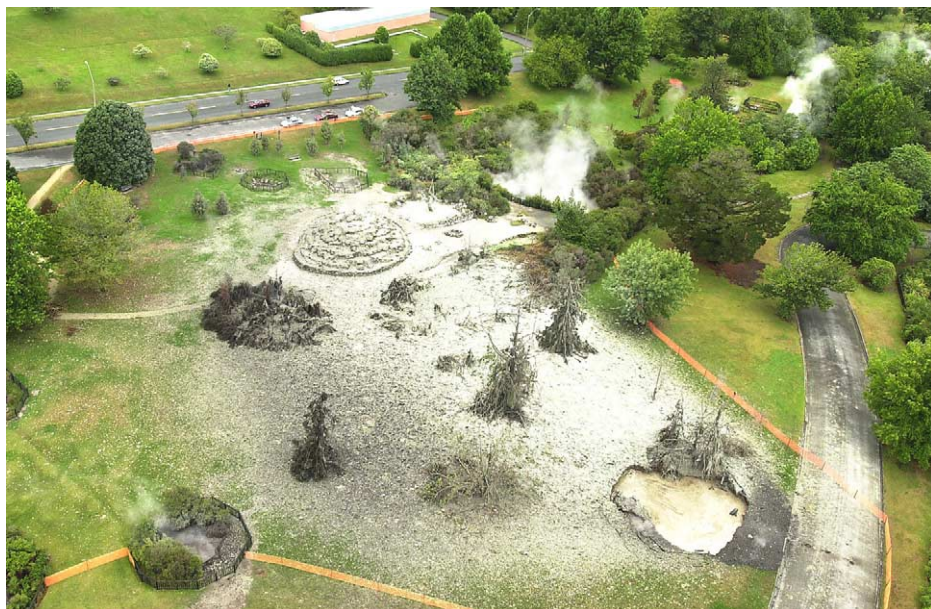
Fig. 10. Aerial view taken shortly after the 26 January 2001 eruption of Spring 721 in Kuirau Park, Rotorua (photo courtesy of the Daily Post newspaper).
