Preventing beater arm failure in cotton ginning machine towards enhanced productivity and energy conservation

Abstract

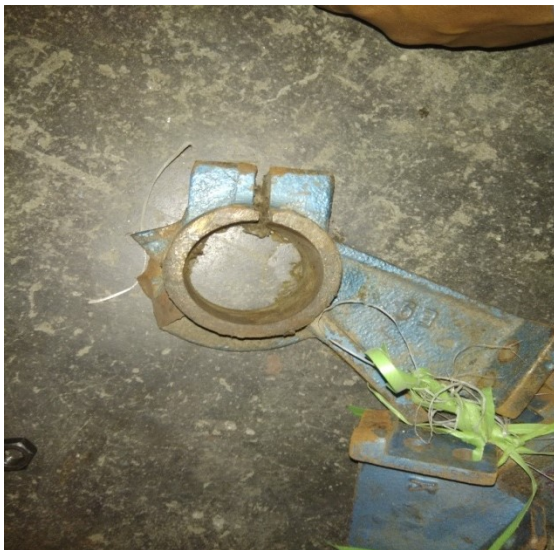
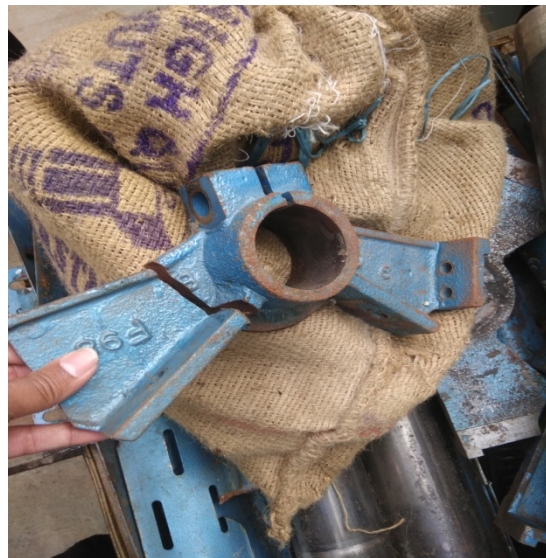
The beater arm is exposed to a high oscillating torque of 1000 rpm through the main rotating shaft. The beater shaft is attached through gear mechanism to a 1440 RPM motor and due to Gears, 1000 RPM is transmitted to beater arm. During its working it was observed that the left arm of beater arm breaks at a particular location frequently. Its working was observed on various geographical locations and sites but the same problem continued to occur. The Maximum breakage cases were at the left arm itself.

Blow holes were observed in the inner side when the broken profile of Beater arm was observed visually. Basically, blowhole is a kind of cavities defect, which is also divided into pinhole and subsurface blowhole. Gases entrapped by solidifying metal on the surface of the casting, which results in a rounded or oval blowhole as a cavity. The occurrence of blow holes state that there is a fault in chemical composition or molding process, so blow hole may be the most probable reason of failure.

The second possible reason observed was cracks developed at the arm joint. The possible conclusion may be the voids or the chemical composition of the material is not able to sustain the high oscillating load at 1000 Rpm. Undetected cracks in the product can bring about potential safety hazards when the product is put in use. Factors such as localized tensile stress and stress concentration result in crack initiation and propagation. On the other hand, conditions such as high temperature, compressive stress and diffusion are conducive to crack healing. The factors that affect crack propagation may result in micro cracks extending to macro cracks. On the contrary, macro cracks probably close gradually, and may heal completely under the right conditions

1. The supplier of Material was immediately changed because maximum observations intended towards fault in material. The test reports after change of supplier are yet to come.
2. The amount of material at the joint of the both arms of the Beater arm was increased for providing greater strength at the joints. The material was uniformly increased as a slope from bottom to top of the Joint.
3. Also arc size at the joint was increased. Increasing the arc size provides a greater amount of area to sustain heavy cycles of load exerted on the beater arm.
