Applies To: **1997-99 CR-V** – All with Accessory Cargo Cover

Accessory Cargo Cover End Caps Come Off

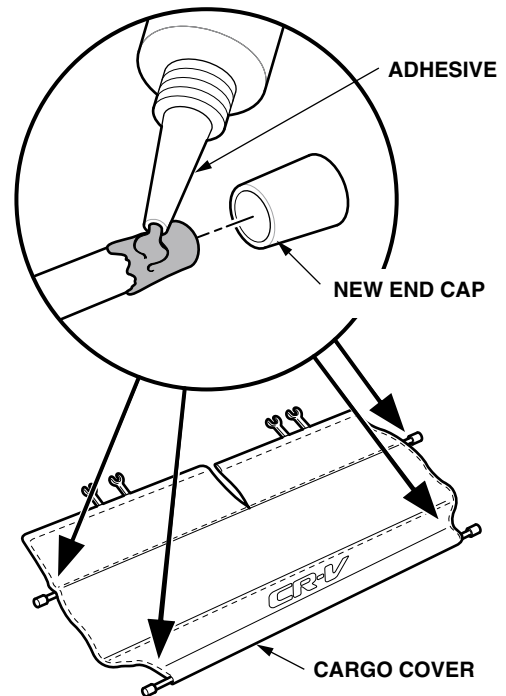
1. Remove the end cap from the flexible rod if the end cap is still there, and remove any remaining adhesive from the rod end with adhesive cleaner.
2. Apply a small amount of adhesive around the outside of the rod end.

3. Install the new end cap onto the rod end.
4. Repeat steps 1 thru 3 for the other three end caps.
