# Mooring equipment should not look like this

A guide for ship staff completing mooring system inspections.

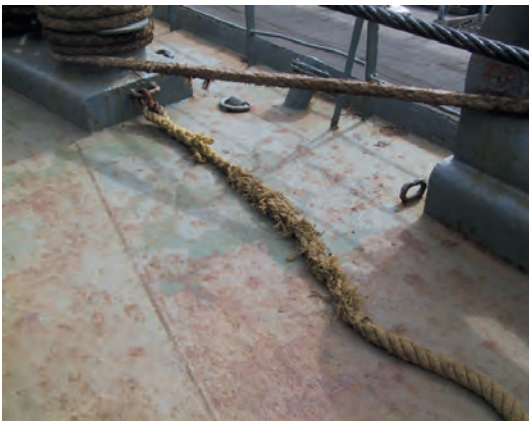
## **Stopper line frayed/unravelled and weak**

Failure of the stopper line whilst under tension may result in unexpected loads acting on the mooring line while it is being manually belayed and endanger the crew who are either holding the stopper line or handling the mooring line.

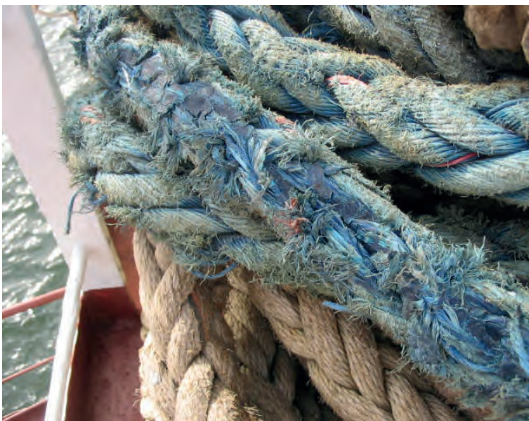
## **Mooring line surface showing evidence of heat damage**

Heat damage can be caused through friction or direct contact with external heat sources.

Generally caused by surging, and affected lines will show glossy or glazed areas on the line surface.

A heat-damaged line is generally more seriously weakened than commonly believed.

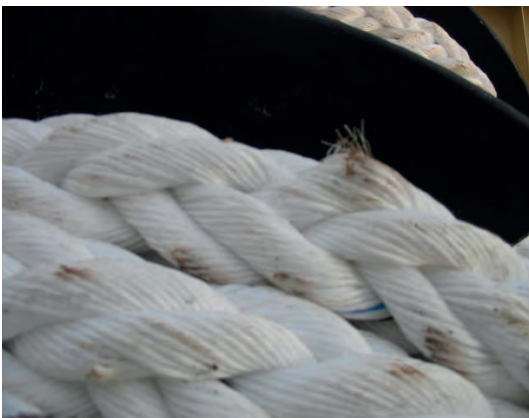
## **Pinching damage**

Results in pulled or cut yarns, which directly affects the strength of the mooring line.

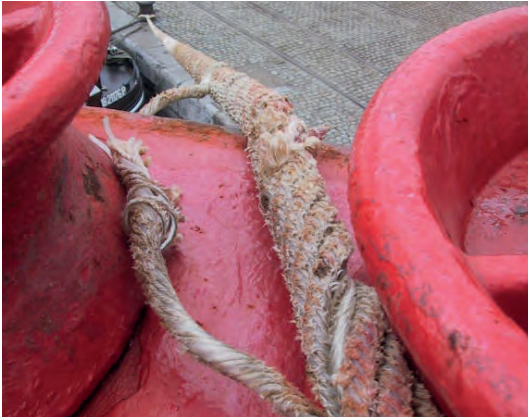
#### **Cut strand on a braided nylon line**

Like cut yarns, cut strands have a direct though more serious effect on the line's strength.

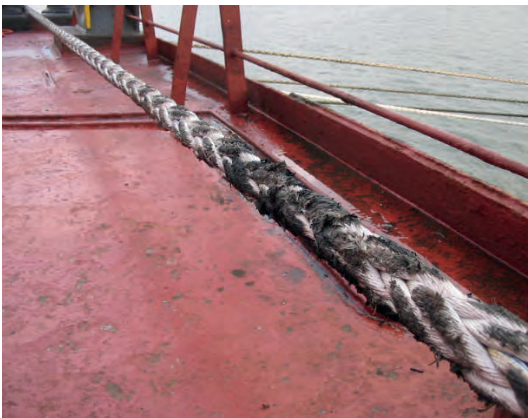
#### **Mooring lines stained with grease**

Contact with chemicals may cause deterioration of the line.

When it is likely that a line will get in contact with grease from winches, roller fairleads and so on, select lines with good chemical resistance.

If a line passes along/over/around greased fittings and equipment, those involved in maintenance/greasing should be instructed to remove excess grease/oil.

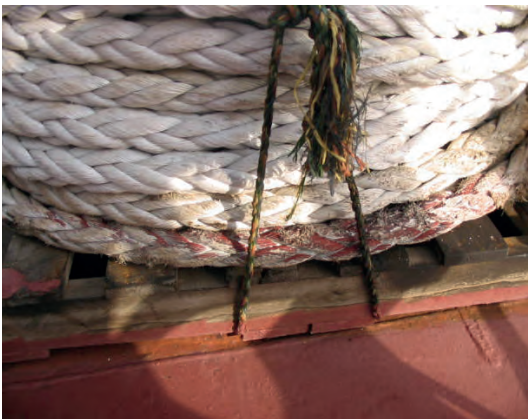
#### **Mooring lines stained with paint**

Contact with chemicals such as paint may cause degradation and should be avoided.

Contact with paint can cause the line to harden, which affects its grip on the drum end.

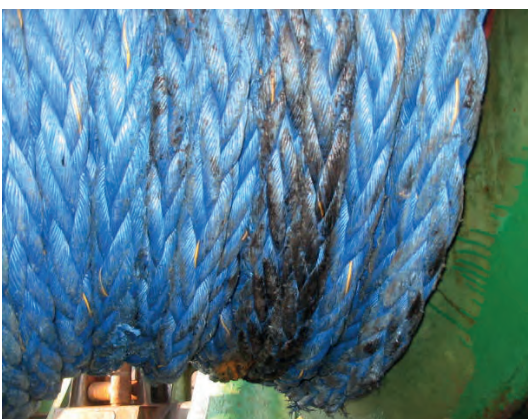
#### **Mooring line stained with fuel oil**

Oil and petroleum products generally do not affect synthetic fibres, but should be avoided and may cause pollution when lines have absorbed oil and are then dropped into the sea.

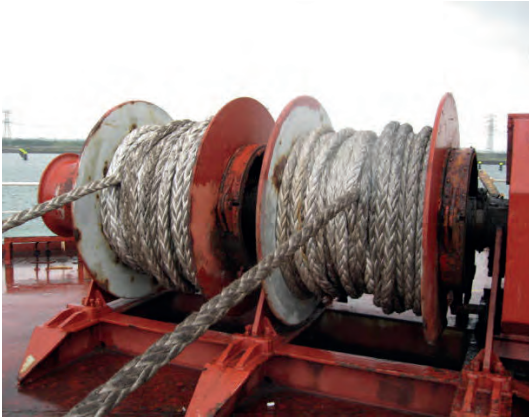
### **Buried turns**

Improper reeling or spooling (without the right pretensioning) causes the tensioned part of the mooring line on the dedicated winch to become buried underneath the underlying turns.

If not noticed in time, buried mooring lines may be dangerous for the linesmen as the line initially pays out when slacking away for letting go, but when wound/spooled back onto the drum, it will continue to turn in the slacking away direction if the line has not been freed in time.

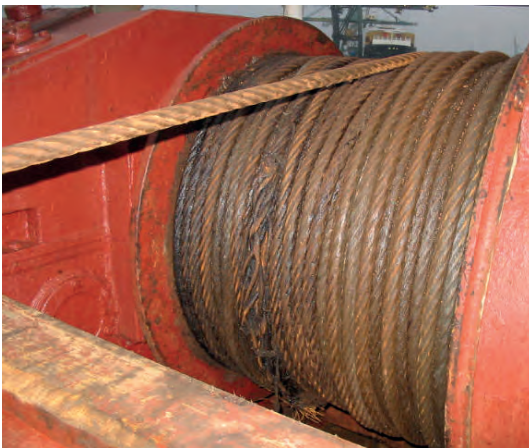
### **Improperly spliced wire mooring line**

Splicing generally reduces the strength of the wire by 10%. Ensure that the correct method of splicing is used (contact the manufacturers).

Good practice requires a number of five full and preferably two additional half tucks in a wire.

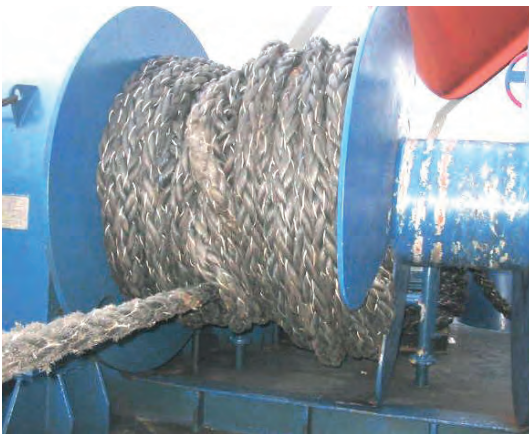
Synthetic mooring line heaved tight on the storage section of a split-drum type winch.

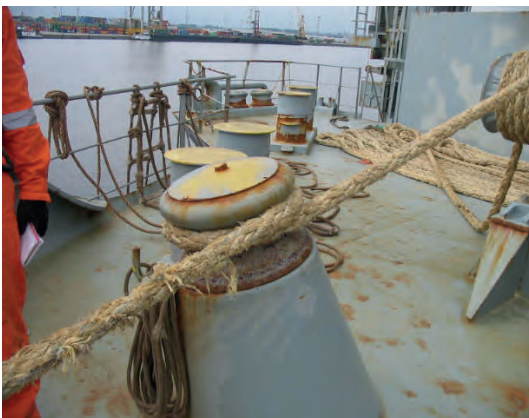
### **Fairlead rollers being “strangled” in order to improve the incoming angle on the winch drum**

Strangling the roller causes the mooring line to chafe.

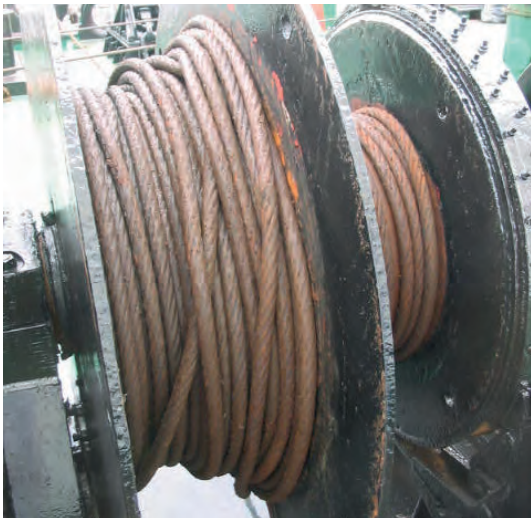
### **Improper spooling of wire line**

Wire mooring line irregularly/unevenly spooled onto the winch drum.

Note crossed wires in underlying layers which are severely damaged or crushed by upper layers of the wire.

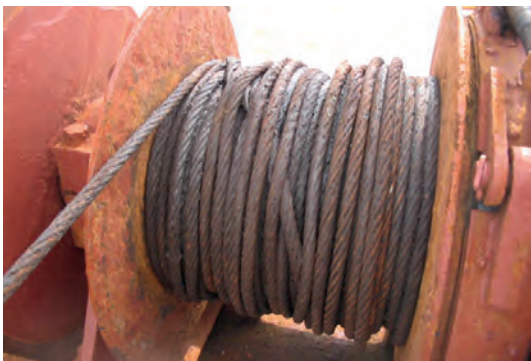
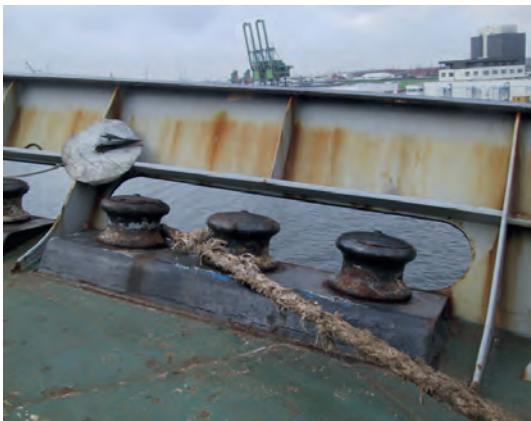
### **Abrasion damage to mooring lines from frozen fairleads**

Chafing between a mooring line and other equipment such as cocks and fairleads causes surface abrasion.

Rust or evidence of wear may be an indication that the rollers do not rotate freely.

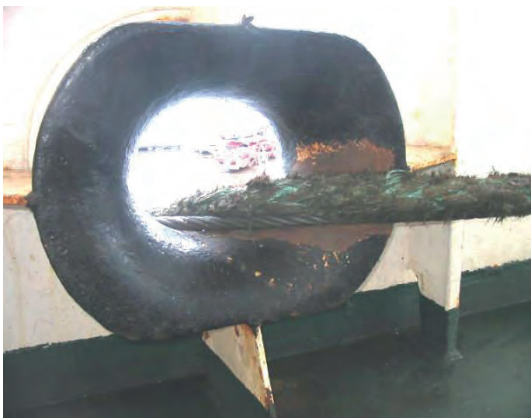
### **Mooring wire and lines through same Panama lead**

Friction or chafing between mooring lines and mooring wire causes damage from surface abrasion and contamination of the line.

The lubricated mooring wire leaves grease deposits on the panama lead and stains mooring lines with grease residues.

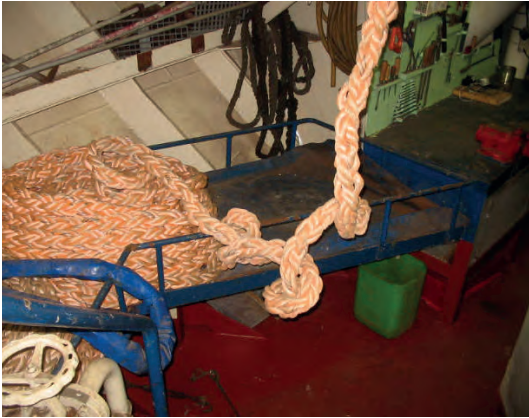
### **Kinks**

Kinks cause permanent distortion of the strands and seriously affect the line's strength.

Expect kinks to cause about 30% reduction in strength. A kinked line means poor contact between line and drum end surfaces and may cause the mooring line to slip.

Kinked lines should be removed from service until they have been examined and properly repaired. Despite being repaired, this line has been weakened.

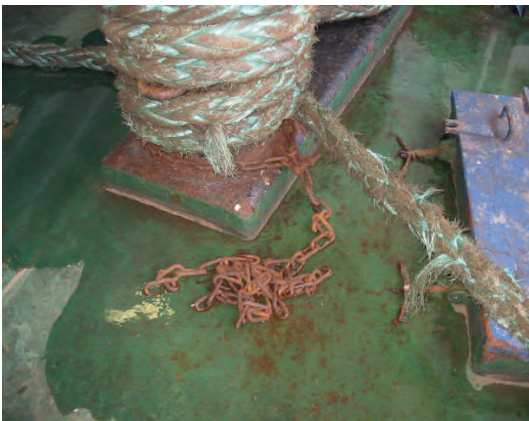
### **Chain stopper for stoppering mooring lines**

Using chain for stoppering might cause crushing and pinching damage to yarns and strands when tension comes on the chain stopper.

Fibre line stoppers should be used for stoppering fibre mooring lines.

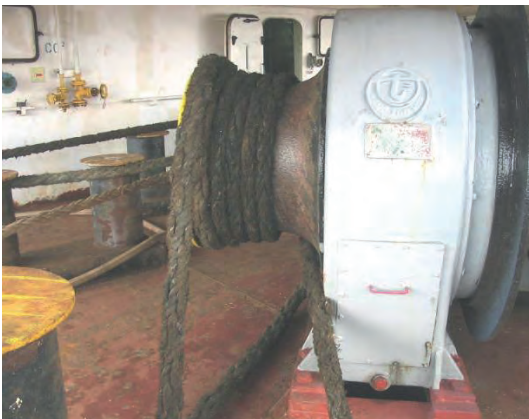
### **Mooring line chafing against winch structure**

Lines not paid out properly may rub on the ship's structure (winch frames, platforms, etc.) involving a considerable risk of damage through chafing, abrasion or cutting.

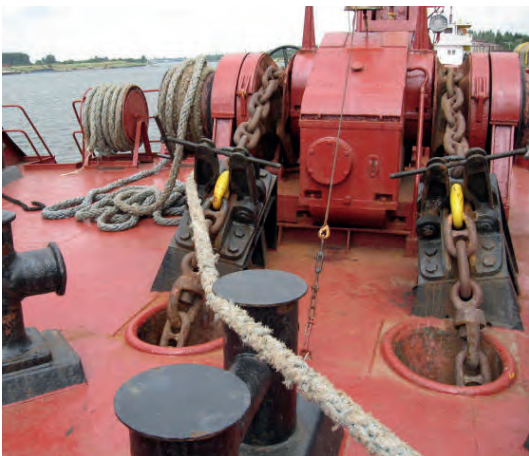
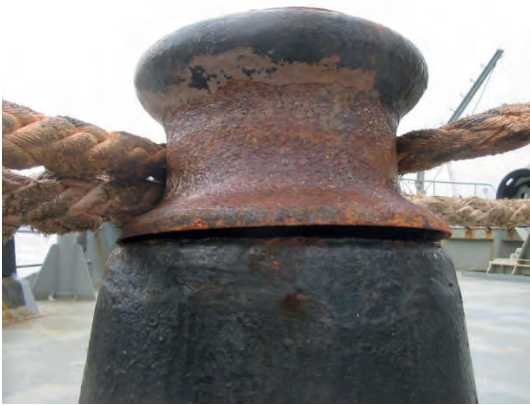
**Excessive clearance between roller and pedestal table, two lines acting on the same roller**

This indicates that the roller pin is worn, meaning it will have lost part of its original strength and may fly back when under tension.

Allowing two lines on the same roller is very bad practice as it may result in overloading the roller/pedestal fairlead and chafing between the two mooring lines.

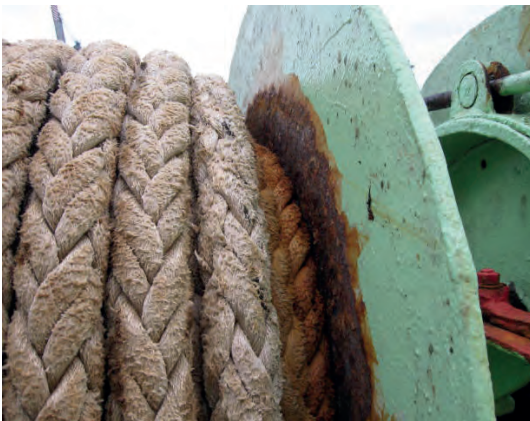
**Chafing damage to line due to rust**

Rusty, knife-edge flakes on the storage drum cause chafing damage and accelerated wear on the mooring line due to contact during operation or as a result of vibration.

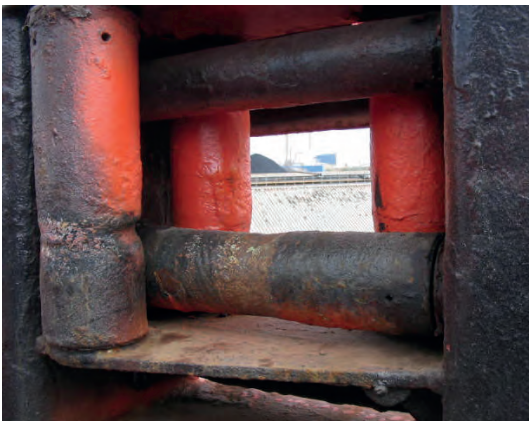
## **Extreme wear and grooving on rollers**

Grooving over part of the surface of the roller indicates that the roller is frozen and that the line/wire is always chafing against the roller in the same area.

Grooving or corrosion and scale accelerates damage to the mooring lines/wires.

Generally, and when under tension, lines/wires will tend to settle in the groove which will cause further/accelerated wear to the grooved surface.

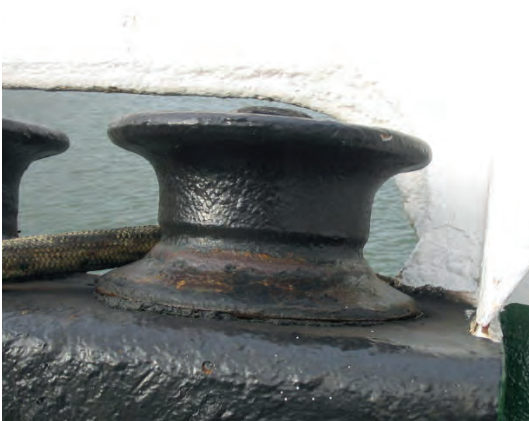
## **Extreme grooving in button type roller fairlead**

The depth and size of the groove indicate that it has previously been used for wire lines, which might cause bird caging or corkscrewing when new wires are installed.

If the fairlead is subsequently used for lines with a different diameter, the sharp edges of the groove will damage the line through abrasion and chafing.

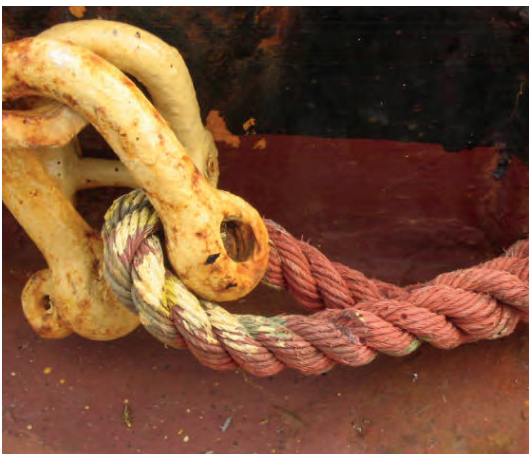
Eye screw pin of D-shackle for connecting the line stopper to the stoppering eye/lug not properly fitted.
