18

Procedural Accidents

ALI NOSRAT, YOSHITSUGU TERAUCHI, AND
MAHMOUD TORABINEJAD

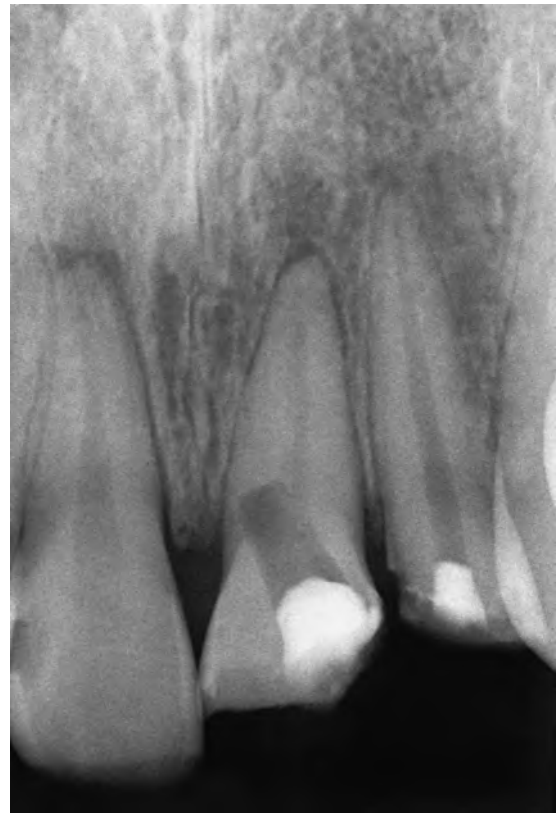
• **Fig. 18.2** Lack of attention to the degree of axial inclination of central incisor in relation to adjacent teeth and to alveolar bone resulted in severe gouging and near perforation in an otherwise simple access preparation.

in relation to adjacent teeth and to alveolar bone may result in either gouging or perforation of the crown or the root at various levels (Fig. 18.2). After establishing the proper access outline form, failure to direct the bur parallel to the long axis of a tooth will cause gouging or perforation of the crown or root. This problem often occurs when the dentist must use the reflected image from an intra-oral mirror to make the access preparation. In these situations, the natural tendency is to direct the bur away from the long axis of the root to improve vision through the mirror. Another reason that can cause failure in directing the bur parallel to the long axis of the root is access cavity preparation under higher magnifications. The clinician may lose “depth perception” when using the microscope at higher magnifications, which can cause deviation from the long axis. Failure to check the orientation of the access opening during preparation may result in a perforation. The dentist should stop periodically to review the bur-tooth relationship. Aids for evaluating progress include transillumination, magnification, and radiographs. Bite-wing radiographs taken during access cavity preparation are useful to adjust the mesiodistal orientation. Shifted periapical radiographs are useful to adjust the buccolingual orientation.

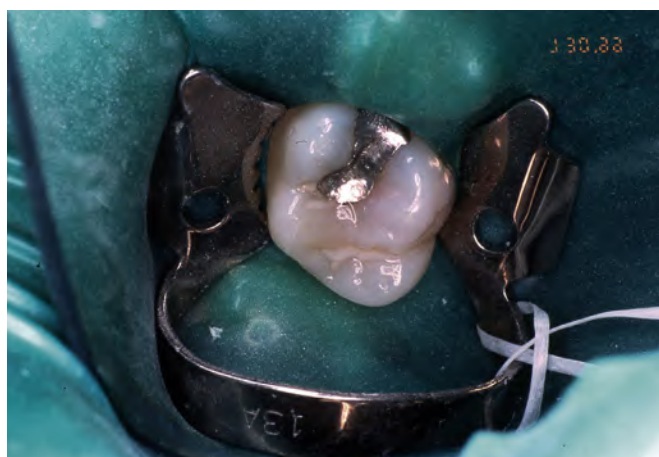
• **Fig. 18.4** Rubber dam must be applied in the anterior and posterior teeth. It provides isolation of the target tooth and prevents procedural accidents.

Use of a rubber dam (Fig. 18.4) during root canal treatment is usually indicated.^{1,2} However, in situations in which problems are anticipated in locating pulp chambers (e.g., tilted teeth, mis-oriented castings, or calcified chambers), initiating access without a rubber dam is preferred because it allows better crown-root alignment. However, when access is made without rubber dam placement, no intracanal instruments, such as files, reamers, or broaches, should be used unless they are secured by a piece of floss⁶ and a throat pack is placed. Constricted chambers or canals must be sought patiently, with small amounts of dentin removed at a time.

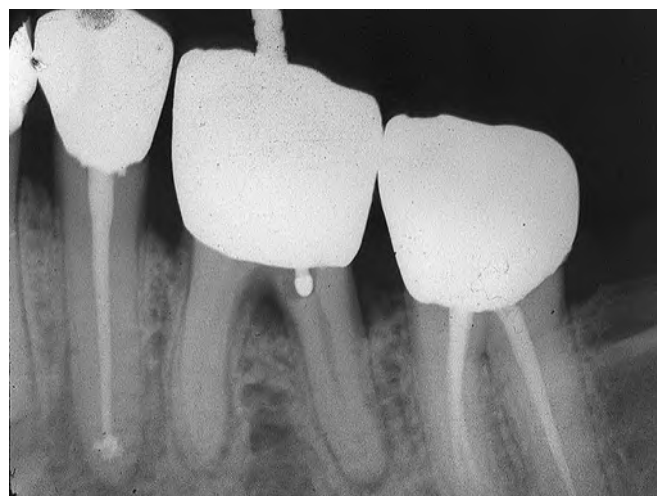
• **Fig. 18.5** A small bur is placed during access preparation when orientation is a problem. This provides information about angulation and depth of bur penetration.

To orient the access, a bur may be placed in the preparation hole (secured with cotton pellets) and then radiographed (Fig. 18.5). This provides information about depth of access in relation to canal location. Remember, a single canal is located in the center of the root. A direct facial radiograph will show the mesio-distal relationship; a mesial- or distal-angled film will show the

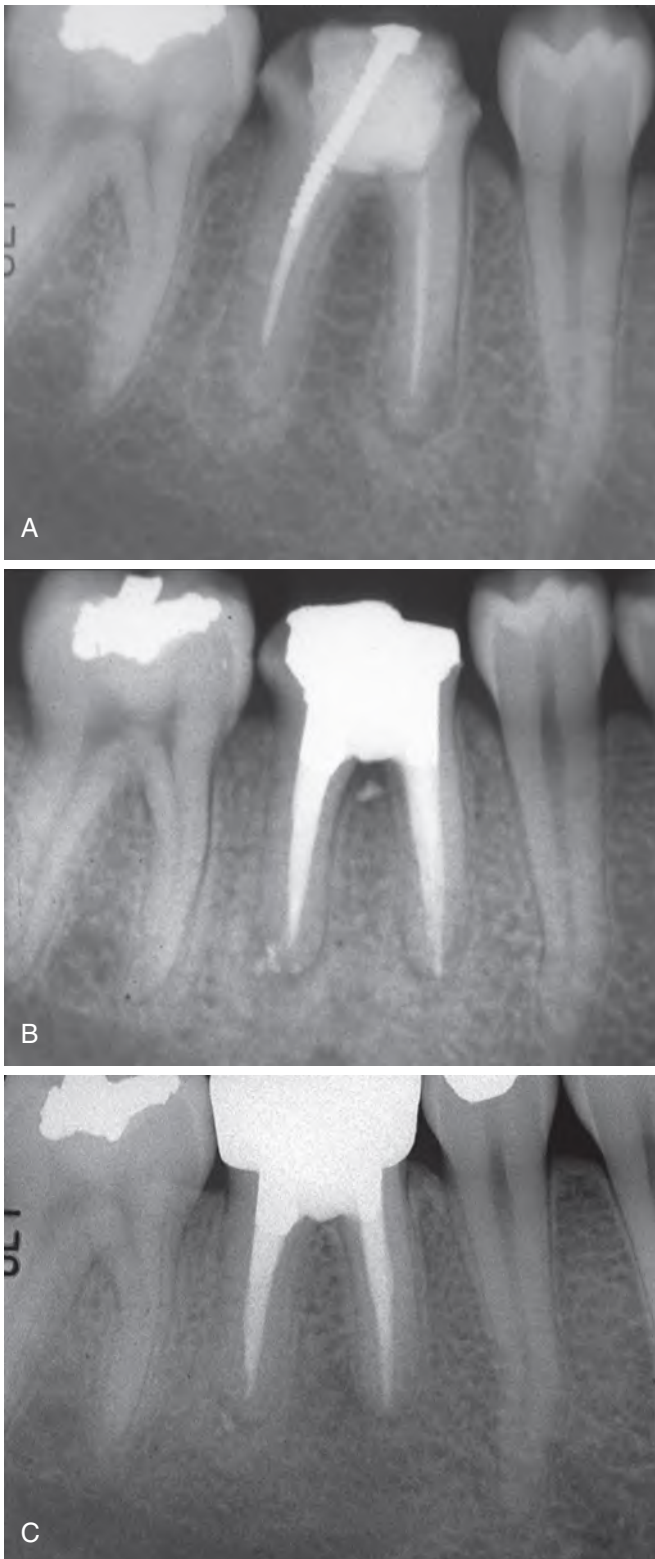
• **Fig. 18.10** (A) Postoperative radiograph of a 58-year-old female after endodontic treatment. The patient is percussion-sensitive, and periapical lesions are present. A 7-mm periodontal pocket exists on the mesiobuccal aspect of the mesial root of the second molar. A fracture is suspected, and extract-replant was performed for diagnostic reasons. The tooth was extracted, and a fracture was noted on the mesial root. (B) The mesial root was resected and the tooth was replanted after retrofilling of the distal root with mineral trioxide aggregate (MTA). (C) Radiograph 1 year later shows osseous repair and restoration of this tooth. The periodontal pocket healed.
