Robotics Sensing and Navigation

ECE 5554

LAB-5

CAMERA CALIBRATION:

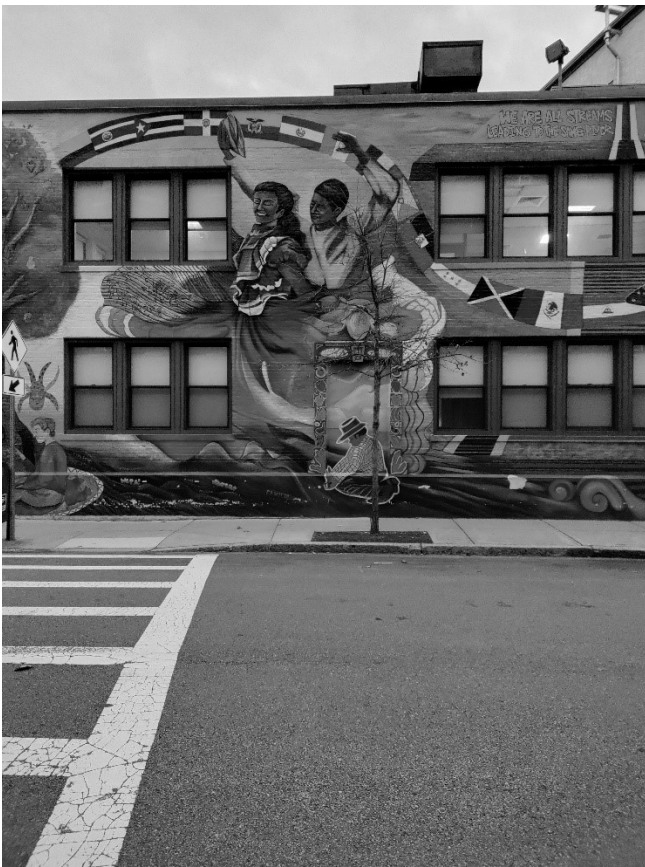
Figure6: Original Distorted Image in grayscale

The above two images show distorted (original image) and undistorted images from calibration toolbox. We apply calibration to get undistorted image from image which is already calibrated by the phone's manufacturers. Hence we get the image as figure7 which has slight curvature.

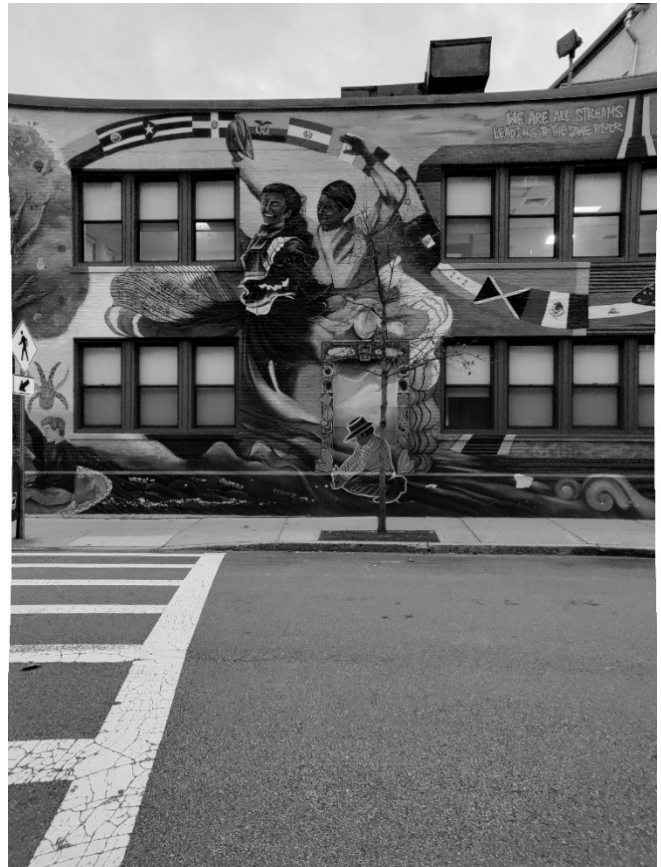
Figure7: Undistorted image generated using calib toolbox

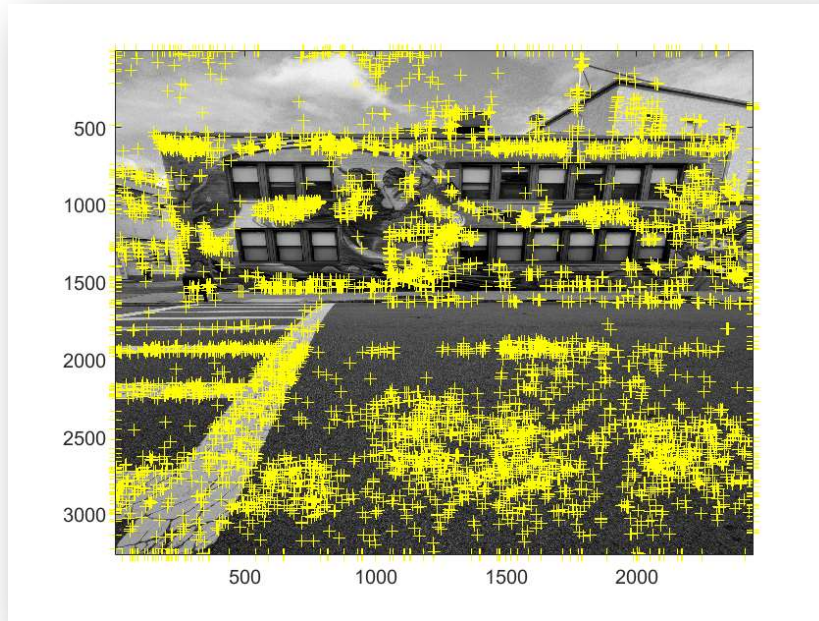
Figure9: Feature detected using Harris Corner detection (second image from montage)

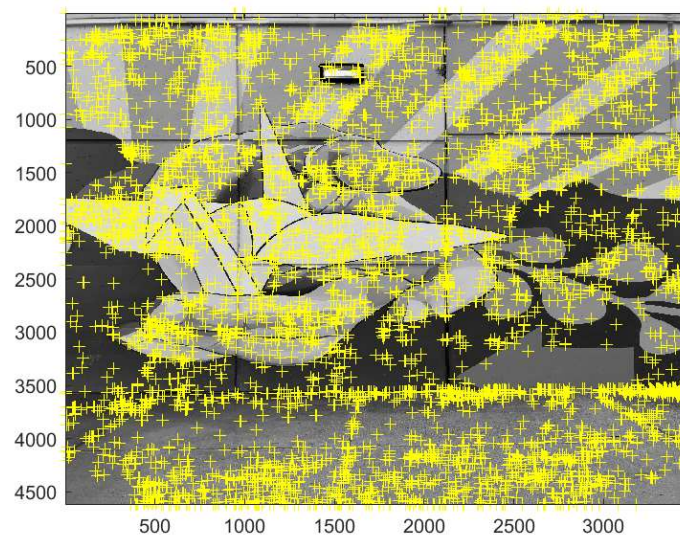
Figure 12: Feature detected using Harris Corner detection (Third image from montage)

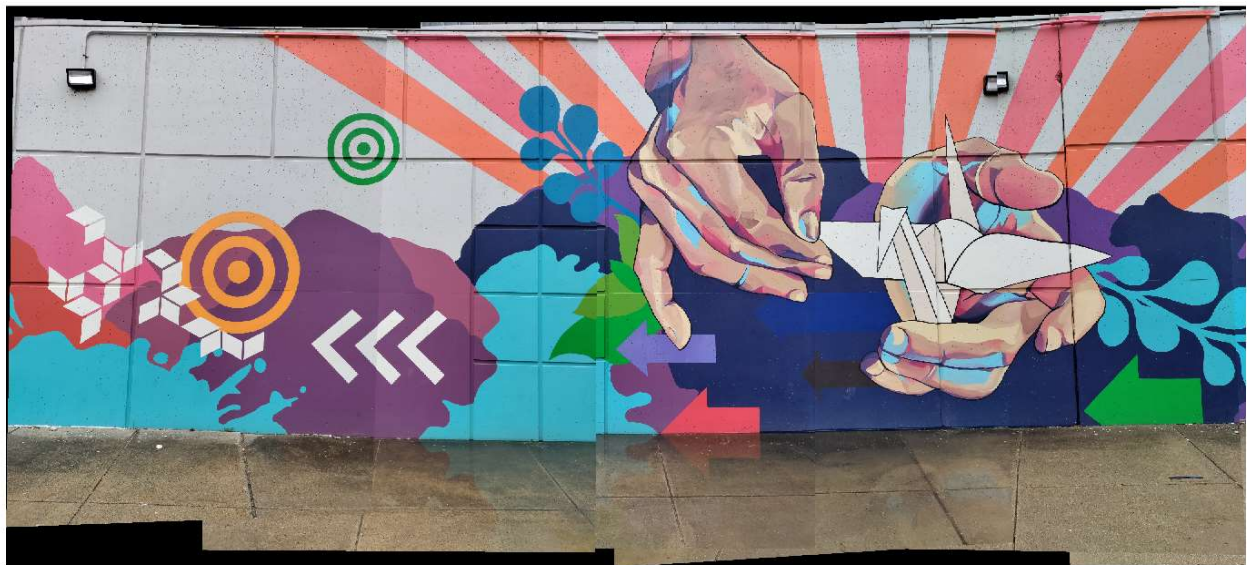
Figure 13: Mosaic Image after applying Harris Corner Detection

The mosaic formed is very much similar to the original images shown in montage. Variations can be seen in flooring because of less features and similarities. Homography doesn't apply to two different planes hence we get slight mismatch.

Computation cost decreases when we use minimum number of features to perform the same operation with acceptable output of mosaic. Instead of using maximum number of features.

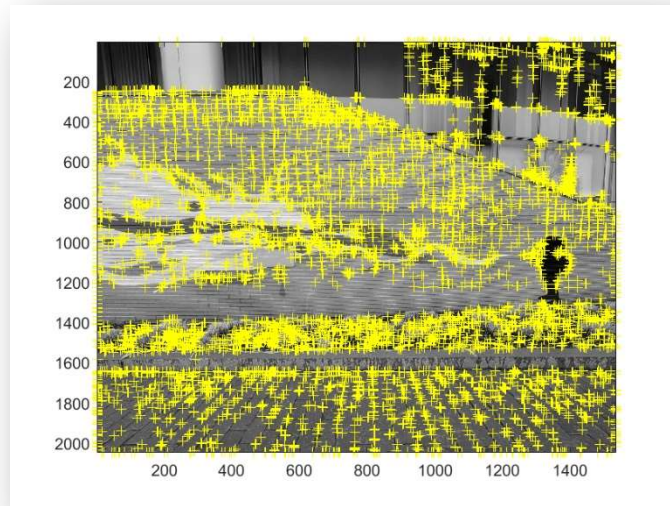
Figure18: Feature detected using Harris Corner detection (Fourth image from montage)
