RESIDENTIAL

1801 S 28th St
Terre Haute, IN 47803

04/22/2025

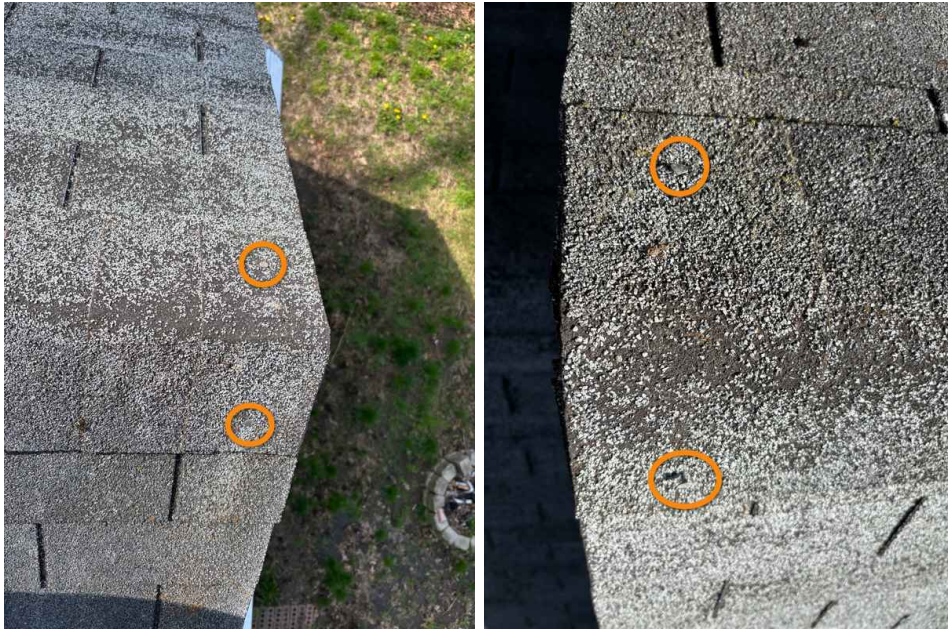
1.1.1 Coverings

EXPOSED NAILS

Under-driven or exposed nails were found in one or more roof coverings. Nails left exposed will eventually rust and deteriorate leaving holes for water intrusion. Recommend a qualified roofer seal nail heads.

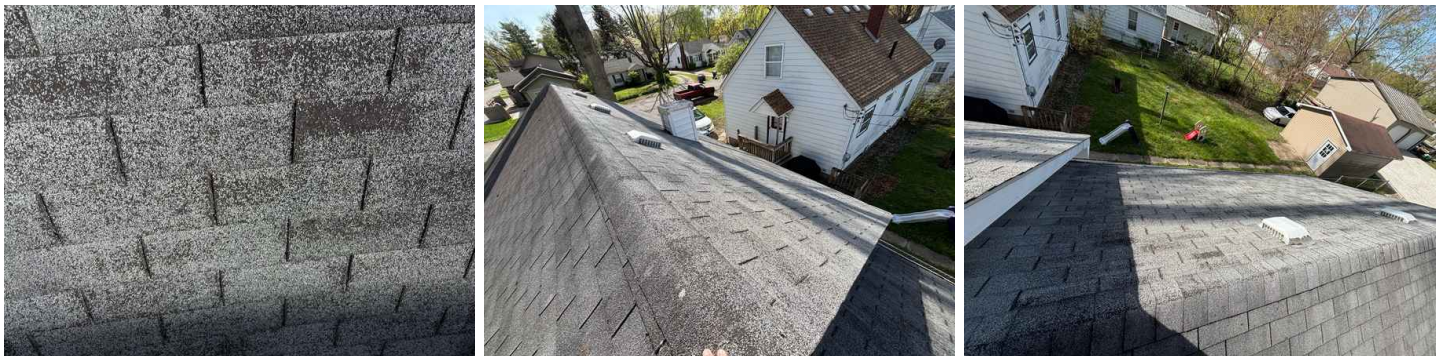
1.1.2 Coverings

END OF LIFE

Roof coverings show significant wear and appear to be nearing end of life. Advise having evaluated by roofer and budgeting for future replacement.

Contact a qualified roofing professional.

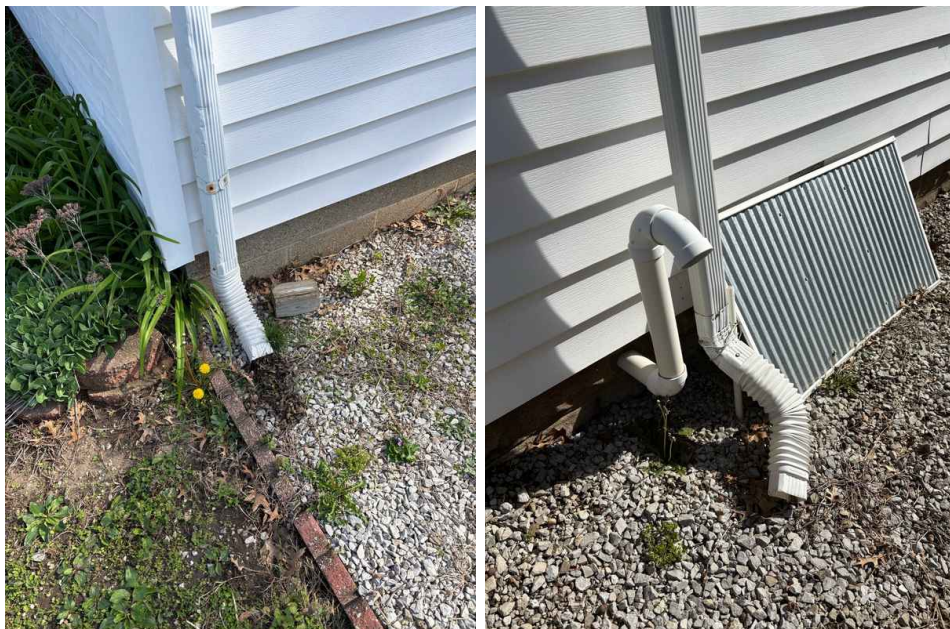
1.3.1 Roof Drainage Systems

DOWNSPOUTS DRAIN NEAR HOUSE

One or more downspouts drain too close to the home's foundation. This can result in excessive moisture in the soil at the foundation, which can lead to foundation/structural movement. Recommend a qualified contractor adjust downspout extensions to drain at least 6 feet from the foundation.

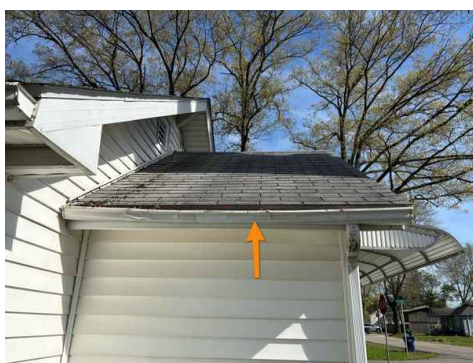
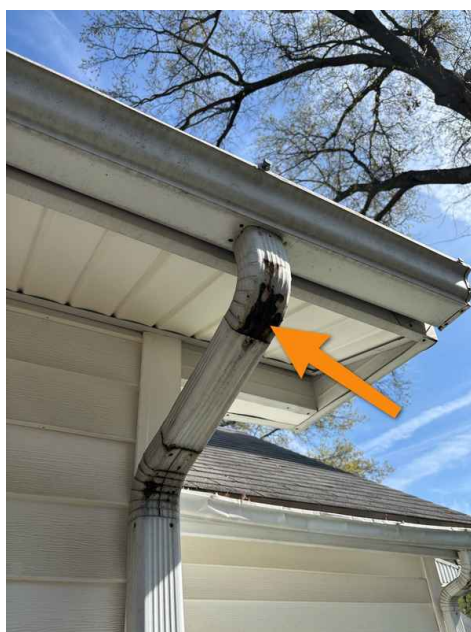
1.3.3 Roof Drainage Systems

GUTTERS- DAMAGE

Gutters/Downspouts were damaged in one or more areas. This can result in leaks or blockages that may cause further issues. Recommend a qualified contractor evaluate and repair.

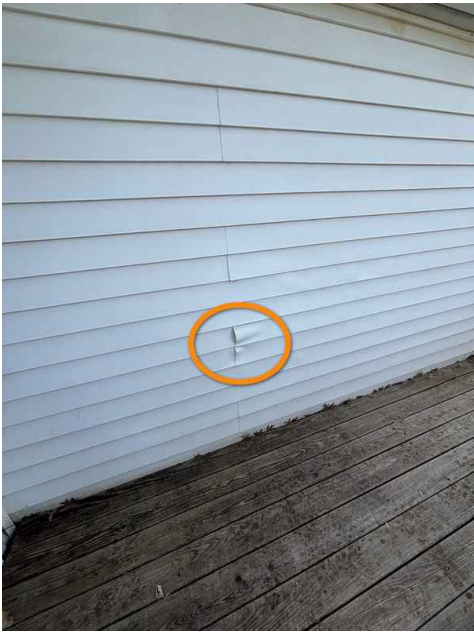
2.2.1 Siding, Flashing & Trim

SIDING- MINOR DAMAGE/WEAR

Siding showed minor damage/wear. Repair/replace damaged sections as needed to maintain protection of structure.

Contact a qualified siding specialist.

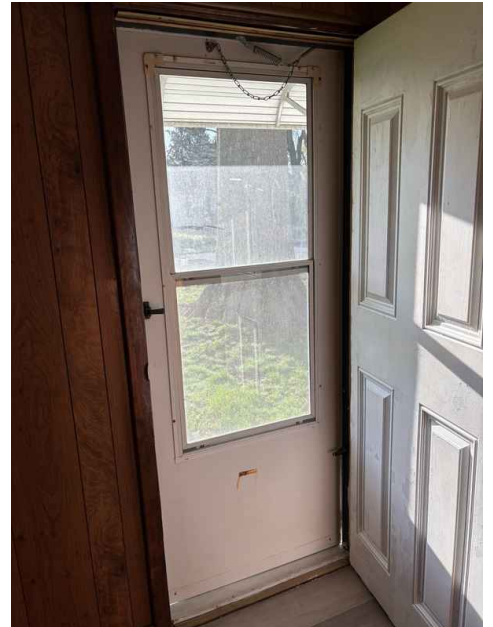
2.4.1 Exterior Doors & Windows

DAMAGED/MISSING WEATHERSTRIPPING

Damaged or missing weatherstripping can allow drafts reducing the efficiency of the home. Recommend replacement to attain a good seal around exterior doors.

Contact a qualified professional.

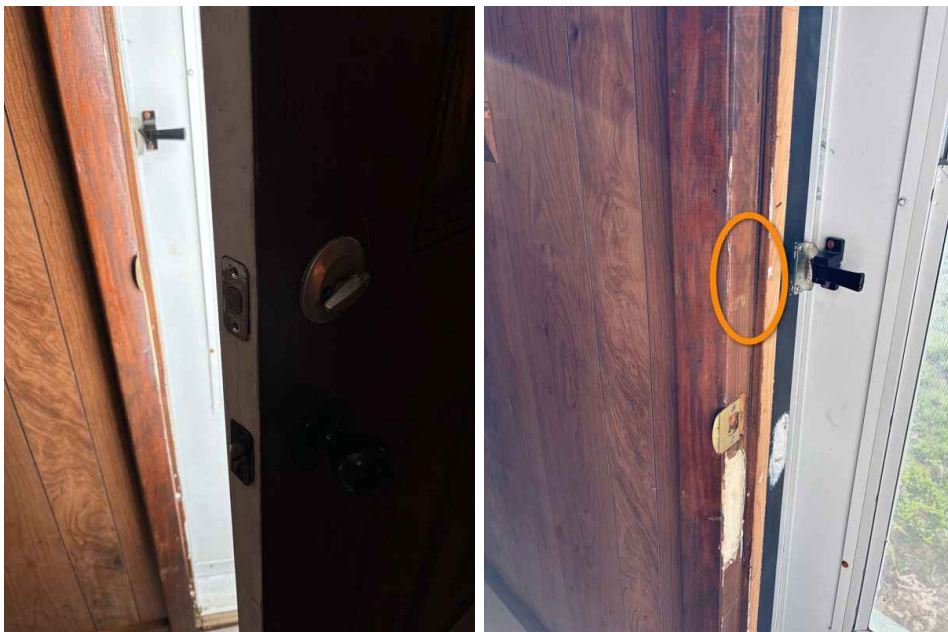
2.4.2 Exterior Doors & Windows

HARDWARE-LOOSE/MISSING

Exterior door hardware was loose or missing. This may affect function and/or security. Have hardware tightened or replaced as needed.

Front-missing deadbolt latch

Contact a qualified professional.

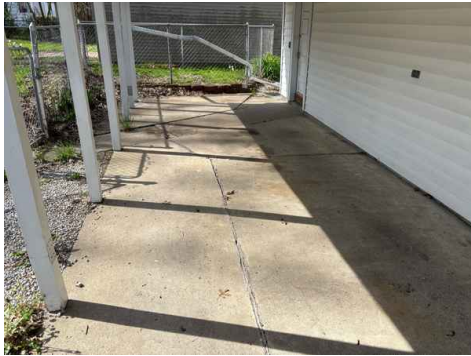
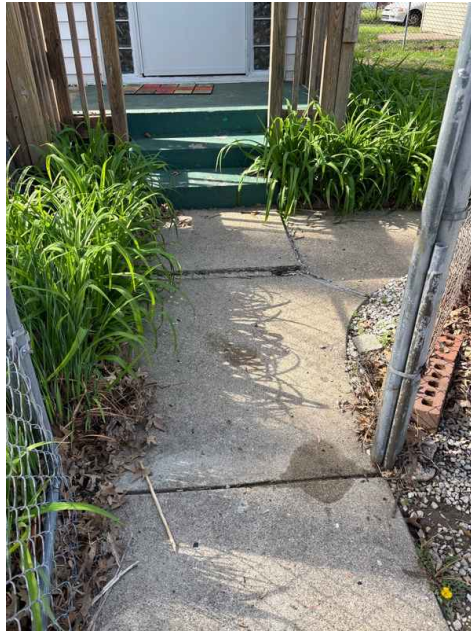
2.5.1 Walkways, Patios & Driveways

CONCRETE CRACKING/SETTLING- MINOR

Minor cracking and/or settling of concrete sidewalks/patios/drives was observed. This typically the result of excess moisture or poor soil preparation during installation. Sections can sometimes be leveled and stabilized by a process call "mud jacking", or be removed and replaced. Consult with a concrete finishing contractor for repair options and cost.

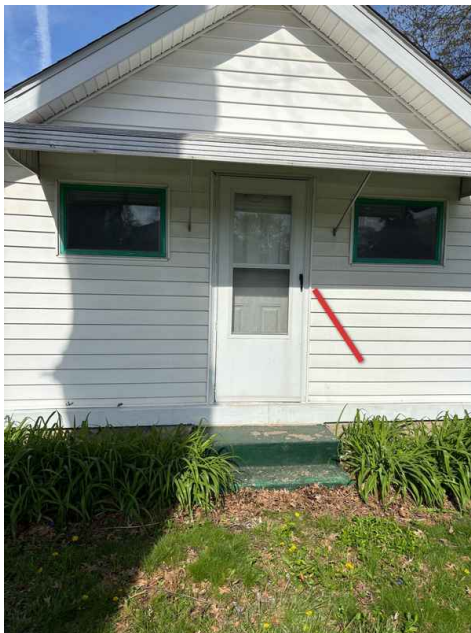
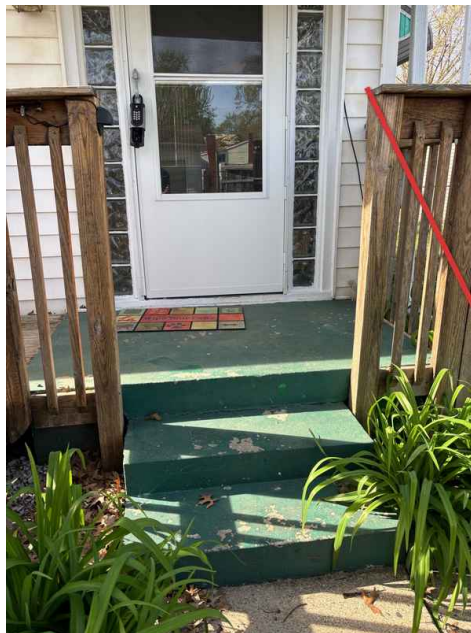
2.6.1 Decks, Balconies, Porches & Steps

STEPS MISSING HAND/GUARDRAIL

Exterior steps were missing Hand/Guardrail. Advise having installed to prevent safety hazard.

Contact a qualified professional.

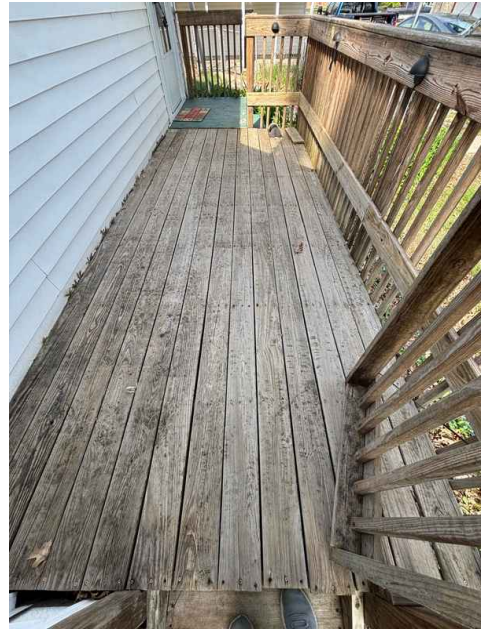
2.6.2 Decks, Balconies, Porches & Steps

DECK - WATER SEALANT REQUIRED

Deck is showing signs of weathering and/or water damage. Recommend water sealant/weatherproofing be applied. Some sanding or treatment of boards may be necessary.

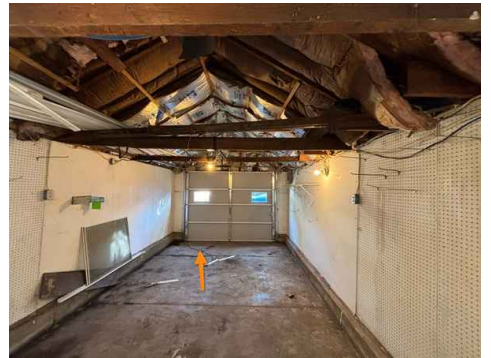
2.7.1 Garage

**GARAGE SLAB- CRACKS/MOVEMENT
MINOR**

Garage slab exhibited general cracks with some movement/settling. This is typically the result of poor soil preparation and/or excess moisture in the soil around the foundation. Recommend steps to ensure good drainage of surface water away from garage, such as adjusting grade and gutters with downspout extensions. Consult with concrete contractor for slab repair options.

Contact a qualified professional.

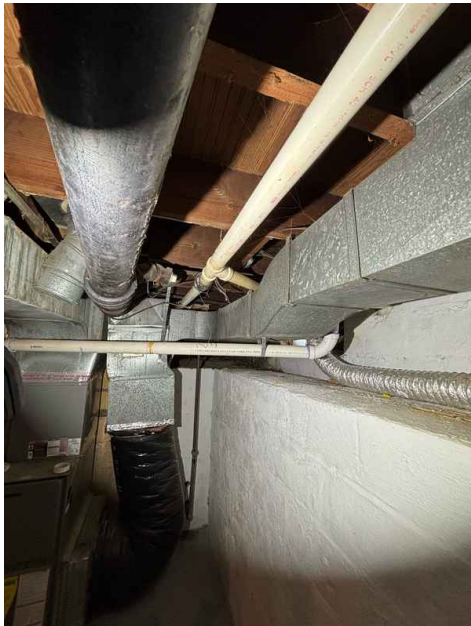
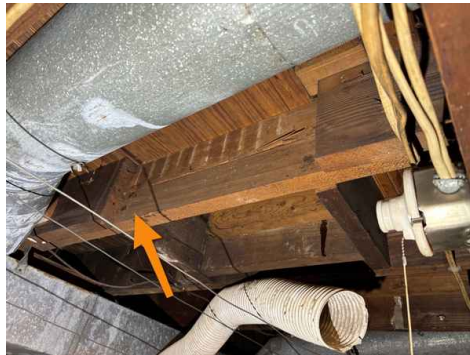
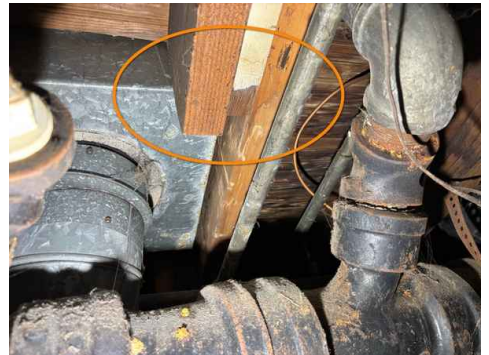
3.2.1 Floor Structure

FLOOR OPENING-INSUFFICIENT FRAMING

Opening in floor framing to allow for ductwork, plumbing, or stairwells was not framed using best standards. This has or may lead to deflection in floors. Have evaluated by a framing/general contractor and repairs/corrections made as needed.

Contact a qualified professional.

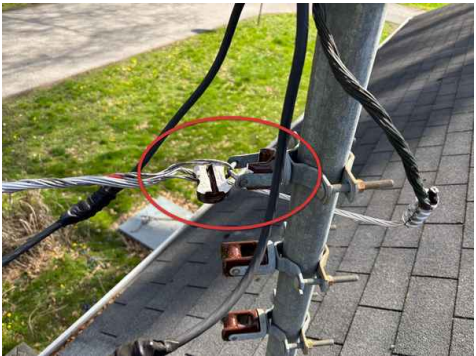
4.1.1 Service Entrance Conductors

SERVICE DROP ATTACHMENT DAMAGED

Overhead service cables attachment/anchor point to structure is damaged/loose. Advise contacting utility company or electrician to evaluate and repair.

Recommendation
Contact a qualified professional.

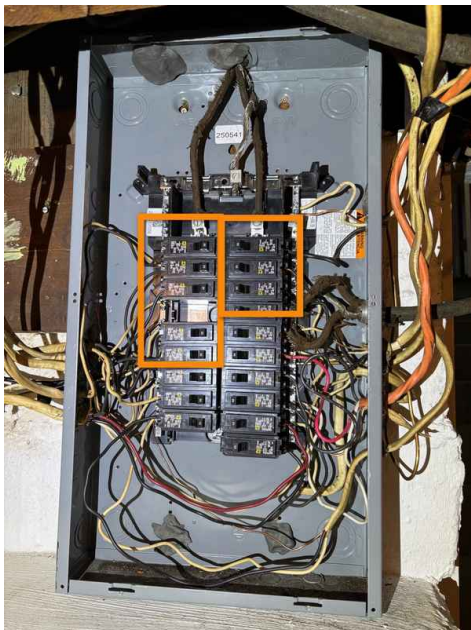
Basement

OVERSIZED BREAKER/UNDERSIZED BRANCH WIRING

Electrical breaker rating and branch circuit rating in main panel do not match. This may lead to overheating or stress of the branch circuit before breaker is safely activated. Advise evaluation by electrician and replacement with correctly rated components.

Contact a qualified professional.

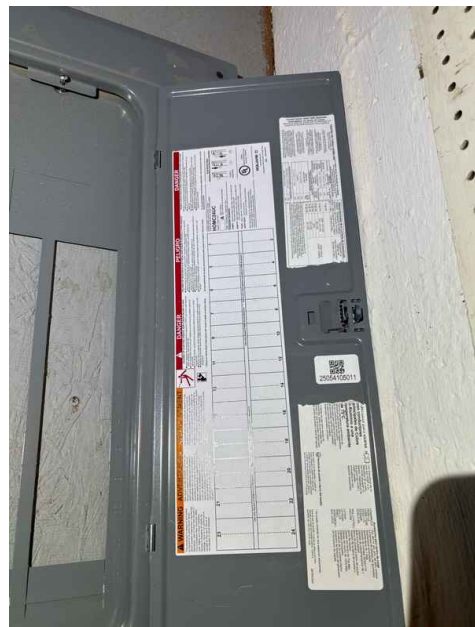
4.2.5 Service and Grounding Equipment, Main Overcurrent Device, Main and Distribution Panels

MISSING LABELS

One or more circuits in the electrical panel were missing labels. Recommend a qualified electrician test and properly label all switches.

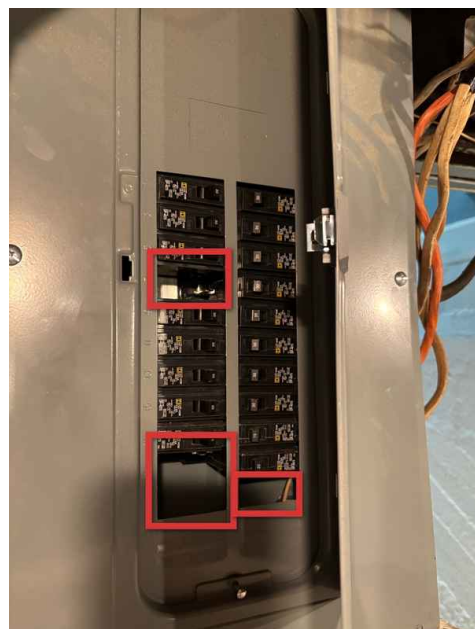
4.2.6 Service and Grounding Equipment, Main Overcurrent Device, Main and Distribution Panels

MISSING BLANK COVER

Open slots in distribution panels allow access to energized components. Recommend installing blank cover.

Contact a qualified professional.

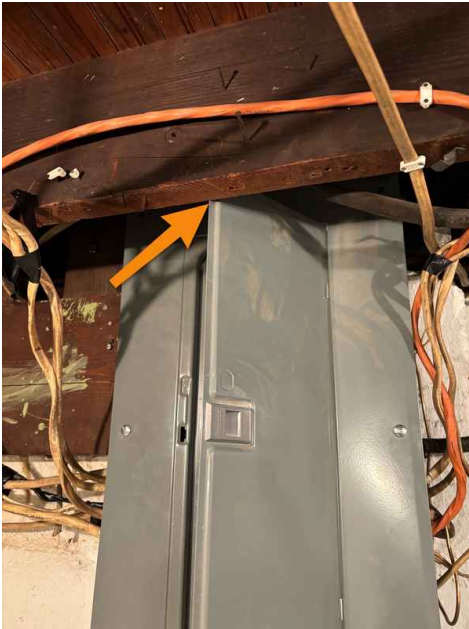
4.2.8 Service and Grounding Equipment, Main Overcurrent Device, Main and Distribution Panels

SERVICE DISCONNECT-MISSING

Contact a qualified professional.

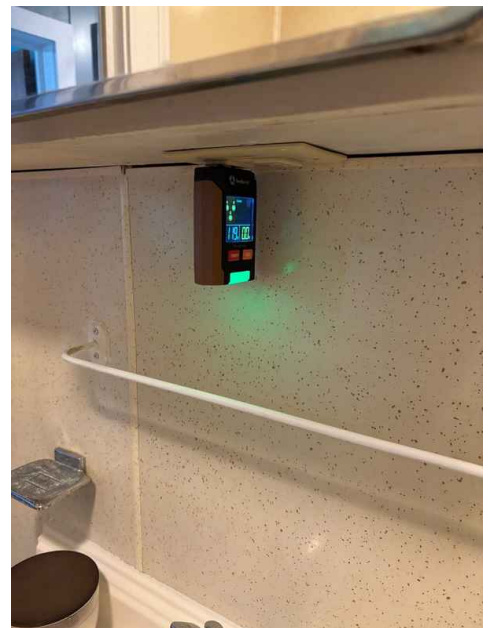
One or more GFCI outlets were not functioning properly when tested. Advise having replaced to maintain safety.

Contact a qualified electrical contractor.

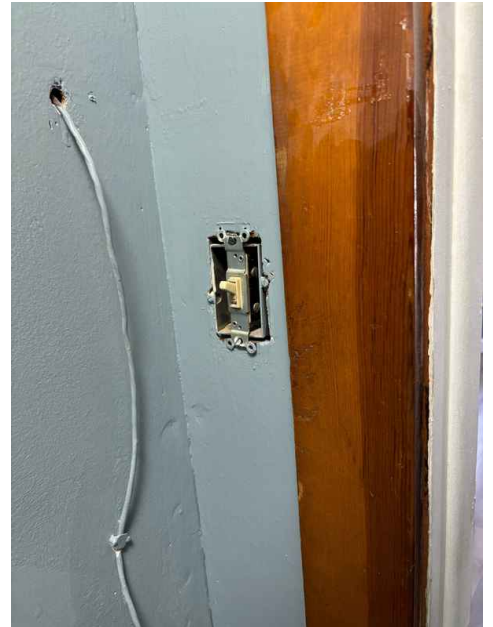
4.3.2 Branch Circuit Conductors and components.

COVER PLATES MISSING/DAMAGED

One or more receptacle covers were missing or damaged. Covers not only provide a finished look, but insulate occupants from energized components. Recommend installing or replacing receptacle covers as needed.

Contact a handyman or DIY project

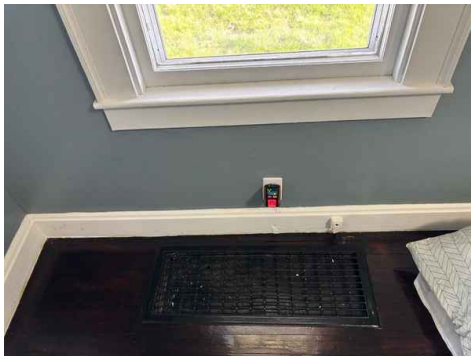
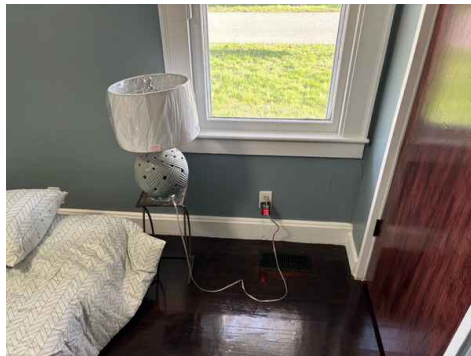
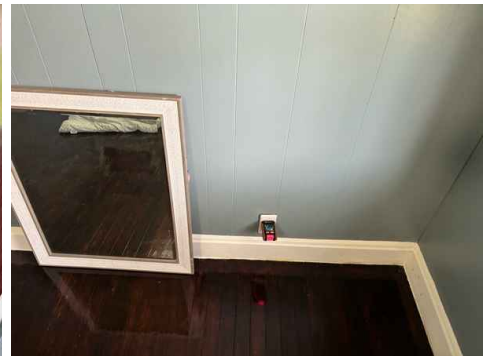
4.3.3 Branch Circuit Conductors and components.

RECEPTACLE(S)-REVERSE POLARITY

One or more receptacles showed reverse polarity when tested. This is caused by swapping the Hot and Neutral wires, causing the the wrong side of the circuit to be energized, increasing the potential of electrical shock. Swapped connections are typically found at the receptacle, although they can be located at other junctions or in the main panel. Advise having evaluated and corrected as needed.

Contact a qualified electrical contractor.

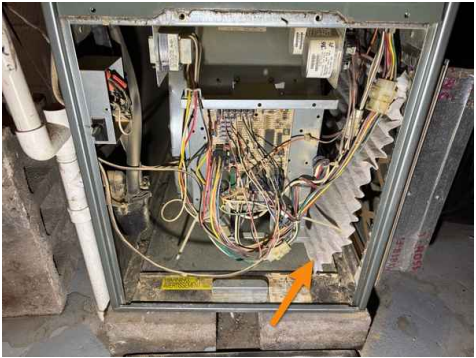
FILTER REQUIRES REPLACEMENT

The furnace filter appears to be beyond its expected lifespan. Recommend replacement.

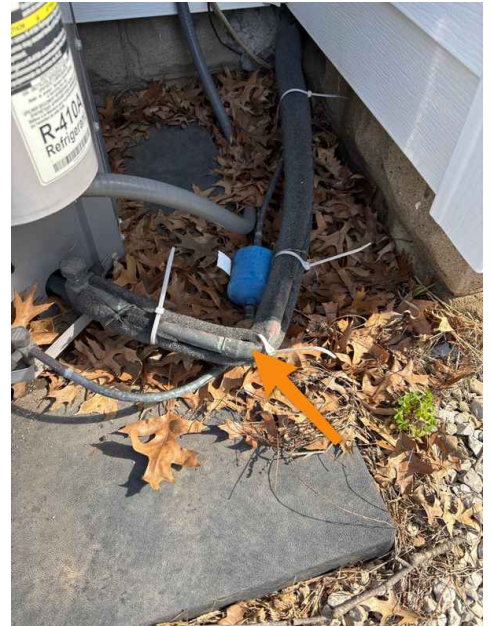
INSULATION MISSING OR DAMAGED

Missing or damaged insulation on refrigerant line can cause energy loss and condensation.

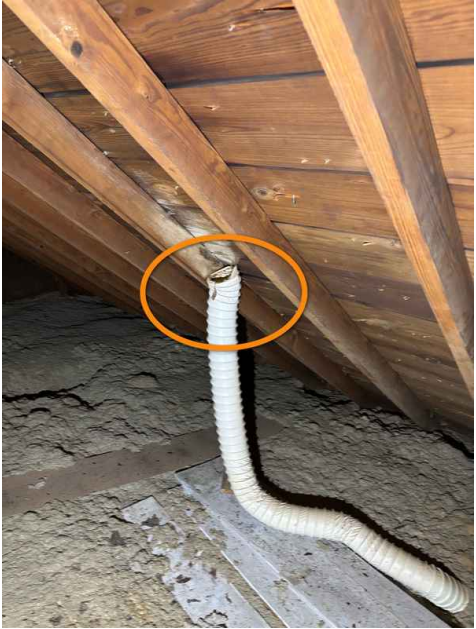
Bathroom Fan exhaust into the attic space increasing potential for moisture damage or mold growth. Recommend exhausting to the exterior of the home.

Recommendation
Contact a qualified professional.

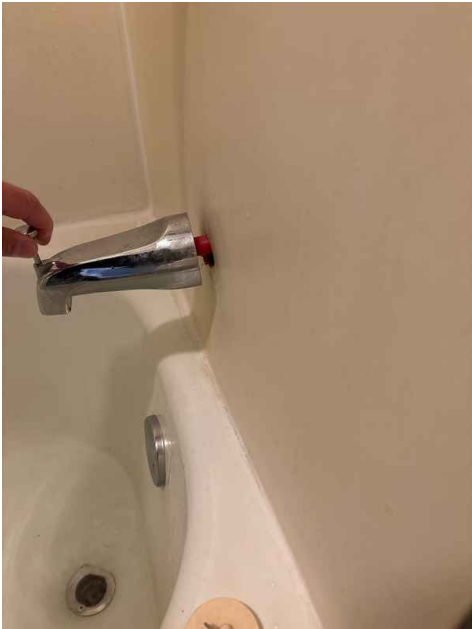
FAUCET/FIXTURE-LOOSE

Faucet/Fixture is not adequately secure, this increases the potential for leaks and damage. Have the appropriate hardware tightened or adjusted as needed.

Recommendation
Contact a qualified plumbing contractor.

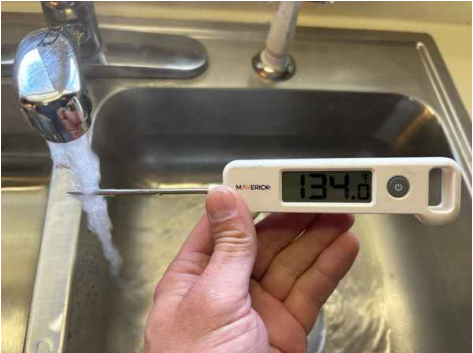
7.2.1 Water Heater

Hot water temperature higher than recommended 120°. Advise adjusting water heater thermostat to a safe level to prevent scolding hazards.

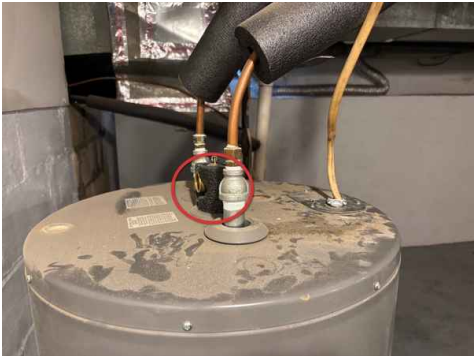
7.2.2 Water Heater

TPR VALVE EXTENSION INADEQUATE

Water heater TPR valve extension should reach to within 6 inches of floor to direct excessive heat and pressure away from potential occupants. Have repaired.

Contact a qualified plumbing contractor.

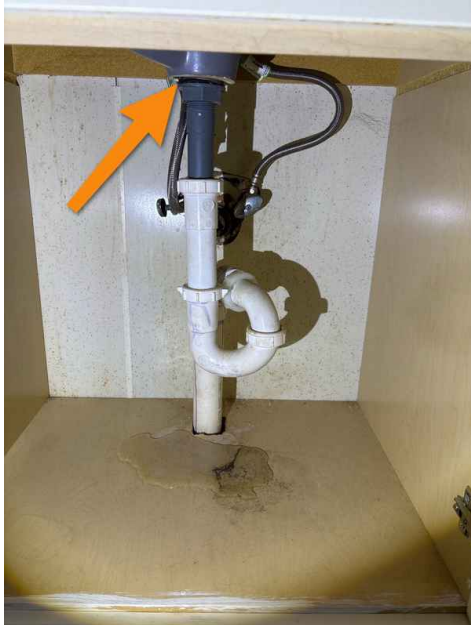
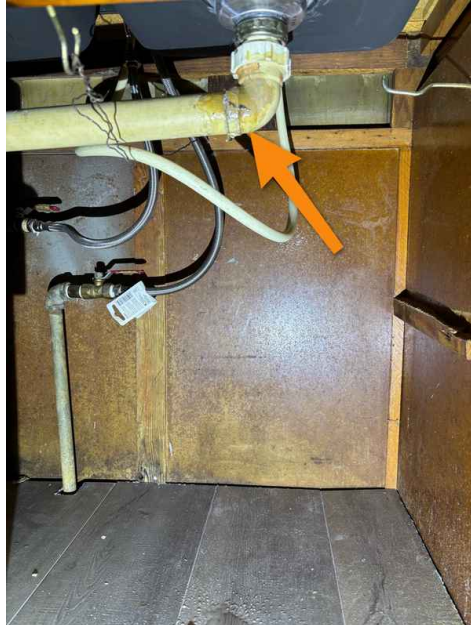
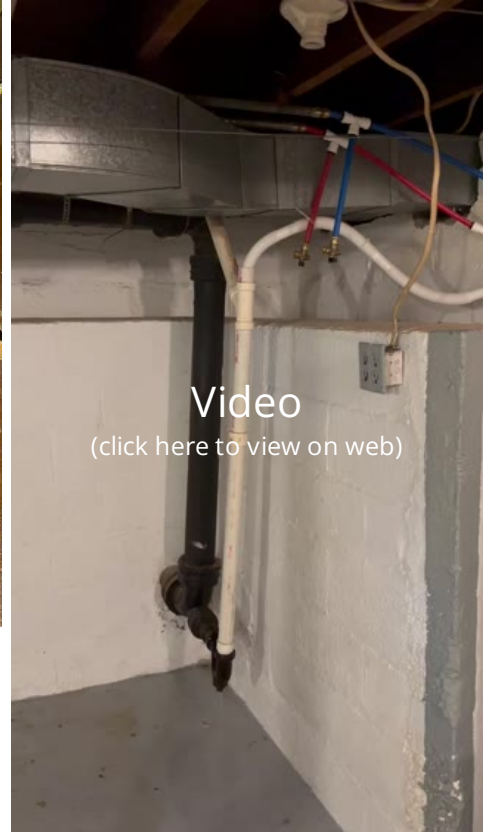
7.3.1 Drain, Waste, & Vent Systems

LEAKS OBSERVED

Leaks were observed in the plumbing drain/waste system. Advise further evaluation and repair as needed.

Contact a qualified plumbing contractor.

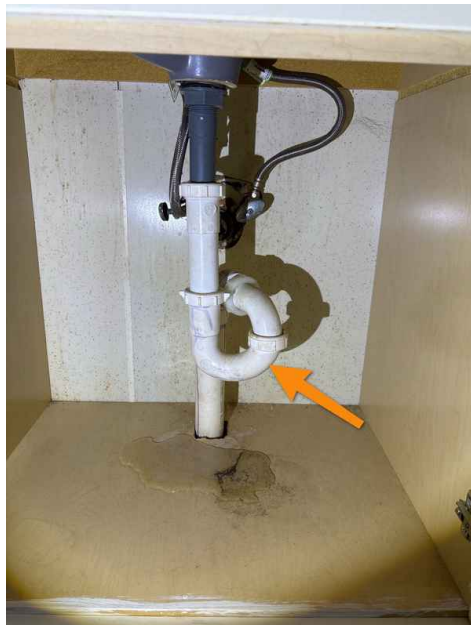
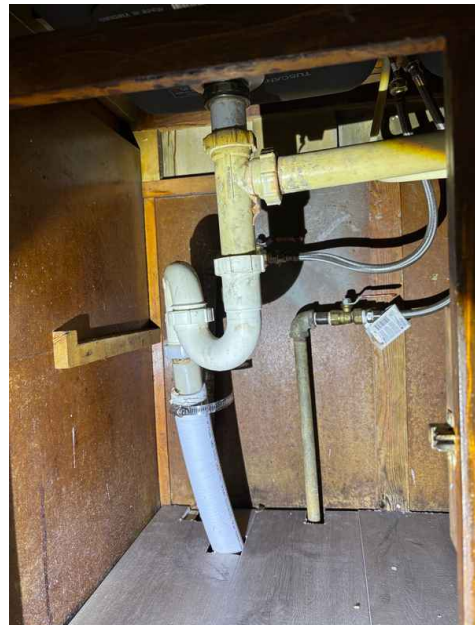
7.3.2 Drain, Waste, & Vent Systems

S-TRAPS PRESENT

Sink drains installed as S trap. This can cause siphoning of trapped water allowing sewage gases to enter home. Recommend installing P-trap where feasible.

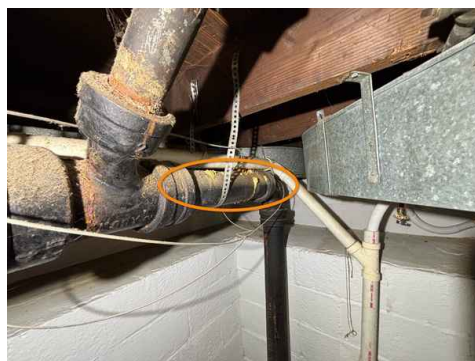
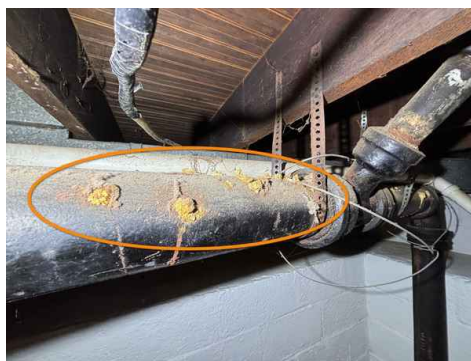
Older Cast iron and galvanized plumbing tends to corrode and rust from the inside out, creating pinhole leaks eventually leading to larger leaks. Monitor these older materials for signs of corrosion and replace sections as needed.

Contact a qualified professional.

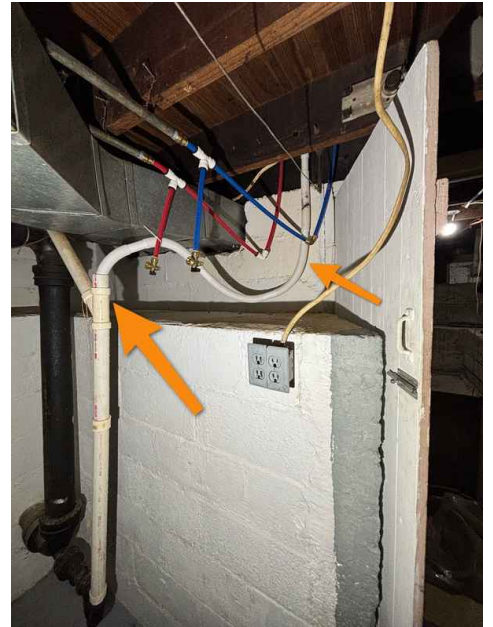
7.3.5 Drain, Waste, & Vent Systems

POOR INSTALLATION PRACTICES

Drain lines were not installed using best practices. This may increase potential for needed maintenance or repairs overtime. Recommend having evaluated by plumbing contractor and repairs or corrections made as needed.

Contact a qualified professional.

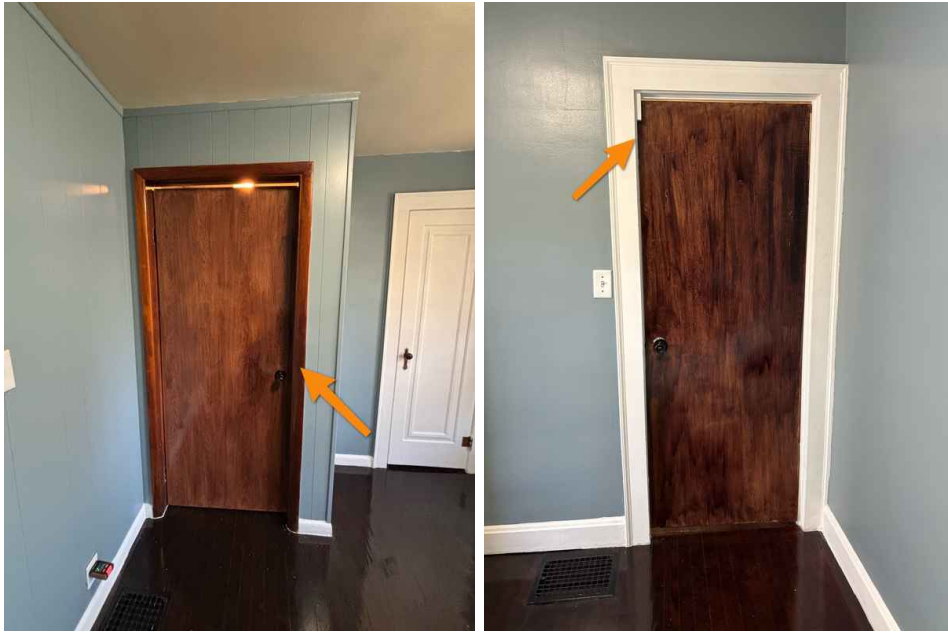
One or more doors/frames in the home were misaligned, causing interference or preventing latch. This is typically caused by minor settling, especially in older homes, but may also be poor installation. Have doors and frames evaluated and corrected by carpenter at owners discretion.

Contact a qualified professional.

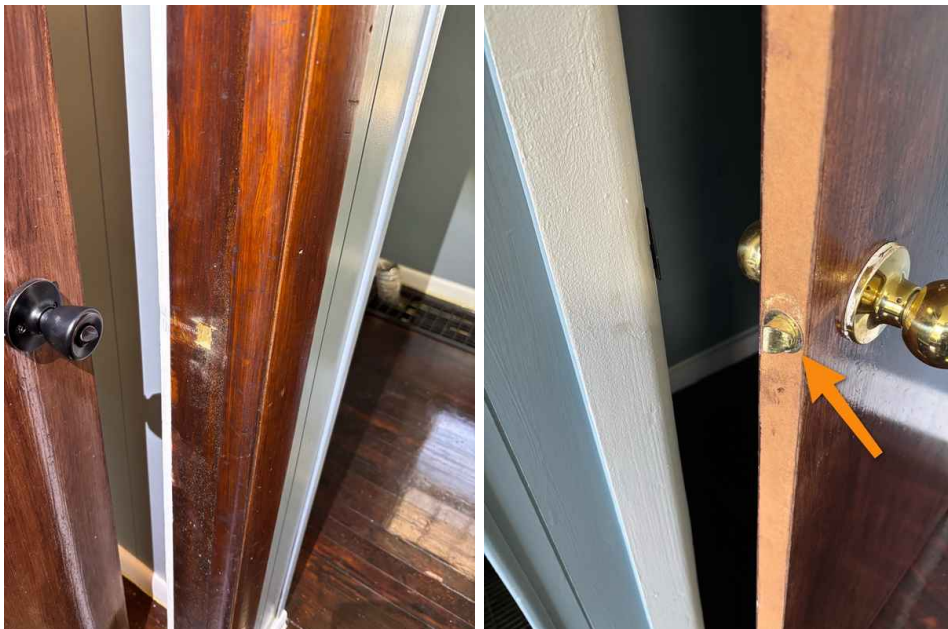
8.4.2 Doors

HARDWARE-LOOSE/MISSING

Hardware for one or more doors was missing or poorly installed. This may or may not affect overall function of door. Hardware should be repaired/replaced as needed at owners discretion.

Missing strike plate

Latch is backwards

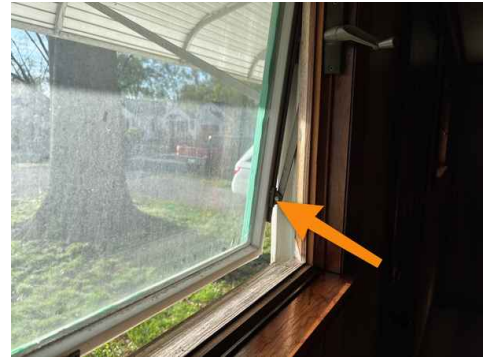
MISSING/DAMAGED HARDWARE

One or more windows were missing Hardware. Have installed to improve function and security.

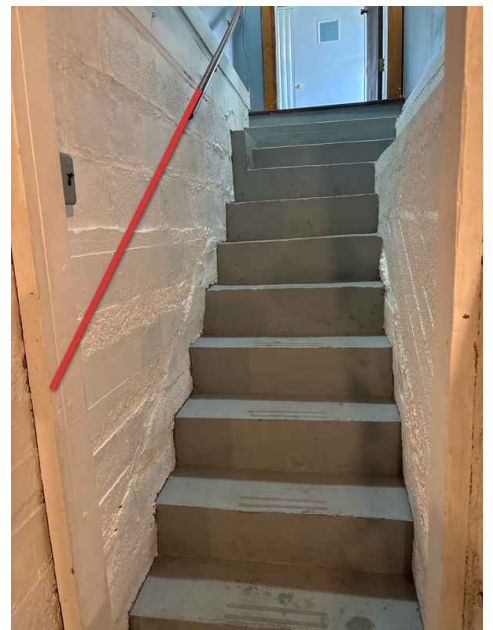
8.8.1 Steps, Stairways & Railings

MISSING HANDRAIL/GUARDRAIL

Staircase was missing handrail/guardrail in one or more sections. This is a safety hazard. Recommend a qualified handyman install a hand/guardrail.
