# FIRE SAFETY ASSESSMENT

**By eGrowth Training and Consultancy Services**

| <b>PREPARED FOR:</b> | <b><u>M/s. Uniproducts India limited</u></b><br><i>Jarthal Village Road, 84 KM Stone, Delhi Jaipur Highway Village Sangwari, Distt. Rewari - 123401 (Haryana) India</i> |
| <b>DATE:</b> | 03 <sup>rd</sup> May 2025 |

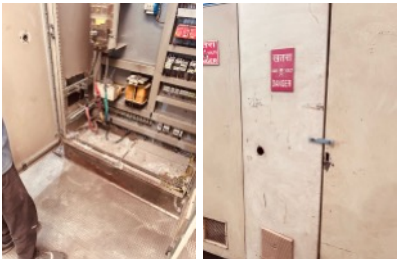
| <b>Pic 13:</b> | Electrical panels found with open doors, damaged door knobs, allowing wool fibres to enter inside. | <b>Pic 14:</b> | Electricians working without proper PPE, specifically missing safety shoes. |

| <b>Proposed Action</b> | Repair/replace damaged panel doors immediately. | <b>Proposed Action</b> | Provide appropriate PPE for electricians including safety shoes, insulated gloves, and arc flash protection where required. |

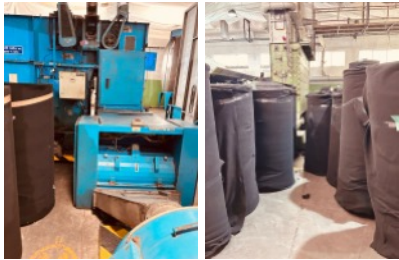
| <b>Pic 17:</b> | Emergency stop button found blocked with material. | <b>Pic 18:</b> | Cabin floor mat rolls kept alongside pathways in improper array/stacking, creating potential emergency evacuation obstruction. |

| <b>Proposed Action</b> | Maintain clear access to all emergency stops. | <b>Proposed Action</b> | Implement proper storage practices. Keep all evacuation routes clear at all times. |

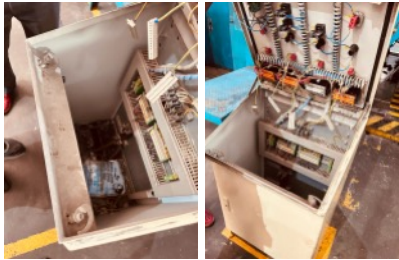
| <b>Pic 25:</b> | PPE (face mask packets) stored inside electrical panel. | <b>Pic 26:</b> | Emergency button not demarcated. Also missing buttons. |

| <b>Proposed Action</b> | Remove all non-electrical items from panels immediately. | <b>Proposed Action</b> | Install proper emergency buttons and clearly mark all controls. |

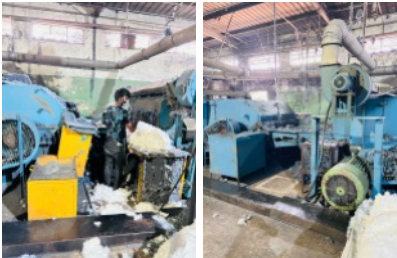
| <b>Pic 39:</b> | Machine operators working between two machines. | <b>Pic 40:</b> | Emergency button and other buttons not demarcated. Also missing buttons. |

| <b>Proposed Action</b> | Improve workstation layout to provide clear access/exit paths. | <b>Proposed Action</b> | Replace missing buttons and label all controls clearly. |
