Review

Residual stress influences on structural reliability

M.N. James^{*}

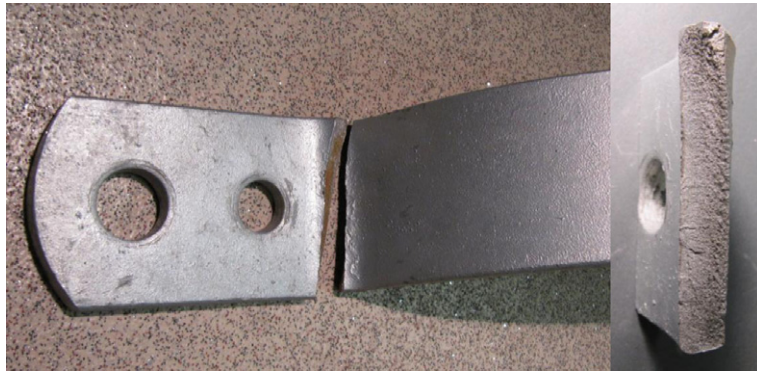
Fig. 2a. Cold formed and galvanised strap that has fractured via strain age embrittlement during assembly by bolting.

Fig. 2a shows one of a pair of cold formed straps which are bolted together around a vertical column. The strap is manufactured from S275 structural steel to BS EN 10025 and is one of a number of examples that fractured either during bolting together of a pair of straps or when the service load was applied to the straps. The parent plate has an average Vickers hardness measured under a 500 gf load of around 172 H_V equivalent to a tensile strength of 550 MPa, which is inside the specification for S275 steel of 430–580 MPa. The cold formed bends have hardness values in the range 248–287 H_V giving local tensile strengths in this critical region of around 783–905 MPa. The mechanism of fracture was brittle cleavage in all cases and the cause of the fracture was strain age embrittlement. The nitrogen content in these straps was low (<20 ppm) and the embrittlement was therefore driven carbon content and by any hydrogen exposure during pickling or galvanising. Interest-

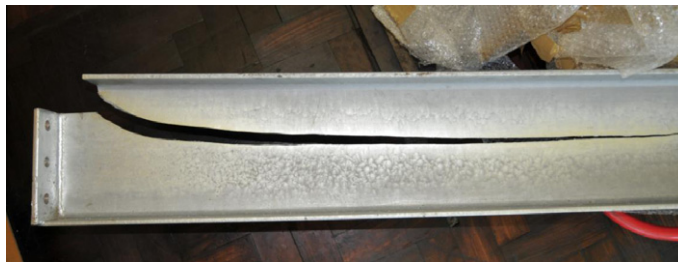
Fig. 5. LMAC crack some 1.1 m long in a hot rolled and galvanised low carbon steel I-beam.

practice, e.g. [14–16]. The type of problem observed in galvanising of steel fabrications and rolled sections is shown in Fig. 5 which illustrates a severe LMAC crack some 1.1 m long in a hot rolled I-beam with a depth of 208 mm.

The crack has initiated at a sharp rectangular cut-out approximately 65 mm long and 25 mm deep, near the end of the beam. Such a rectangular cut-out in the beam would have significant local plastic deformation and a high local stress concentration at the corner. The crack has started growing at perhaps 30° to the longitudinal axis of the beam. As it grew towards the centre-line of the beam it has progressively turned, eventually growing parallel to the longitudinal axis and finally arresting at a length of some 1100 mm. Published work has demonstrated that in a rolled I-beam the longitudinal residual stress demonstrates an “end effect” leading to the existence of a “tension bow” towards the end of the beam [17,14]. If a crack initiates from the corner of the cut-out this stress field can drive further crack growth. A finite element stress analysis by Feldmann [17] of the residual fabrication stresses in a rolled steel ‘I’ beam demonstrates that although the longitudinal stresses in the web are compressive, symmetry in the beam implies that they must form a “tension bow” along the centre-line near the free end (Fig. 6). Overlaying the shape of this tension bow onto the crack initiated at the cut-out corner in the cracked I-beam clearly shows how the residual stresses could drive growth. Crack growth would cause the tension bow to move along the beam, keeping pace with the crack extension, but with a steady decay in magnitude. This allows the crack to reach a significant length during galvanising before arresting.

- Joining of dissimilar thickness sections, e.g. thick connecting or reinforcing plates welded to the web or flange of I-beam, channel and other sections. This leads to high local strain concentration coupled with high local hardness differences and with weld defects (Fig. 8).
- Plate terminations coincident with regions of high fabrication stress in rolled or fabricated steel sections. This ensures an optimum combination, in terms of assisting crack initiation under either static or dynamic loading, of high local strain and stress concentration, weld defects and high tensile residual stresses, as evidenced in Figs. 5 and 6.

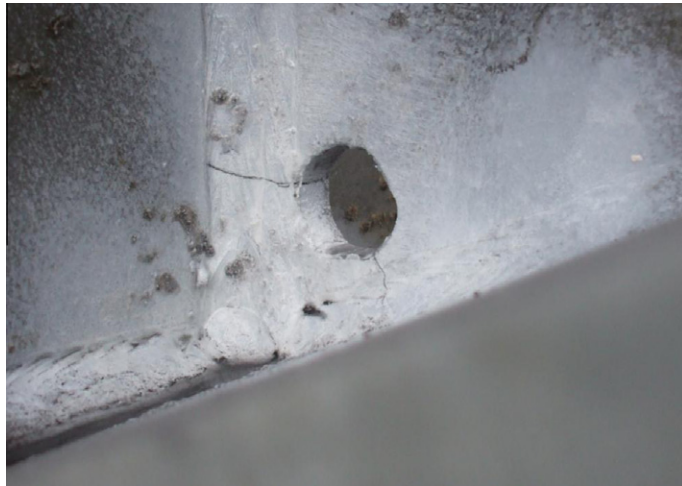
Fig. 7. Cracking from a drain hole that was situated too close to a weld junction in a fabricated steel beam. Drain holes are added to allow molten zinc to drain off the galvanised item when it is removed from the bath, but they may be unnecessary and advice should be sought from galvanisers.

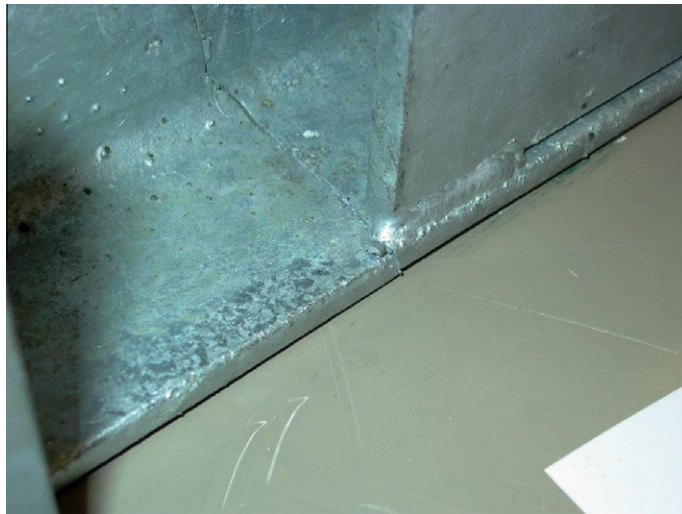
Fig. 8. LMAC that has occurred from the end of the intermittent weld joining a stiffener plate to a channel section 250 mm deep.

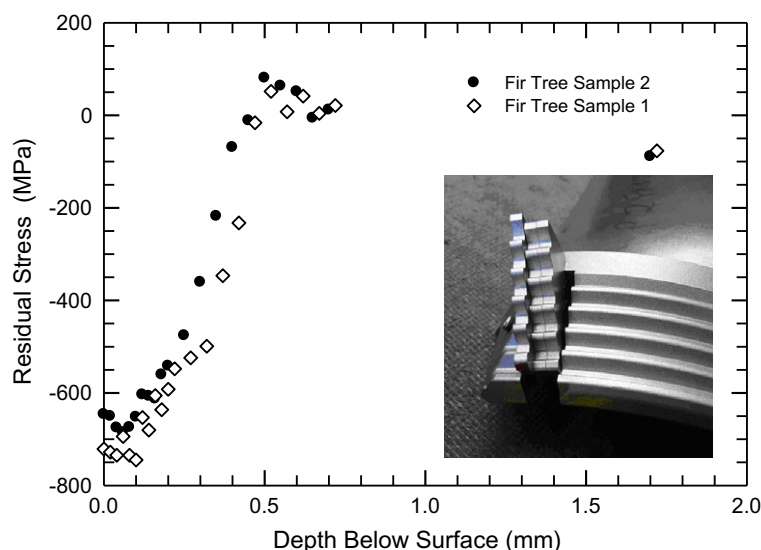
Fig. 13. Stresses measured over a distance of 2 mm below the first notch root in two adjacent LP steam turbine blade fir tree samples (shown in the inset). Stress values are consistent and have high magnitudes.

An example of the quality of data that can be obtained from synchrotron diffraction radiation experiments is shown in Fig. 13. The diagram shows the stresses measured below the root of the first notch in the fir tree attachment for two adjacent slices cut from a low pressure (LP) steam turbine blade similar to that shown in Fig. 1a. This work was part of a large programme of research aimed at exploring uniformity of coverage around the fir tree root and assessing the influence of shot peening coverage on fatigue performance of these blades [4]. Stresses have been estimated via a biaxial isotropic stress approximation and were measured using synchrotron diffraction on the very high energy beam line ID31 at the European Synchrotron Radiation Facility in Grenoble. In addition to this, measurements were made on beamline ID15B in similar positions on three complete blades, comprising one unused peened blade and two ex-service blades, one of which that had originally been peened whilst the other was unpeened. On this very high energy beam line it was possible to measure strains right across the 35 mm thick root section using synchrotron diffraction. Surface stress measured in the blades had maximum values between -300 MPa and about -500 MPa. These values can be compared with the peak surface values in Fig. 13 obtained under controlled and optimised shot peening conditions of between -625 MPa and -660 MPa.
