The Tacoma Narrows Bridge Project

“From Triumph to Tragedy : The
Fall of Galloping Gertie”

The Fall of “Galloping Gertie”

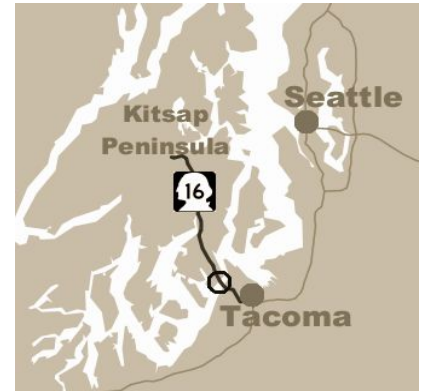
The third-longest suspension bridge of its era, the Tacoma Narrows Bridge was built as a showcase of contemporary engineering and opened for traffic on July 1, 1940. Leon Moisseiff created this amazing creation, which took 19 months to finish and cost \$6.4 million. Nevertheless, in favor of a streamlined profile, the bridge's inventive design disregarded conventional trusses, rendering it incapable of withstanding aerodynamic pressures. Due to aeroelastic flutter, it collapsed abruptly during a windstorm on November 7, 1940, just four months after it was opened. This accident demonstrated how important it is for engineering designs to take into account natural forces, which had a profound impact on bridge building habits all over the world.

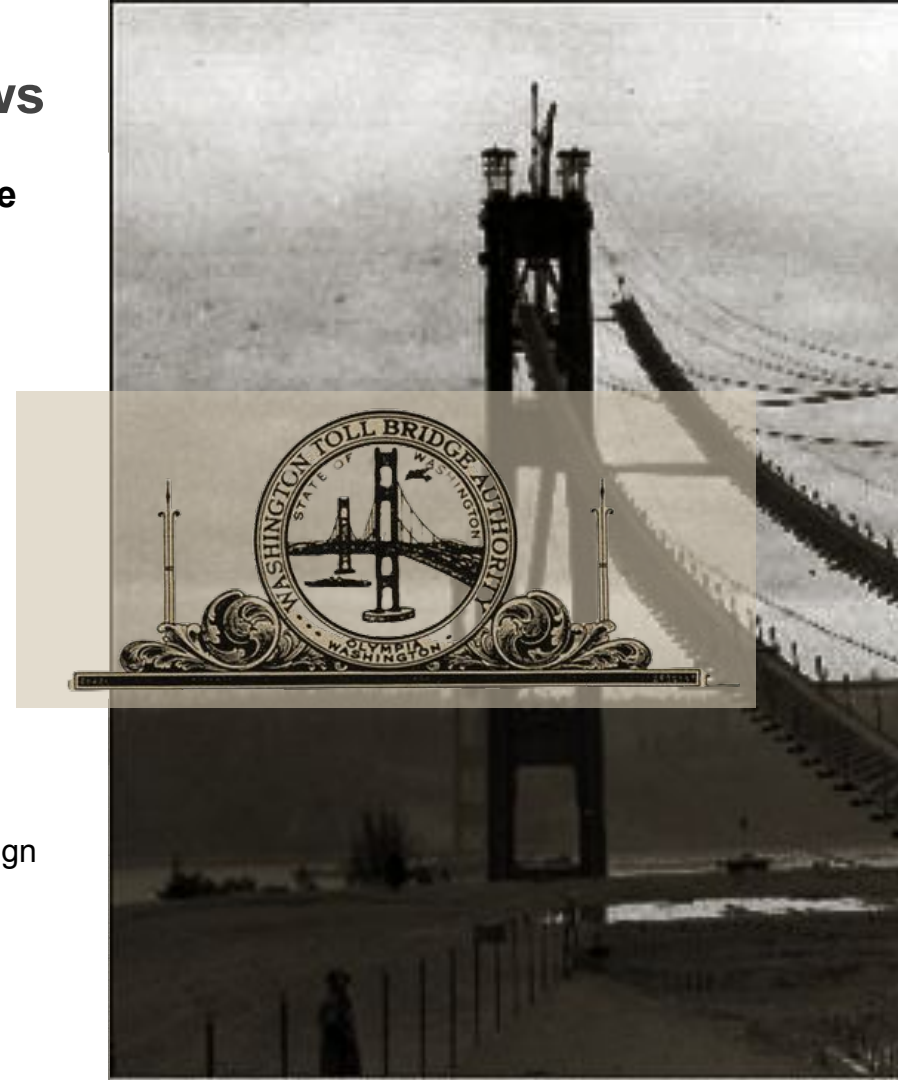
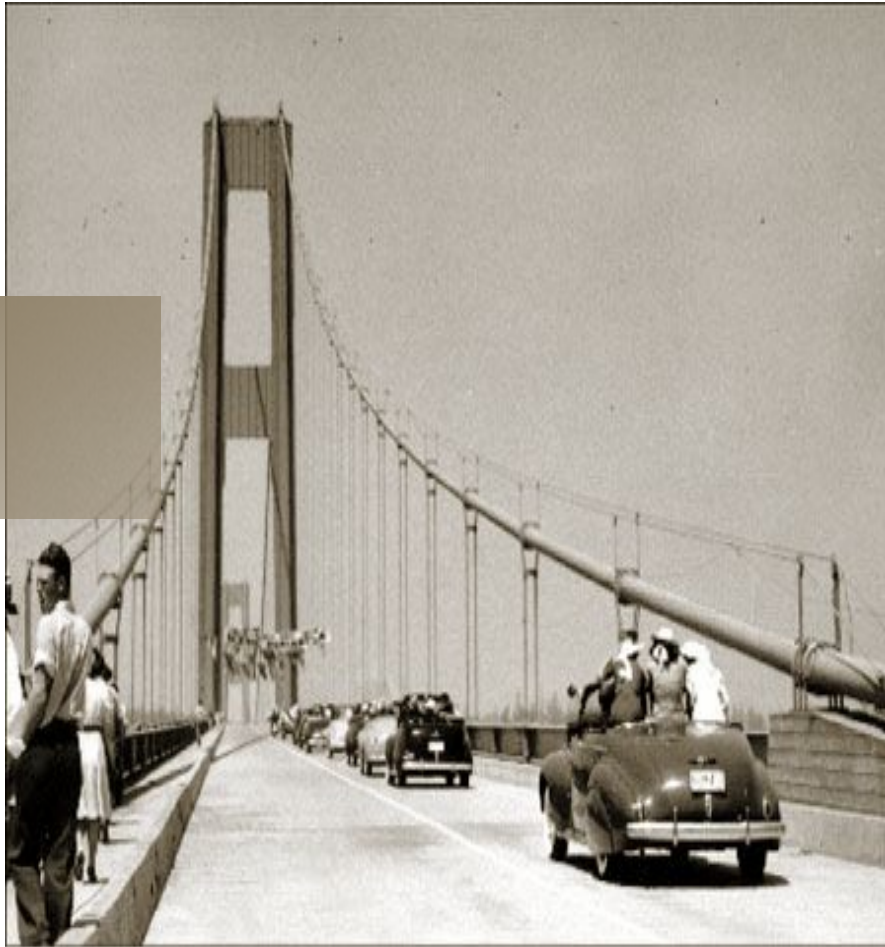
- **Innovative Yet Flawed Design**
 - Eliminated traditional trusses for aesthetic appeal
- **Aerodynamic Stability Oversight**
 - Neglected crucial wind-resisting features
 - Featured shallow and narrow stiffening elements
- **Cost-Saving Over Structural Integrity**
 - Prioritized budget constraints
 - Chose a cheaper, less stable design
- **Susceptibility to Wind-Induced Vibrations**
 - Vulnerable to aeroelastic flutter
 - Common windy conditions in Tacoma Narrows
- **Dramatic Oscillations**
- **Adequate Funding and Resource Allocation**
 - Original design was rejected due to cost; a cheaper design compromised integrity (PLS, n.d.).
- ❑ **Stakeholder Management and Communication**
 - Conflicts between engineers and financiers.
