Revetment repair with Elastocoast® in Holland-on-Sea (Great Britain)

Case Study

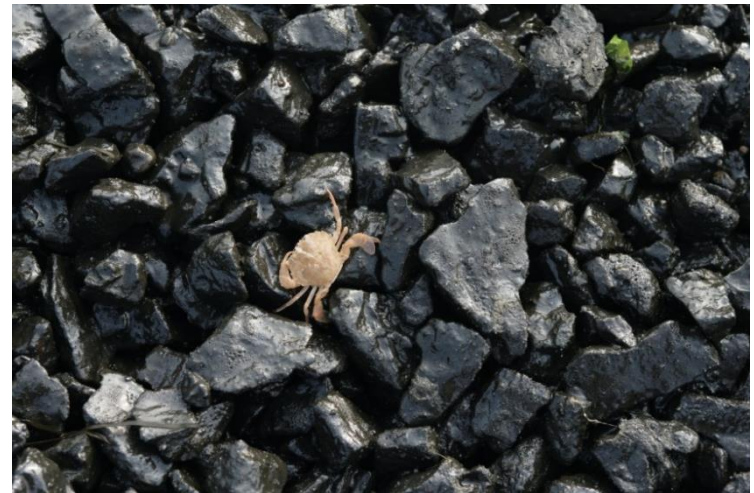
The revetment in Holland-on-Sea has been steadily eroded by violent wave impacts. For the repair Elastocoast® was used and applied in a 20 cm thick layer. Even on a slope of 1:3, the work was completed within two days.

Construction: Flint stones with Elastocoast®
