# Black Spots Studies On National Highway 209 Kanakpura Road Bangalore For A Stretch Of 15km.

Shaik Salauddin.\* , Reshma. E. K +

\*P.G. Scholar, Highway Technology, DSCE, Bangalore

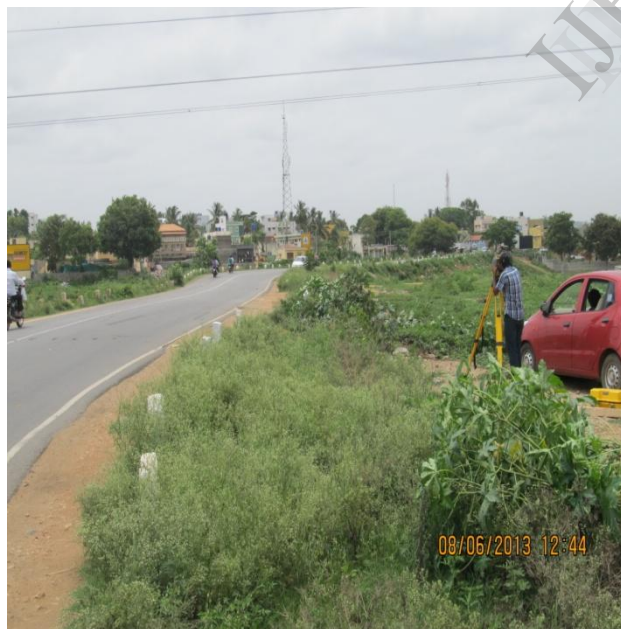
- Two of the eight black spots are located on tank bunds with narrow shoulder width. Strong barricades have not been erected to protect the vehicles accidentally falling into lakes. As an eco-friendly measure trees can be raised on tank bunds as an alternative to expensive barricades and embankments.

**Plate 1 Absence of barricades along Nelguri kere, Kanakpura Road Stretch Bangalore.**

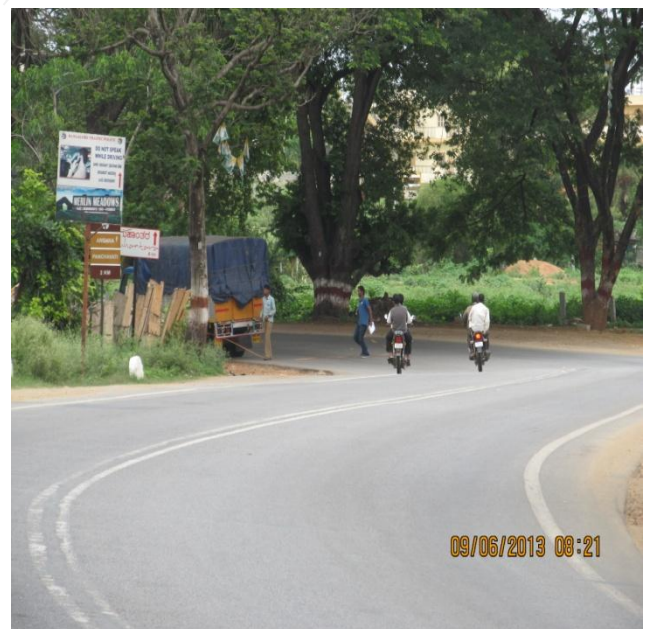
- Although, the geometric design for Kanakpura road stretch provides for restricted sight distances different categories of vehicles move in the speed range of 60 to 80 kmph. The inadequate sight distances contribute for traffic accidents. Hence, at few locations realignment of the highway is recommended to improve sight distances..

**Plate 3 Blocking the view for driver negotiating s- curve due to Presence of huge trees along Kanakpura Road Stretch Bangalore.**
