A FORMATTIVE ASSESSMENT 1 REPORT ON THE CONCEPTS OF

SAFETY, HEALTH AND ENVIRONMENT

A SAFETY AUDIT AND INSPECTION OF THE

PCCOE WORKSHOP, ARCHITECTURE BUILDING

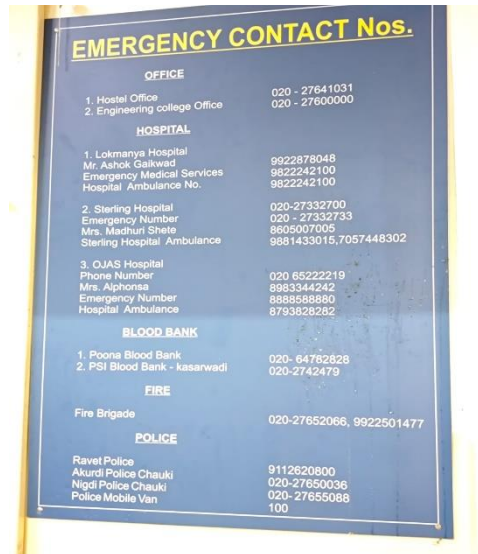
Availability of Emergency Contacts Signboard

STATUS: **POSITIVE**

IT OBEYS

Section 38 of the Factories Act, 1948 – Fire Safety and Emergency Preparedness

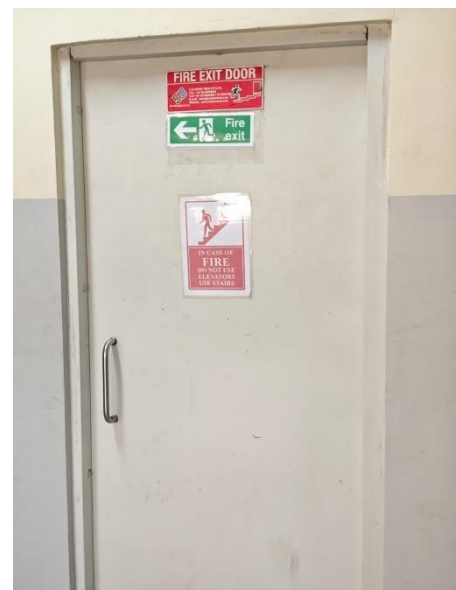
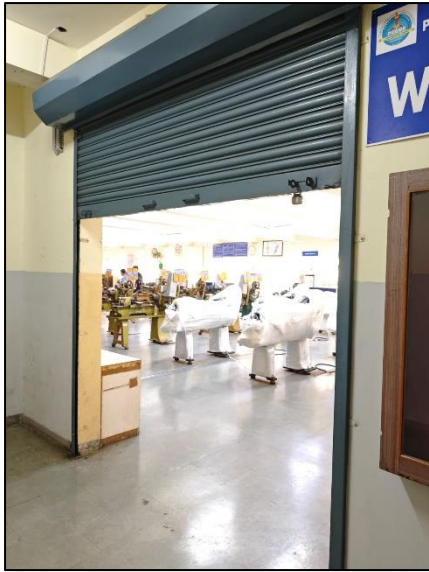
Availability of Fire Exit

STATUS: **POSITIVE**

Availability of Wide Entrances to Workshop

STATUS: POSITIVE

Availability of Drinking Water close to Workshop

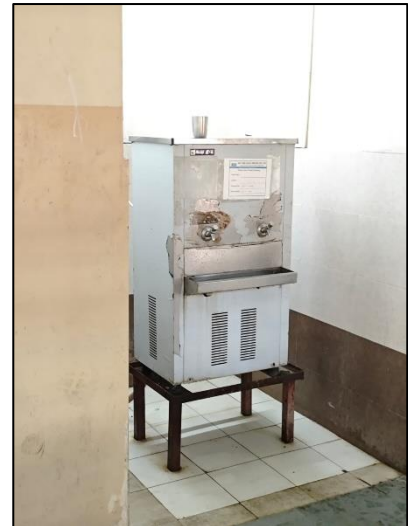
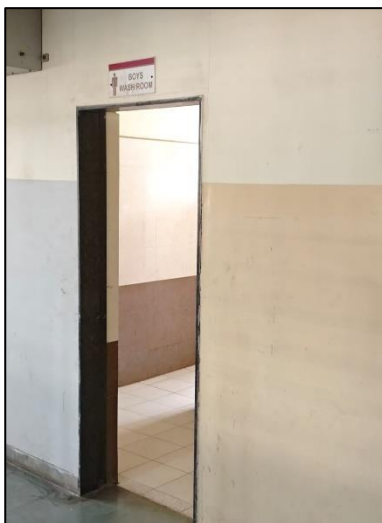
Availability of Washrooms close to Drinking Water Source

STATUS: POSITIVE

IT OBEYS

Section 19 of the Factories Act, 1948 –

Latrines and Urinals

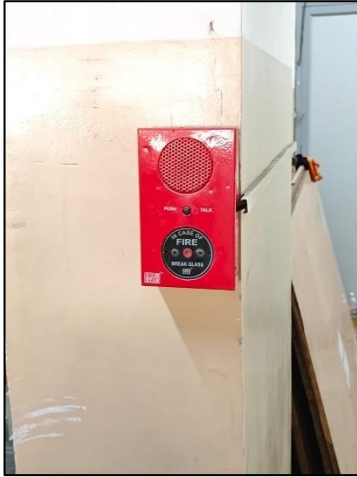
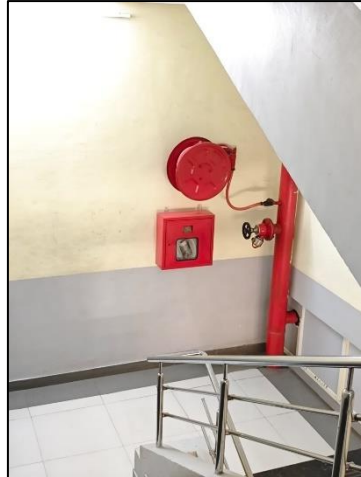
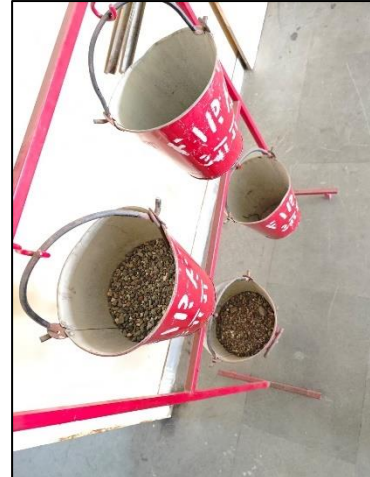
Availability of Working Fire Safety Measures

STATUS: POSITIVE

IT OBEYS

**Section 38 of the Factories Act, 1948 –
Fire Safety and Emergency Preparedness**

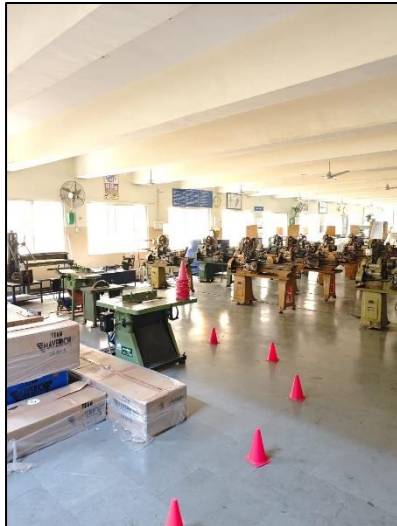
Proper Use of Safety Cones to Mark Boundaries

STATUS: **POSITIVE**

IT OBEYS

Section 7A of the Factories Act, 1948
General duties of the occupier

Section 21 of the Factories Act, 1948
Fencing of Machinery

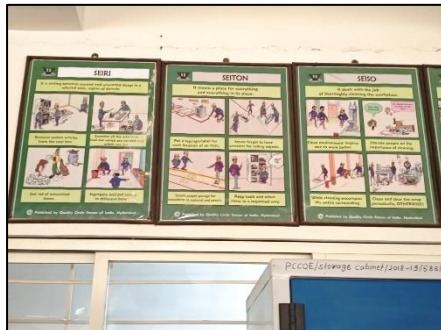
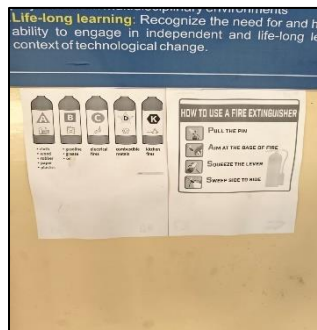
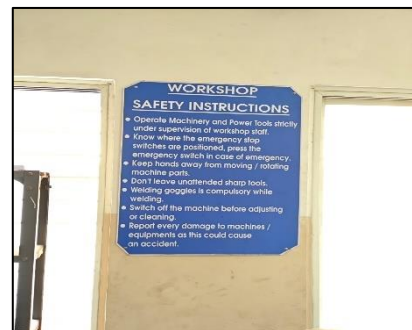
Availability of Safety and Awareness Sign Boards

STATUS: **POSITIVE**

IT OBEYS

Section 7A of the Factories Act, 1948
General duties of the occupier

Section 111A of the Factories Act, 1948
Rights of Workers, etc.

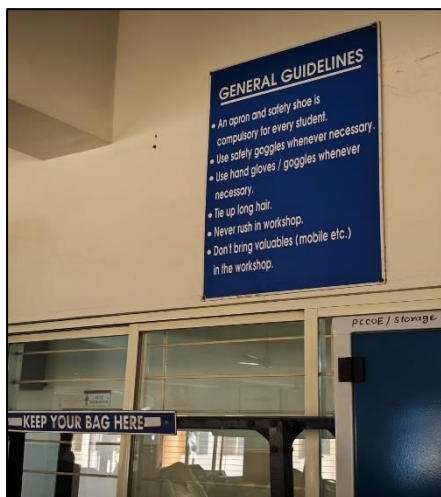
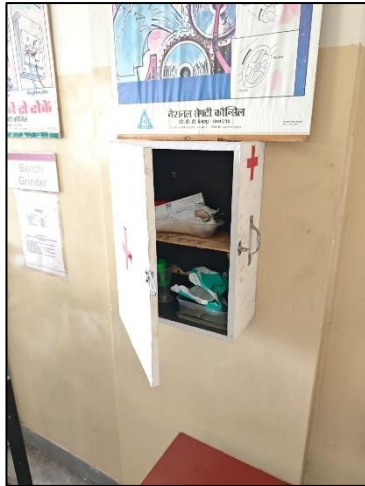
Availability of Functional First Aid Kits

STATUS: **POSITIVE**

Availability of Adequate Ventilation in Workshop

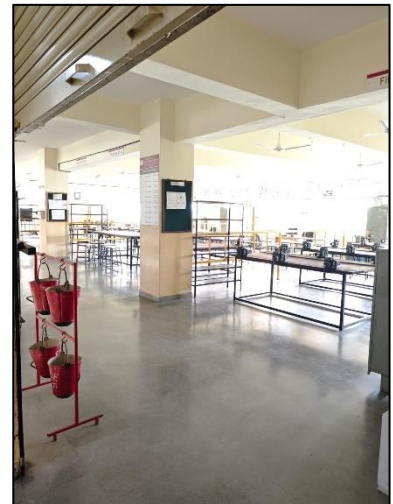
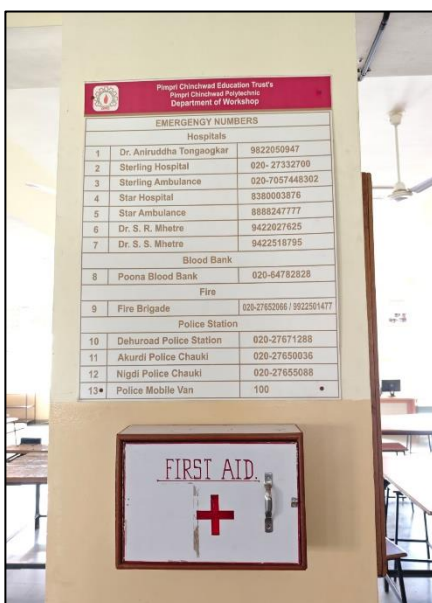
Availability of Emergency Contacts inside Workshop

STATUS: **POSITIVE**

IT OBEYS

Section 38 of the Factories Act, 1948
Fire Safety and Emergency Preparedness

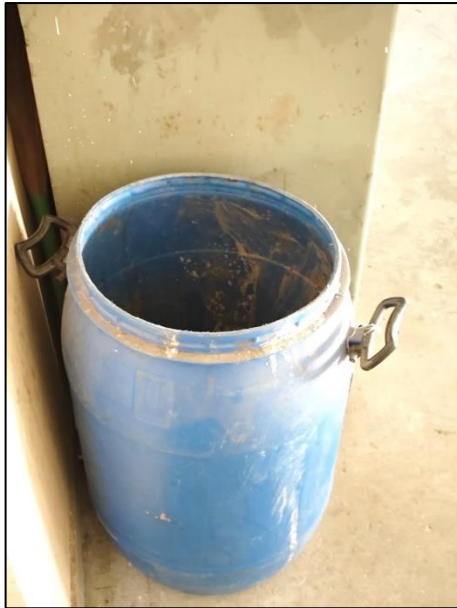
Lack of proper waste bins with covers

STATUS: NEGATIVE

IT DOES NOT OBEY

Section 11 of the Factories Act, 1948
Cleanliness

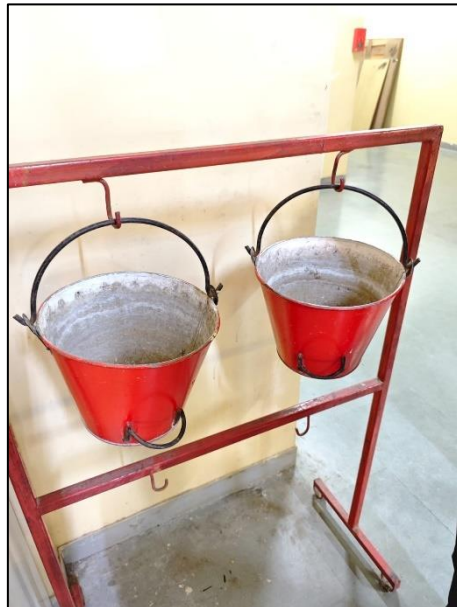
Lack of some Functional Sand Buckets

STATUS: NEGATIVE

IT DOES NOT OBEY

Section 38 of the Factories Act, 1948
Fire Safety and Emergency Preparedness

IS 1646: Code of Practice for Fire Safety of Buildings (General)

- ❖ **Provide proper Hearing Protection to students and workers**
- ❖ **Soundproofing Measures to keep noise in check**
- ❖ **Equipment Maintenance to ensure safety**
- ❖ **Electrical Safety as loose connections were spotted**
- ❖ **Unobstructed Fire Safety Equipment**
- ❖ **Increase Sand Bucket Availability**
- ❖ **Regular Safety Drills to create awareness**
- ❖ **Proper Scrap Storage Area**
- ❖ **First Aid Kits that are filled and well maintained should be available**
- ❖ **Stable Workbenches for students and workers to work on**

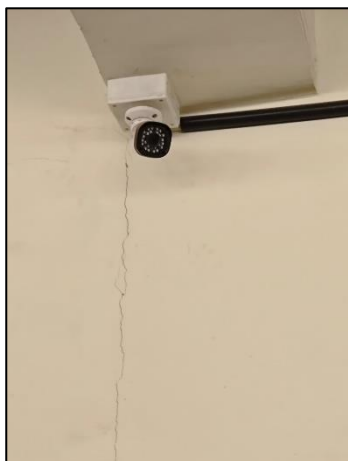
Availability of CCTV cameras

STATUS: POSITIVE

IT OBEYS

Section 7A of the Factories Act, 1948
General duties of the occupier

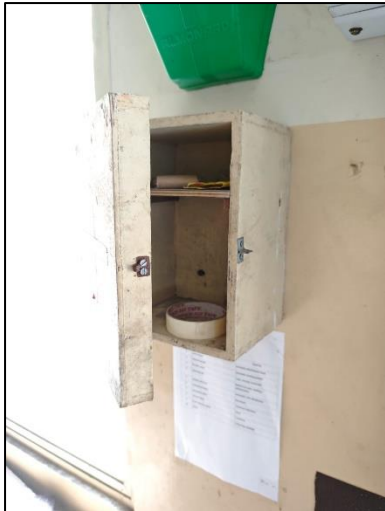
Lack of some First Aid Kits

STATUS: NEGATIVE

IT DOES NOT OBEY

Section 45 of the Factories Act, 1948

First-aid appliances

Improper Storage of Scrap near Machinery

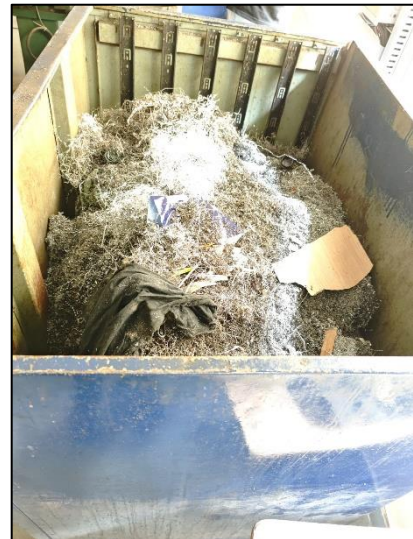
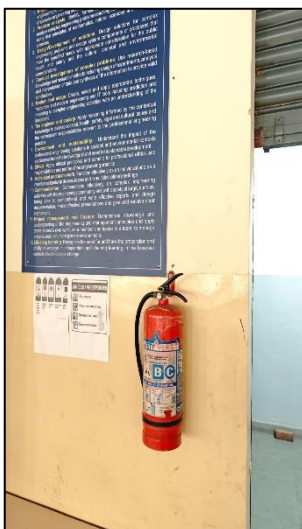
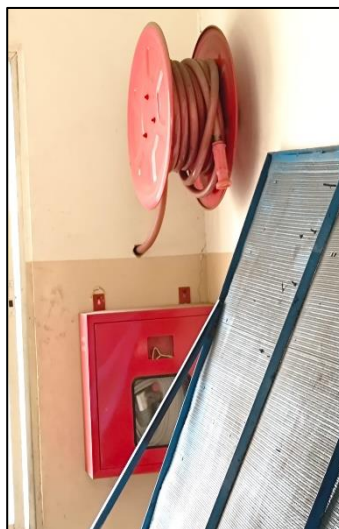
Availability Fire Safety Equipment

STATUS: POSITIVE

IT OBEYS

Section 38 of the Factories Act, 1948

Fire Safety and Emergency Preparedness

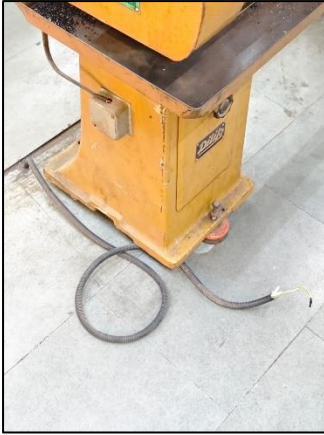
Improper Grounding of Earth Wires

STATUS: **NEGATIVE**

IT DOES NOT OBEY

Section 87 of the Factories Act, 1948
Dangerous Operations

IS 3043: Code of Practice for Earthing

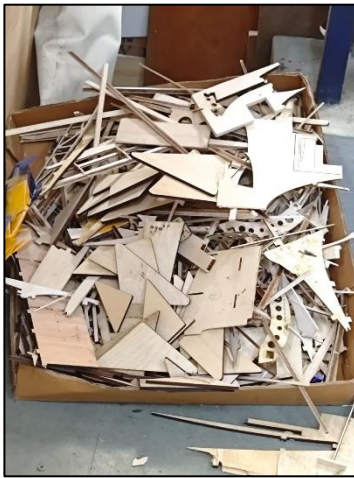
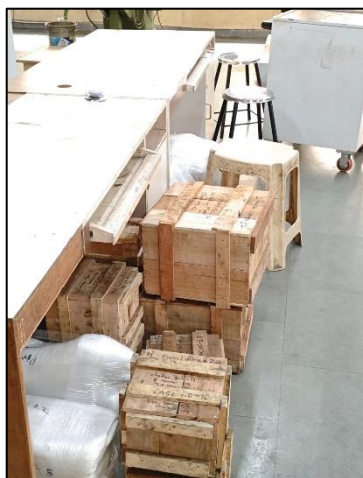
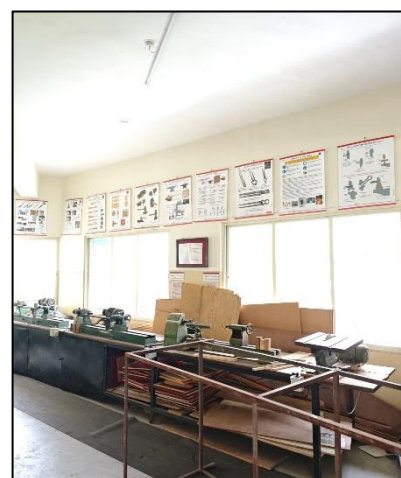
Improper Storage of Scrap near Machinery

STATUS: **NEGATIVE**

IT DOES NOT OBEY

Section 11 of the Factories Act, 1948
Cleanliness

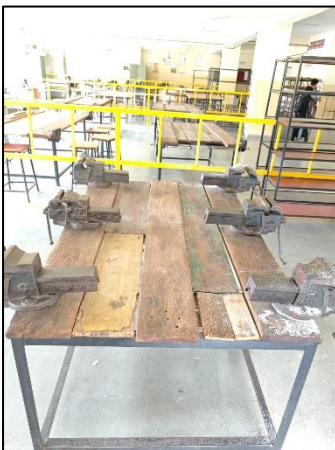
Lack of stable and safe working benches

STATUS: **NEGATIVE**

IT DOES NOT OBEY

Section 40A of the Factories Act, 1948
Maintenance of buildings

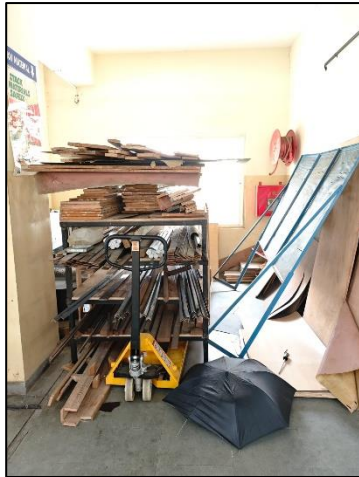
Obstruction to access Fire Hydrant and Hose

STATUS: NEGATIVE

IT DOES NOT OBEY

Section 38 of the Factories Act, 1948
Fire Safety and Emergency Preparedness

IS 1646: Code of Practice for Fire Safety of Buildings (General)

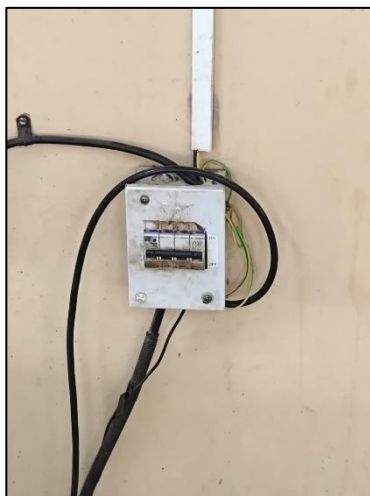
Unsafe and exposed Electrical Switches and circuits

STATUS: NEGATIVE

IT DOES NOT OBEY

Section 87 of the Factories Act, 1948
Dangerous Operations

IS 732: Code of Practice for Electrical Wiring Installations

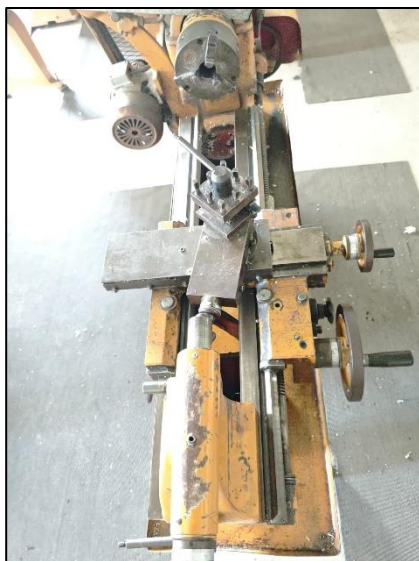
Some Equipment were unkept and rusty

STATUS: NEGATIVE

IT DOES NOT OBEY

Section 40 of the Factories Act, 1948
Safety of buildings and machinery

Section 40A of the Factories Act, 1948
Maintenance of buildings
