TEST REPORT

Division	Specification
Product Name	Sigfox asset tracker
Basic Model	IET20W
Series Model	IET21W, IET30W, IET31W
Sample Quantity	1 EA

3.1 IK08 Impacts Test

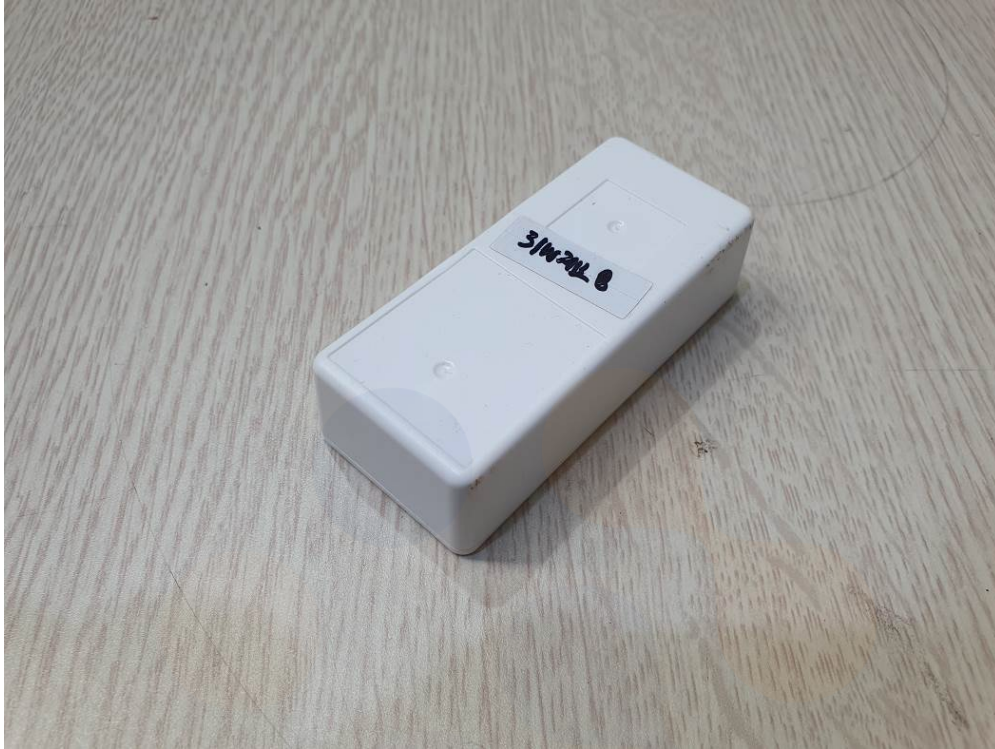
[Test result confirmation 01]

Check List	Test Result
1. Visual inspection after impact test - Damage, crack, separation occur	No abnormality was found
2. Protected against access to hazardous parts	No abnormality was found
