Elevate Claims Solutions

Risk overview 7061 Springfield Hills
Dr. S.

This risk is a three bedroom, two bathroom, two-story dwelling with 1560 ft.², vinyl siding, brick veneer, and 30 year laminated shingles built in 1997.

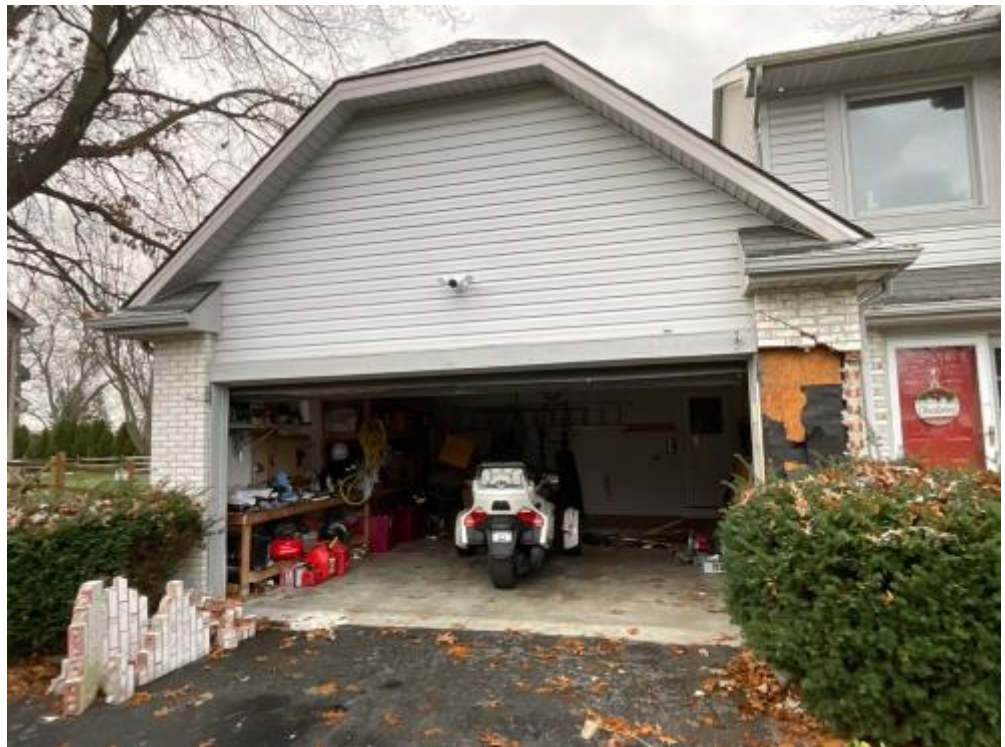
4 4-COL

Front elevation damaged area
overview

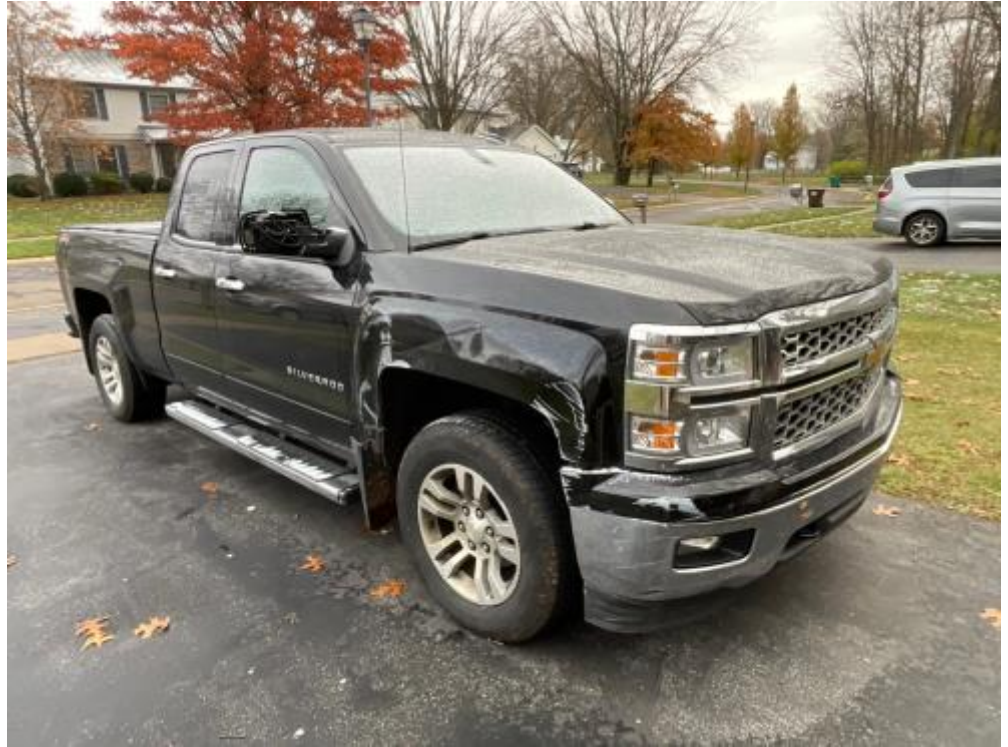
5 5-COL

The policyholder stated that he accidentally hit the right side of the overhead door opening, causing damage to the brick veneer, wall sheathing, wall framing, the overhead door track, and the cedar trim around the overhead door.

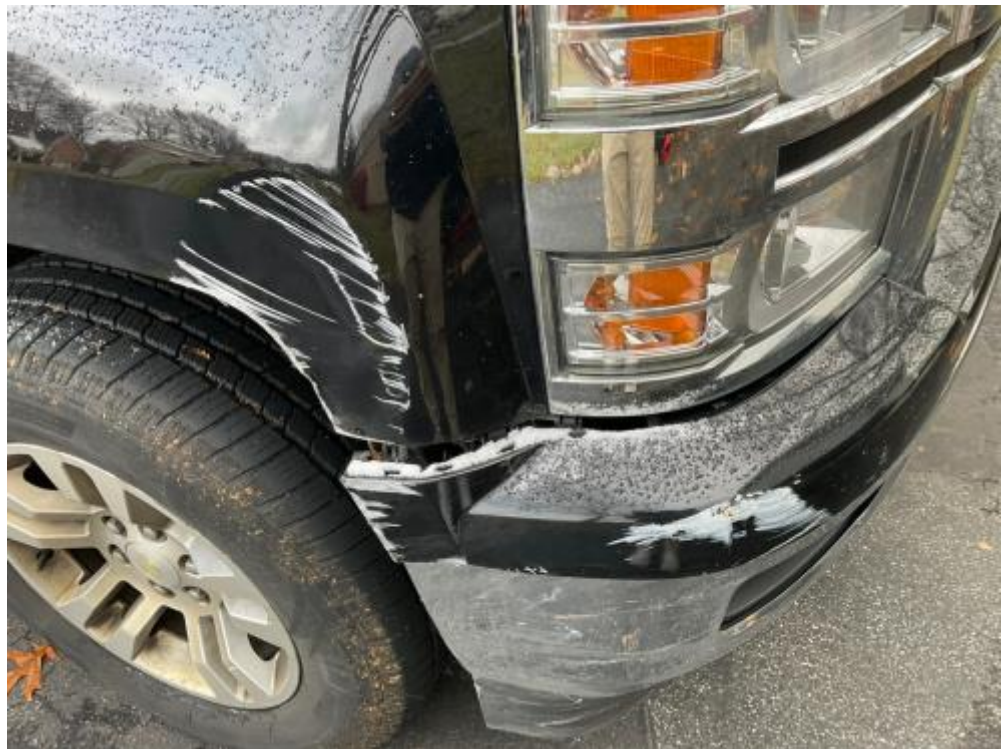
6 6-COL

The policyholder stated that he accidentally hit the right side of the overhead door opening, causing damage to the brick veneer, wall sheathing, wall framing, the overhead door track, and the cedar trim around the overhead door.

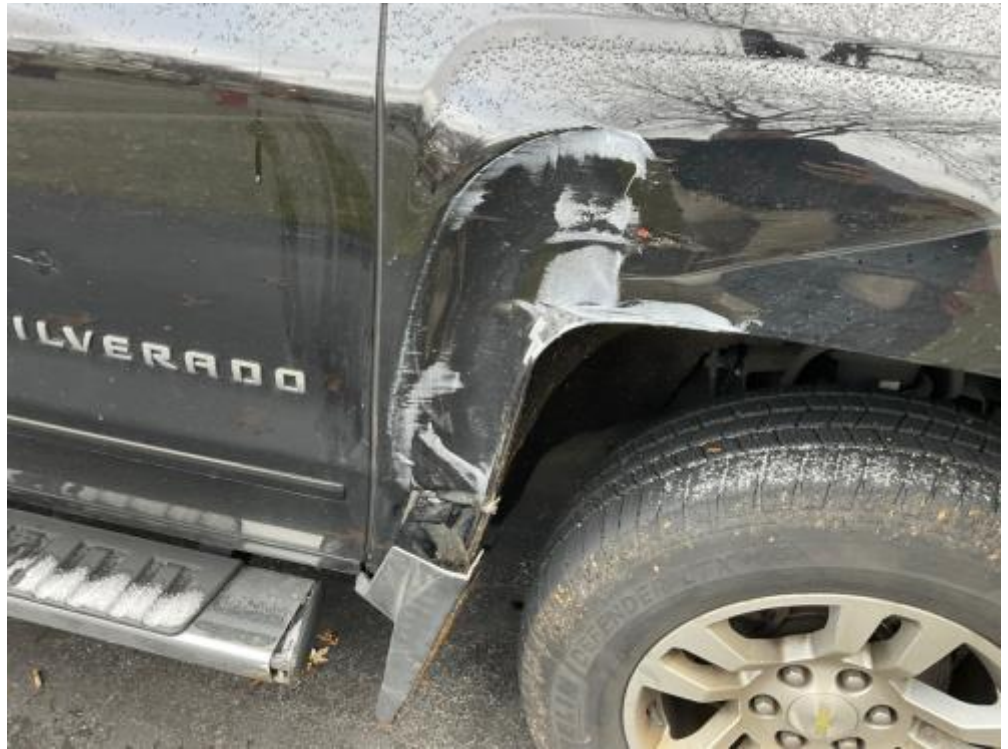
7 7-COL

The policyholder stated that he accidentally hit the right side of the overhead door opening, causing damage to the brick veneer, wall sheathing, wall framing, the overhead door track, and the cedar trim around the overhead door.

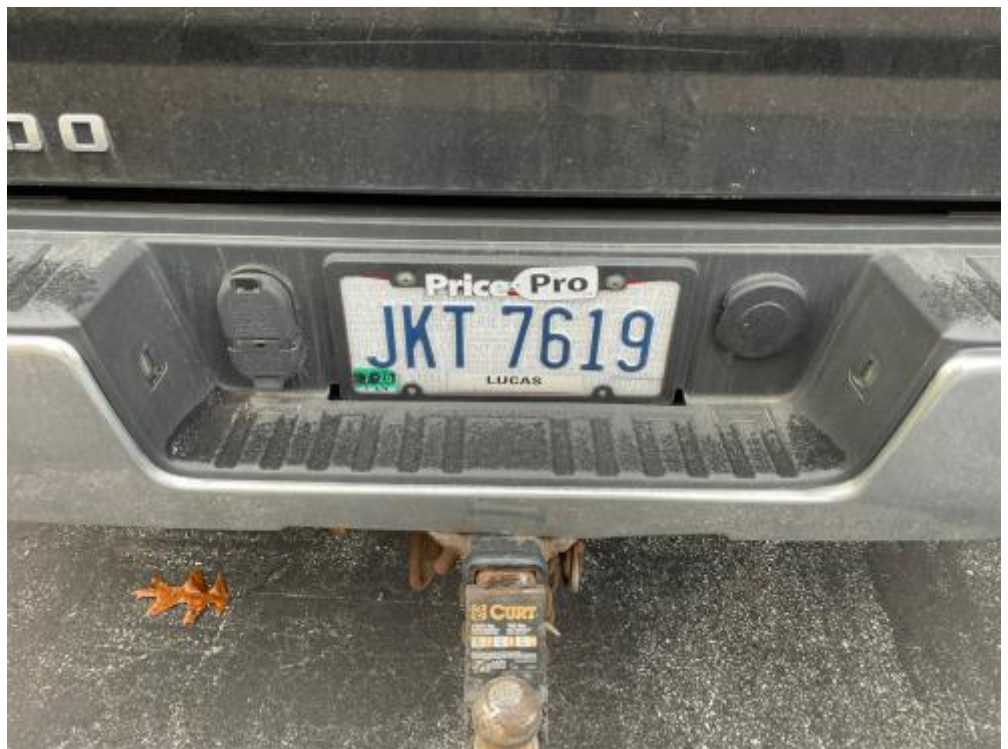
8 8-COL

The policyholder stated that he accidentally hit the right side of the overhead door opening, causing damage to the brick veneer, wall sheathing, wall framing, the overhead door track, and the cedar trim around the overhead door.

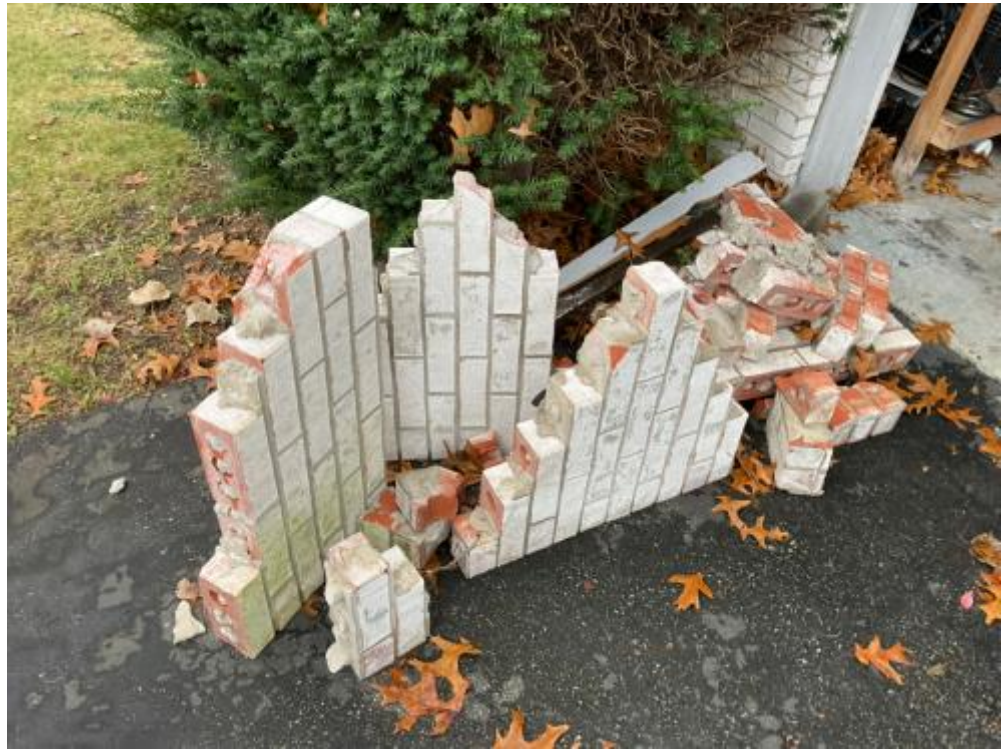
- 9 9-Attached Garage
Date Taken: 11/21/2024
Taken By: Steven Kujawski

The vehicle has caused damage to the brick veneer, wall sheathing, and stud framing, CMU foundation wall at the base of the wall, the overhead door track, and cedar trim around the overhead door opening.

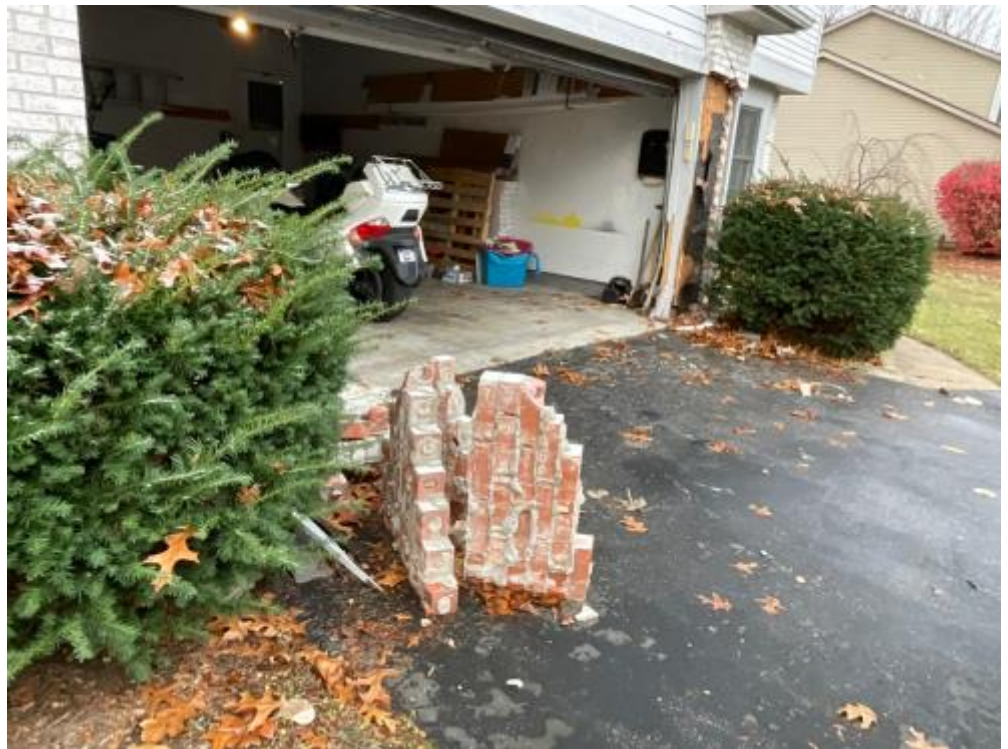
- 10 10-Attached Garage
Date Taken: 11/21/2024
Taken By: Steven Kujawski

The vehicle has caused damage to the brick veneer, wall sheathing, and stud framing, CMU foundation wall at the base of the wall, the overhead door track, and cedar trim around the overhead door opening.

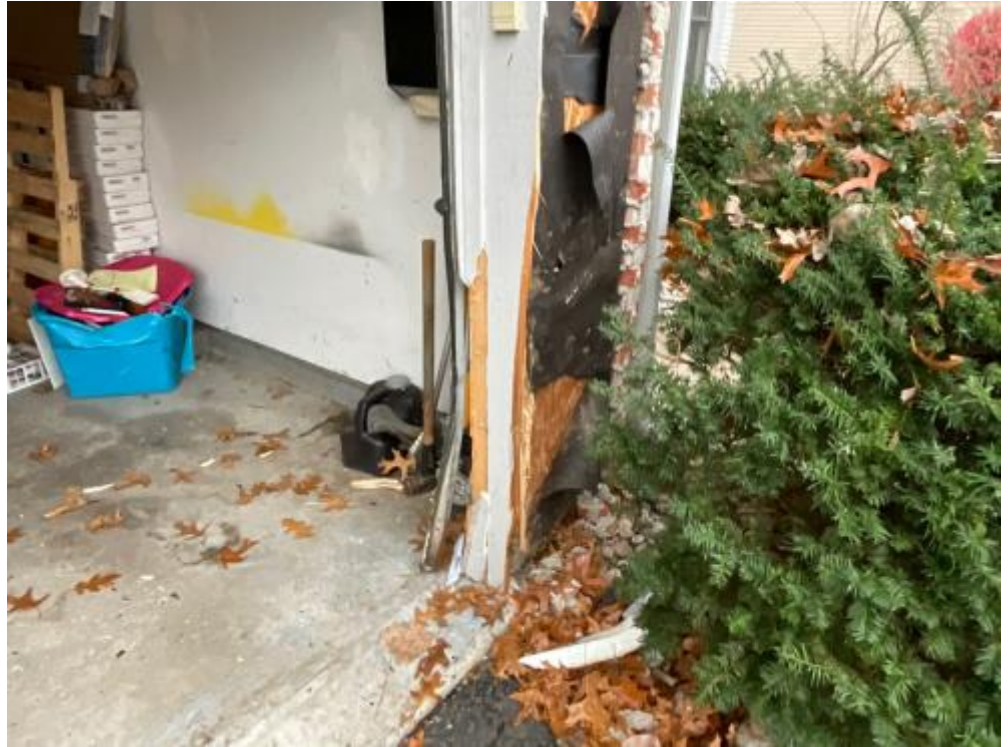
11 11-Attached Garage

The vehicle has caused damage to the brick veneer, wall sheathing, and stud framing, CMU foundation wall at the base of the wall, the overhead door track, and cedar trim around the overhead door opening.

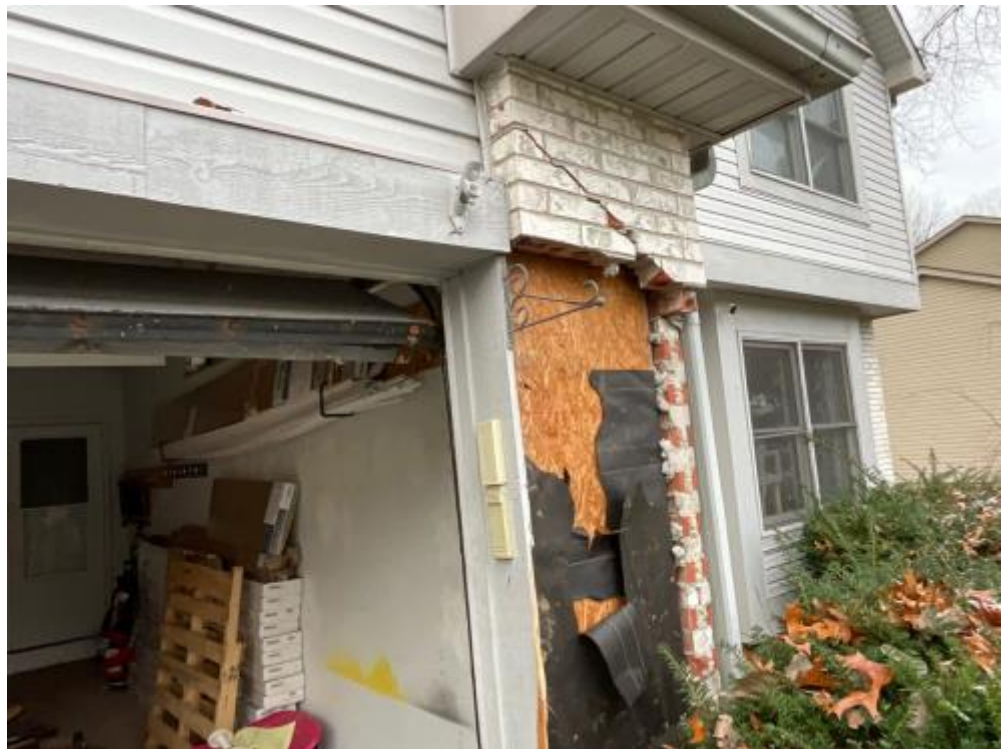
12 12-Attached Garage

The vehicle has caused damage to the brick veneer, wall sheathing, and stud framing, CMU foundation wall at the base of the wall, the overhead door track, and cedar trim around the overhead door opening.

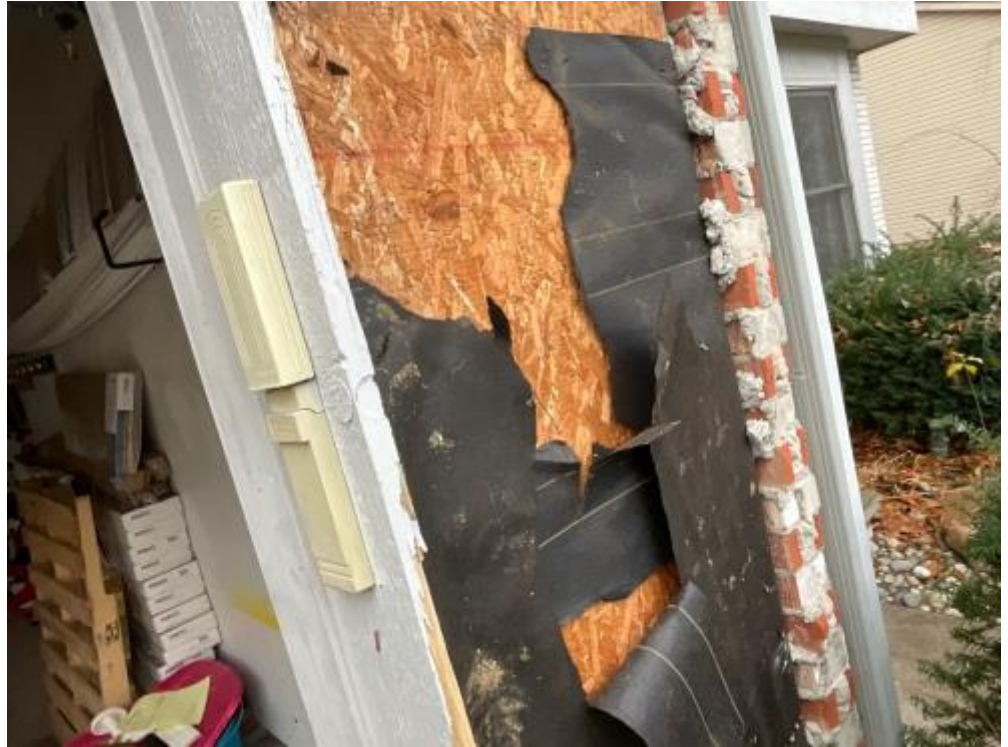
13 13-Attached Garage

The vehicle has caused damage to the brick veneer, wall sheathing, and stud framing, CMU foundation wall at the base of the wall, the overhead door track, and cedar trim around the overhead door opening.

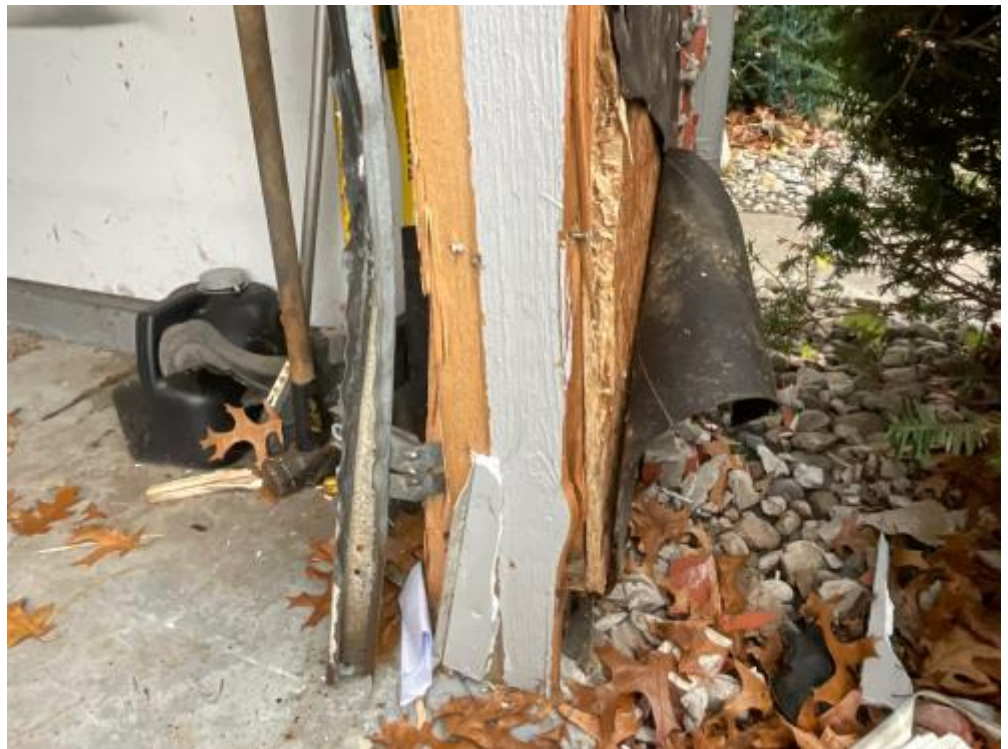
14 14-Attached Garage

The vehicle has caused damage to the brick veneer, wall sheathing, and stud framing, CMU foundation wall at the base of the wall, the overhead door track, and cedar trim around the overhead door opening.

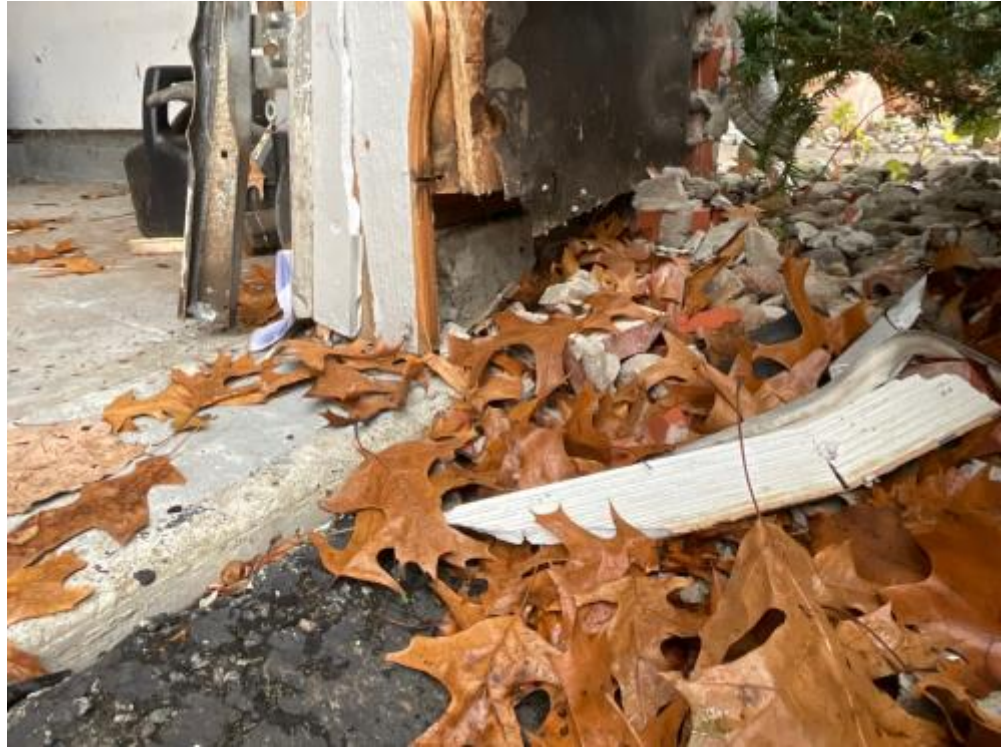
15 15-Attached Garage

The vehicle has caused damage to the brick veneer, wall sheathing, and stud framing, CMU foundation wall at the base of the wall, the overhead door track, and cedar trim around the overhead door opening.

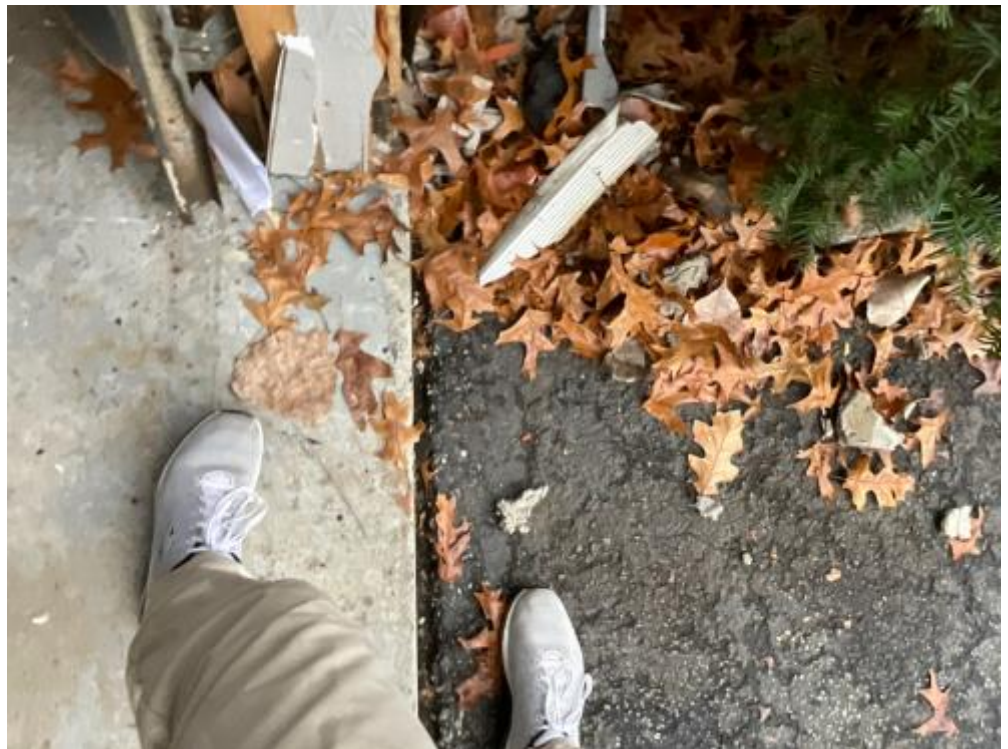
16 16-Attached Garage

The vehicle has caused damage to the brick veneer, wall sheathing, and stud framing, CMU foundation wall at the base of the wall, the overhead door track, and cedar trim around the overhead door opening.

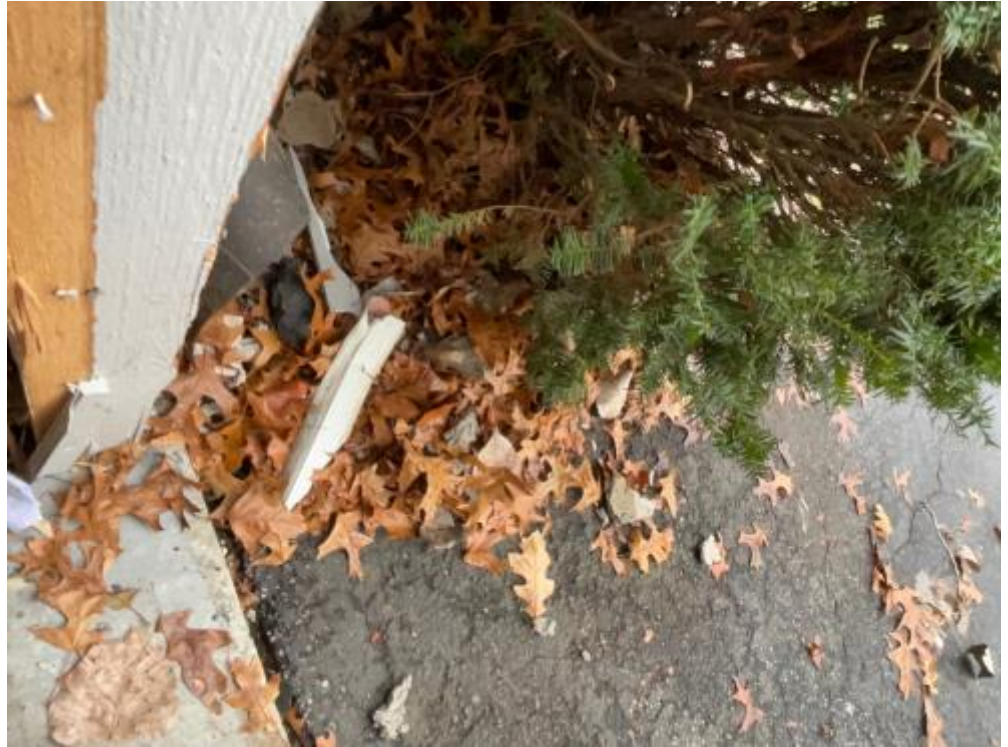
17 17-Attached Garage

The vehicle has caused damage to the brick veneer, wall sheathing, and stud framing, CMU foundation wall at the base of the wall, the overhead door track, and cedar trim around the overhead door opening.

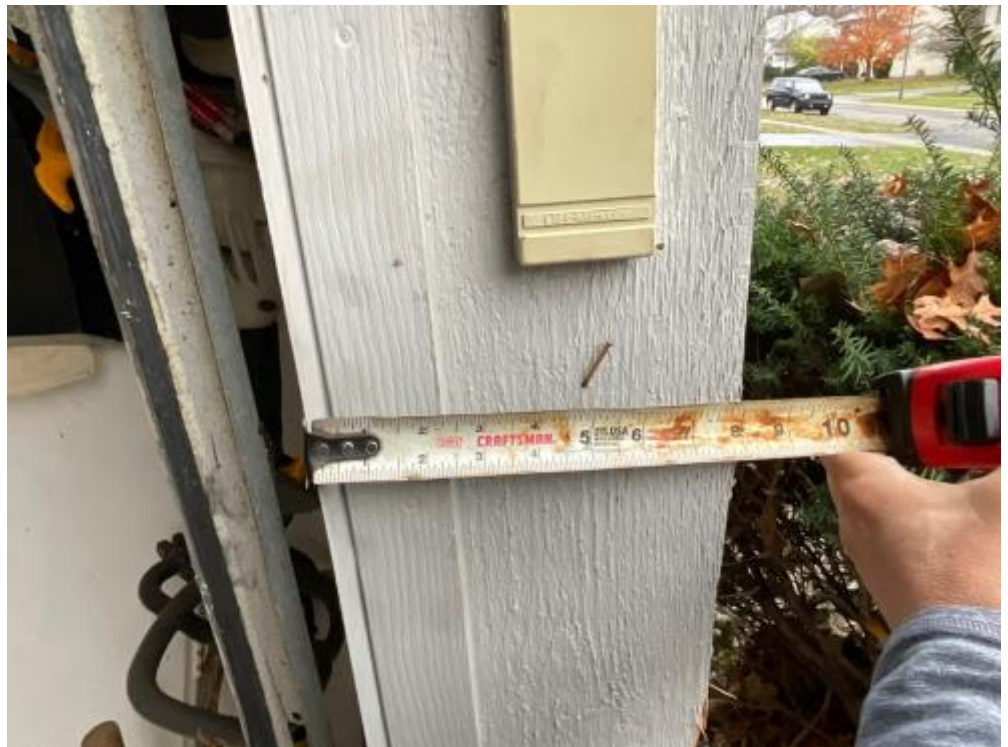
18 18-Attached Garage

The cedar trim around the overhead door measures 8 inches wide.

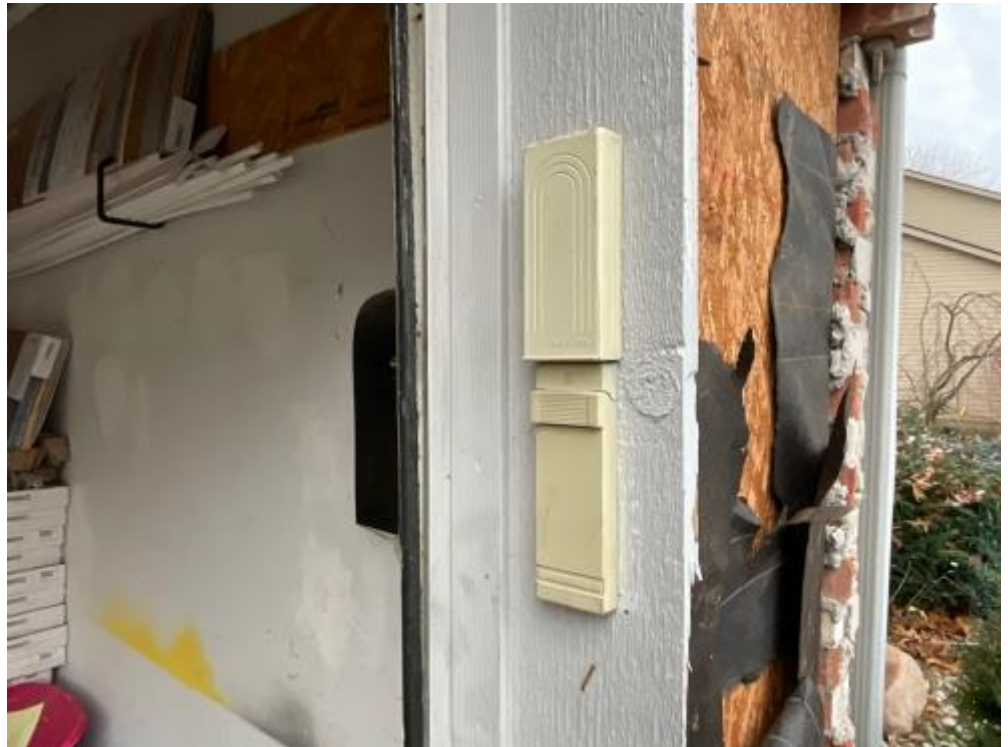
19 19-Attached Garage

Two wireless door openers are installed over the painted cedar door.

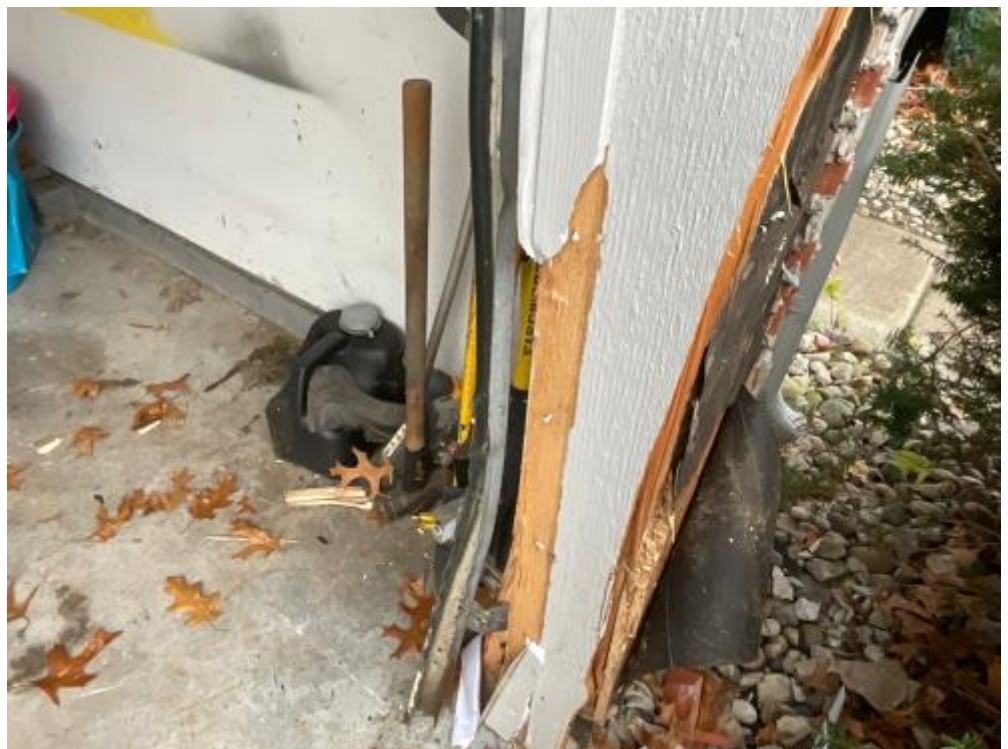
20 20-Attached Garage

The weather stop has been damaged in this loss.

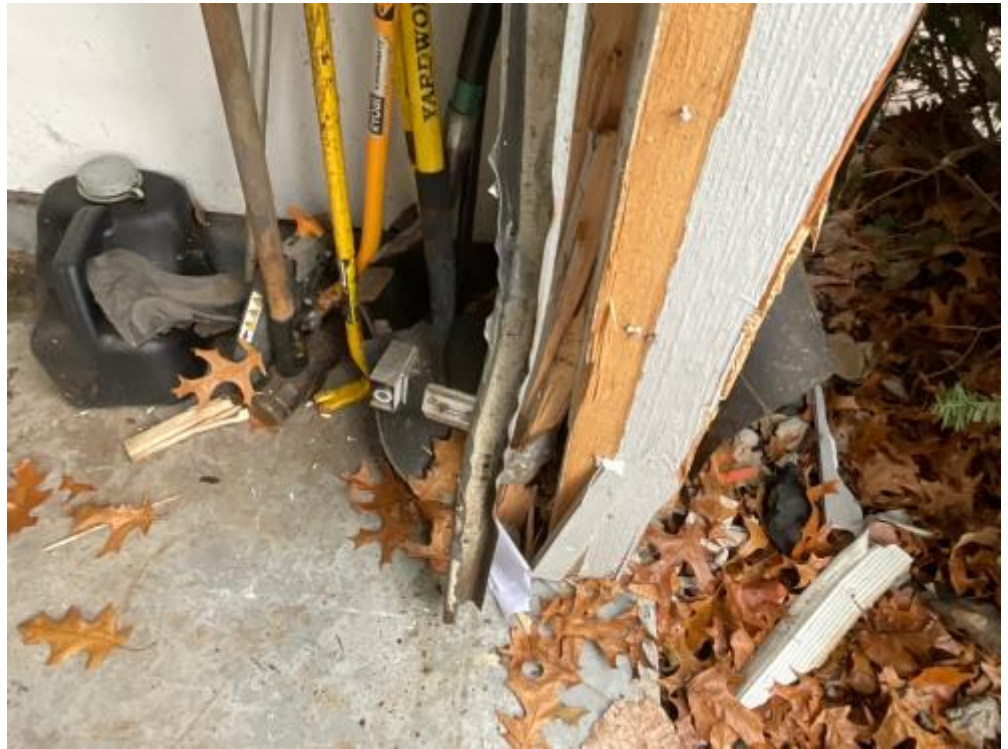
21 21-Attached Garage

The overhead door track has been damaged in this loss.

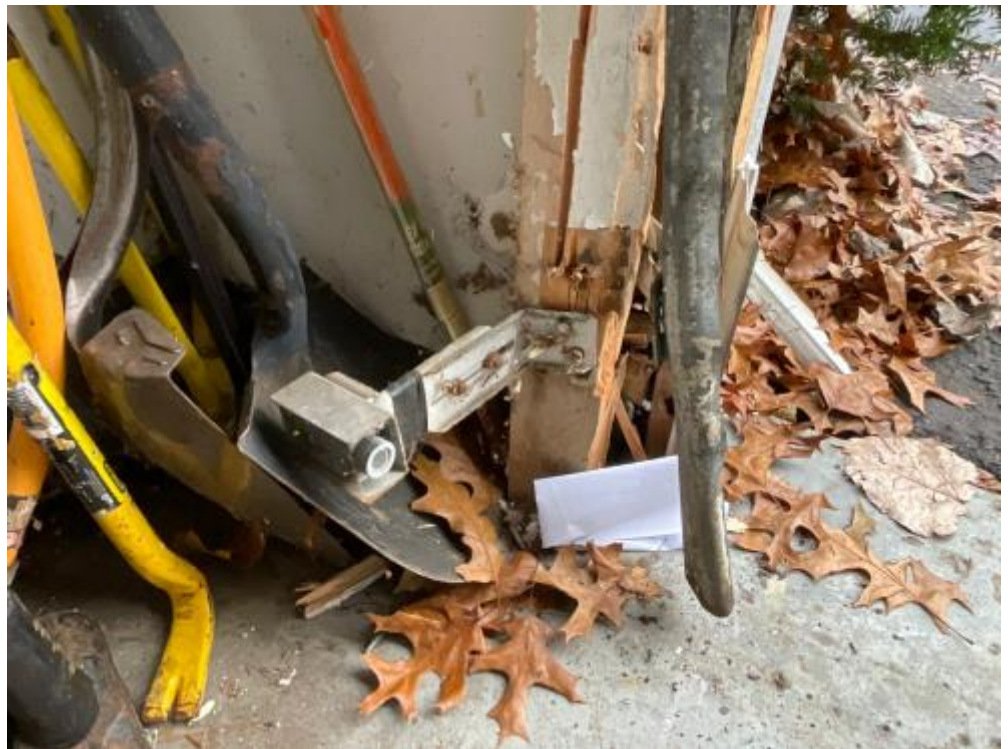
22 22-Attached Garage

The vehicle collision has damaged the drywall and 2 x 4 nailer that the overhead door track is fastened too.

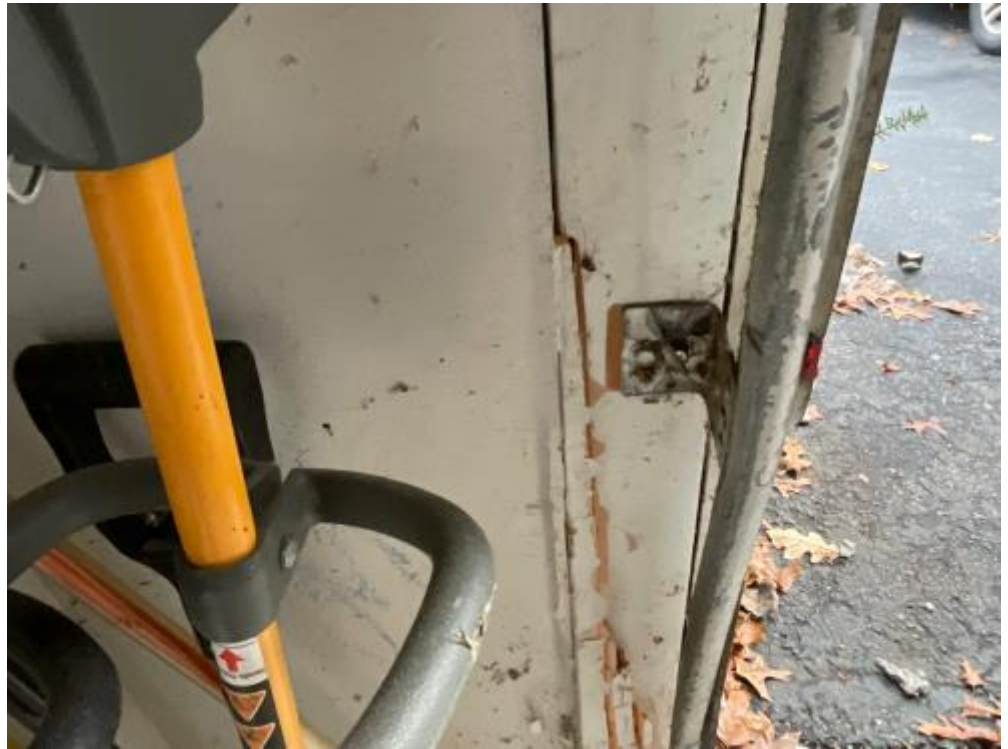
23 23-Attached Garage

The vehicle collision has damaged the drywall and 2 x 4 nailer that the overhead door track is fastened too.

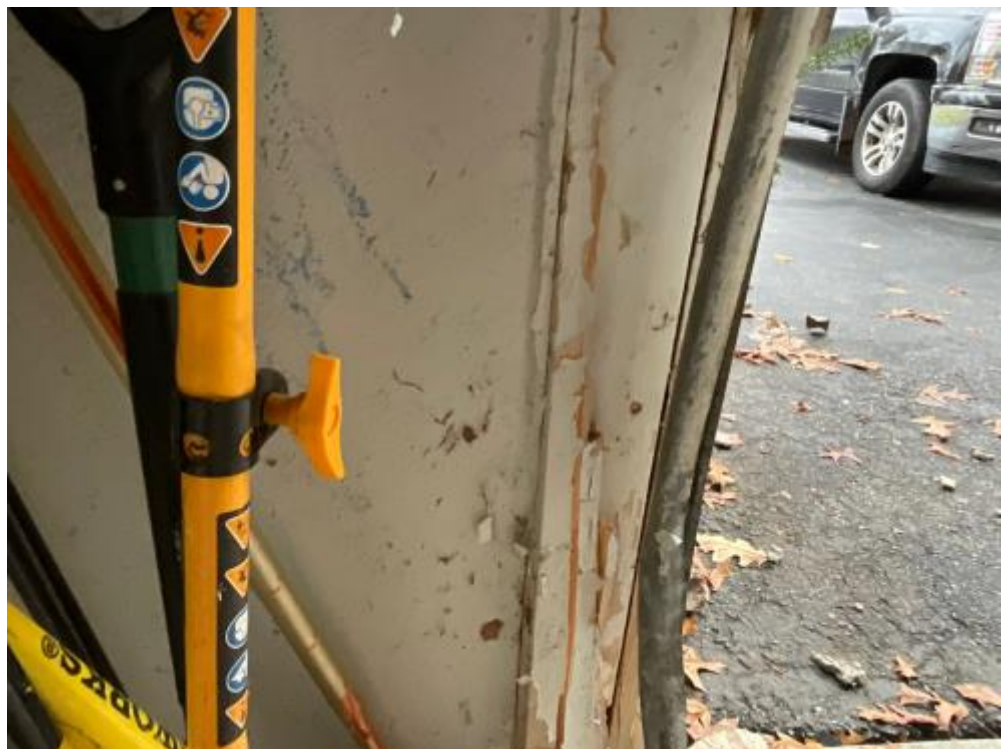
24 24-Attached Garage

The vehicle collision has damaged the drywall and 2 x 4 nailer that the overhead door track is fastened too.

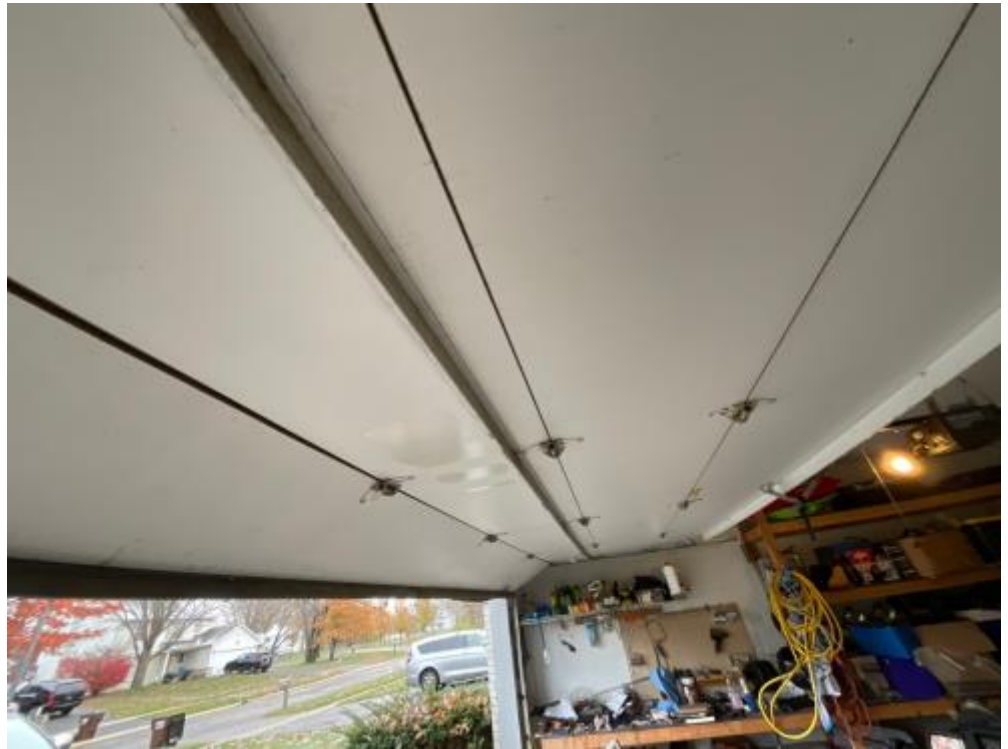
25 25-Attached Garage

The insulated overhead door itself appears to be undamaged by this loss.

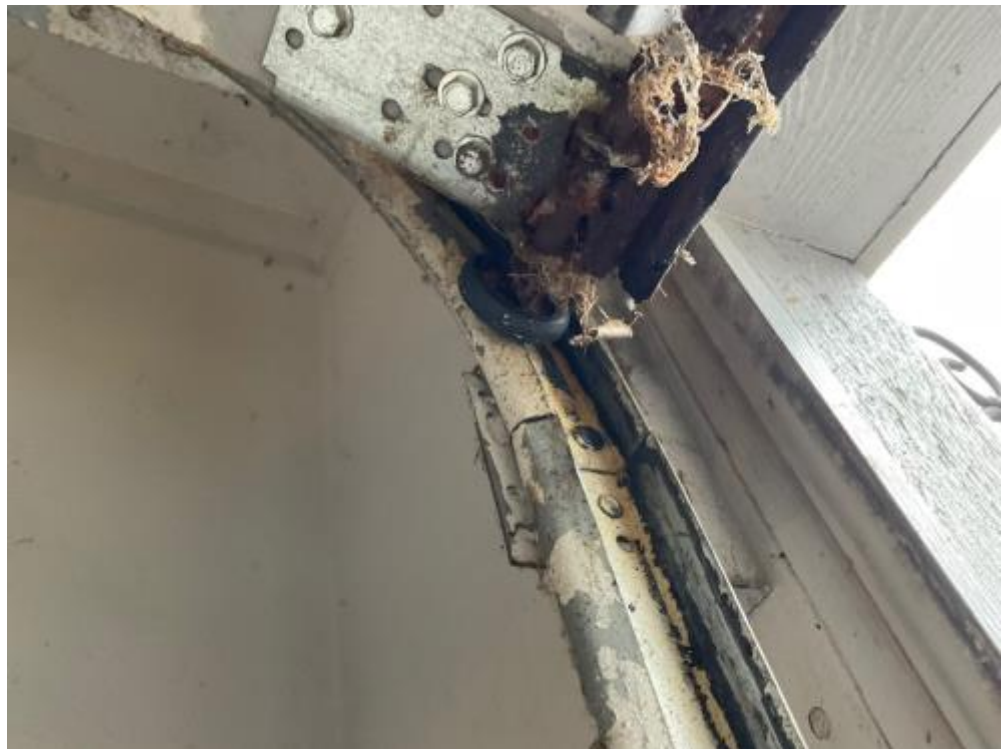
26 26-Attached Garage

The insulated overhead door itself appears to be undamaged by this loss.

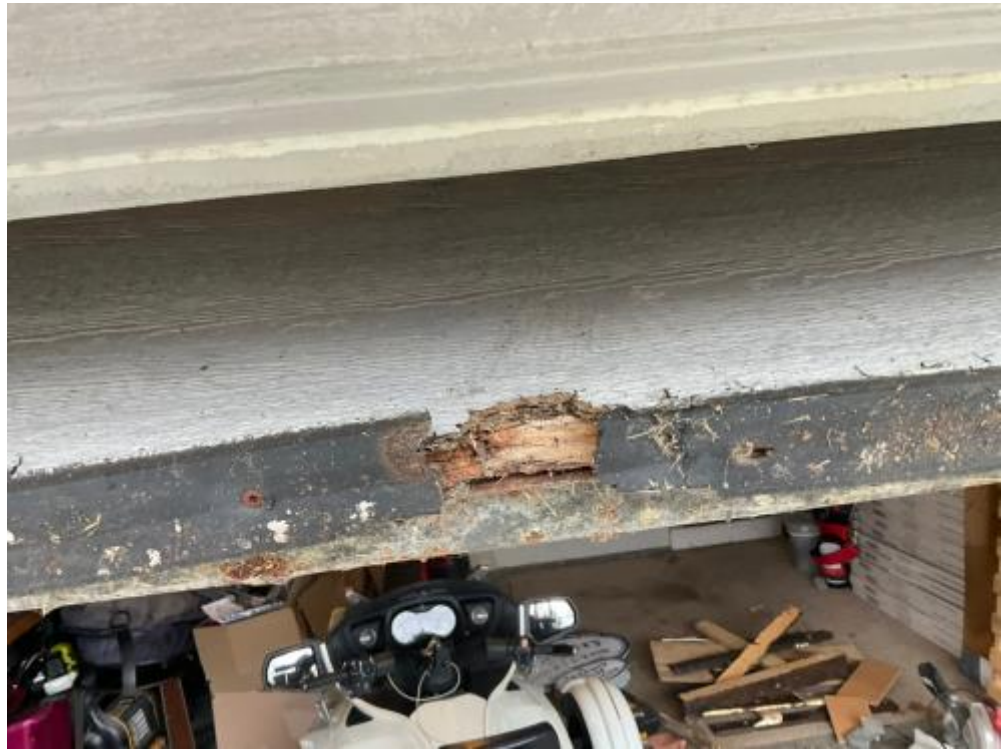
27 27-Attached Garage

Prior damage to the bottom of the the overhead door was noted. This damage is not a result of this vehicle incident.

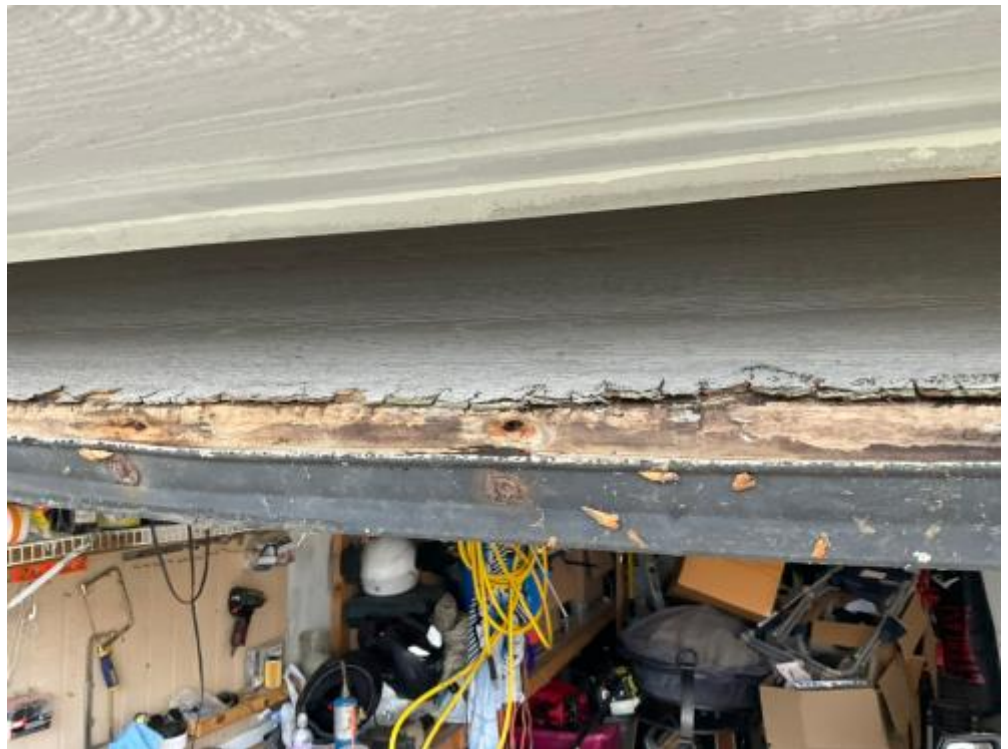
28 28-Attached Garage

Prior damage to the bottom of the the overhead door was noted. This damage is not a result of this vehicle incident.

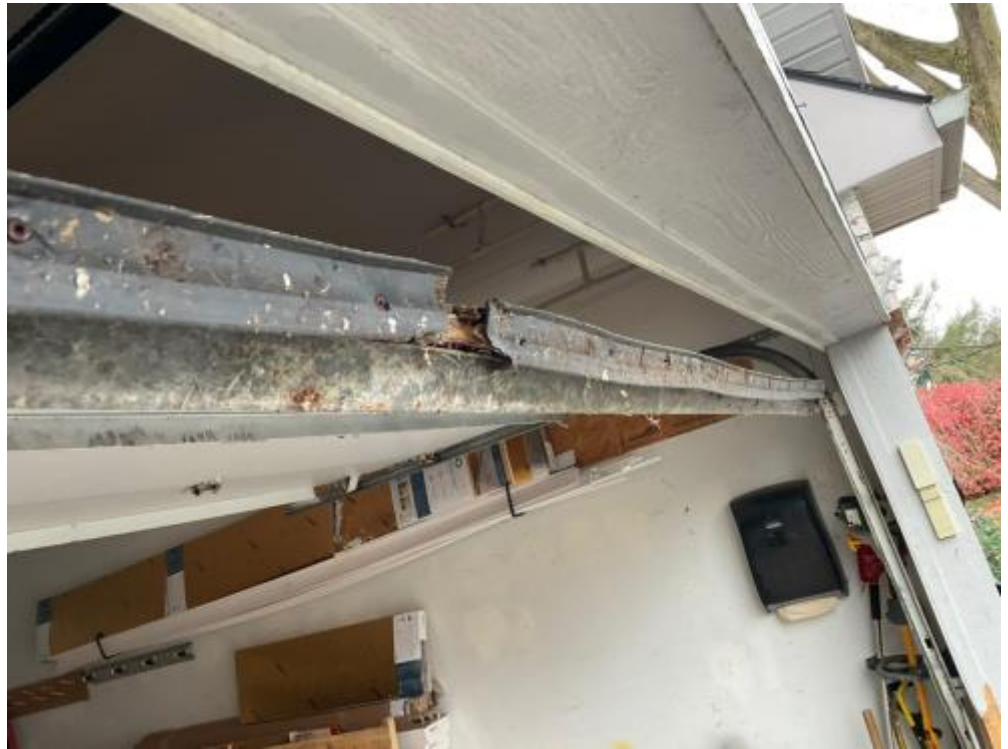
29 29-Attached Garage

Prior damage to the bottom of the the overhead door was noted. This damage is not a result of this vehicle incident.

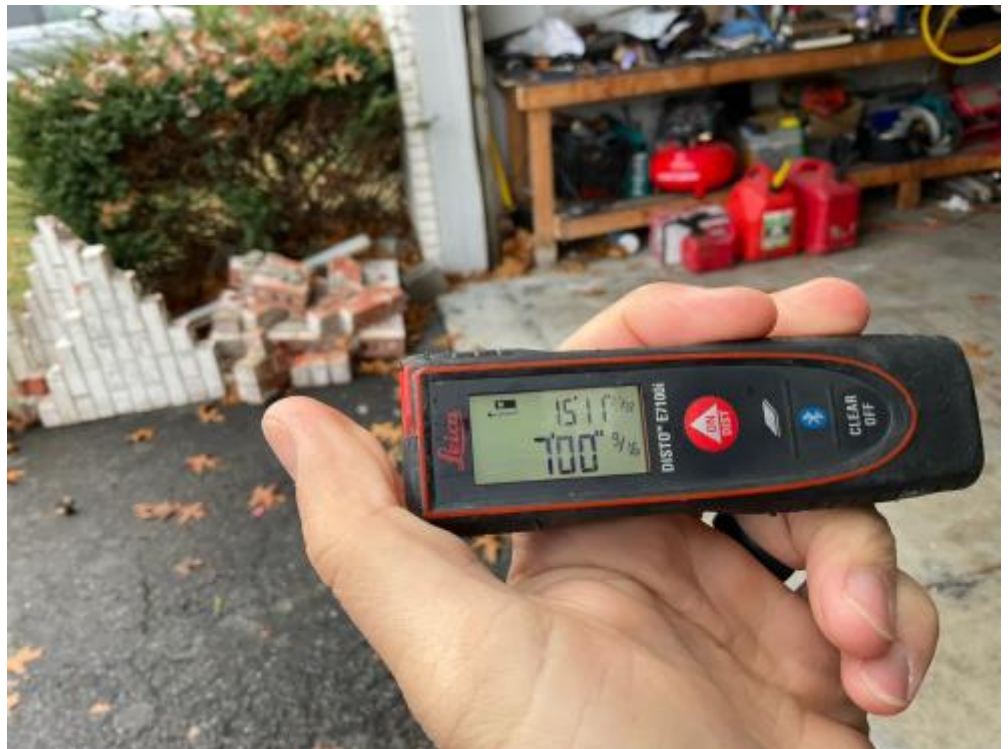
30 30-Attached Garage

The overhead door measures 16 feet wide by 7 feet tall.

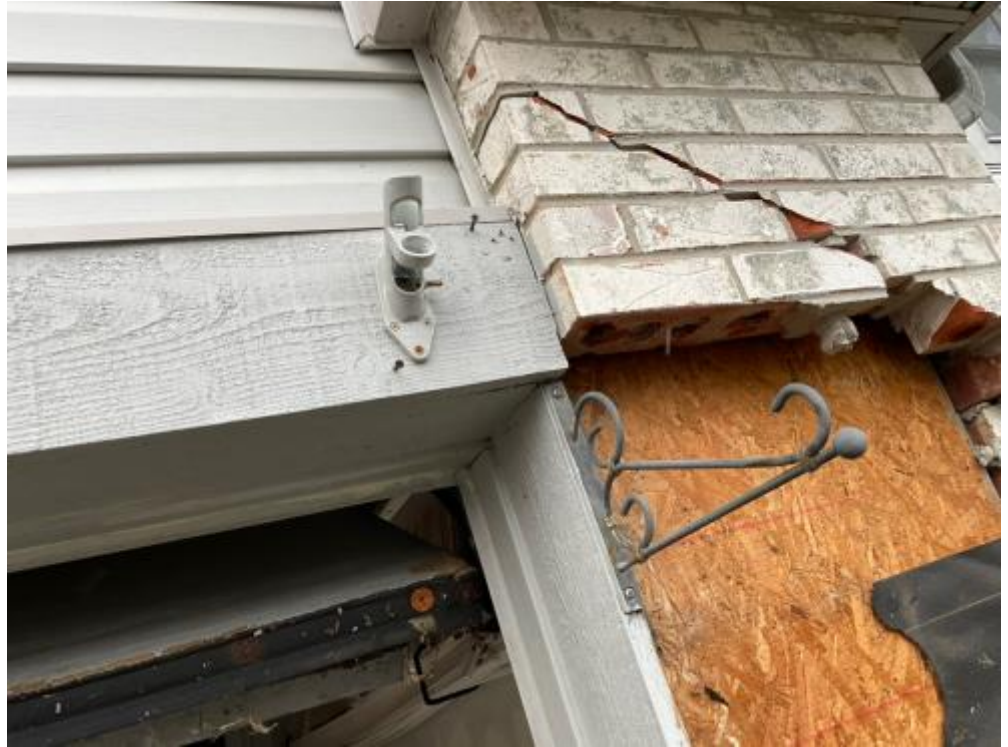
31 31-Attached Garage

A flag holder and two plant hooks are installed over the painted overhead door trim.

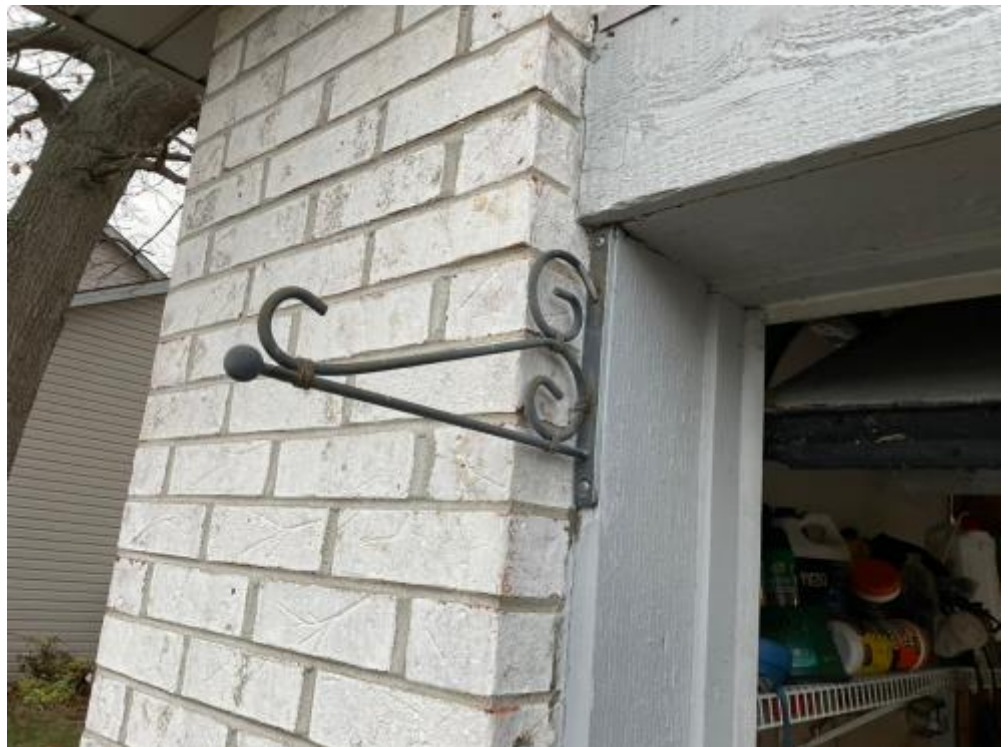
32 32-Attached Garage

A flag holder and two plant hooks are installed over the painted overhead door trim.
