Elevate Claims Solutions

Risk overview 7061 Springfield Hills
Dr. S.

This risk is a three bedroom, two bathroom, two-story dwelling with 1560 ft.², vinyl siding, brick veneer, and 30 year laminated shingles built in 1997.

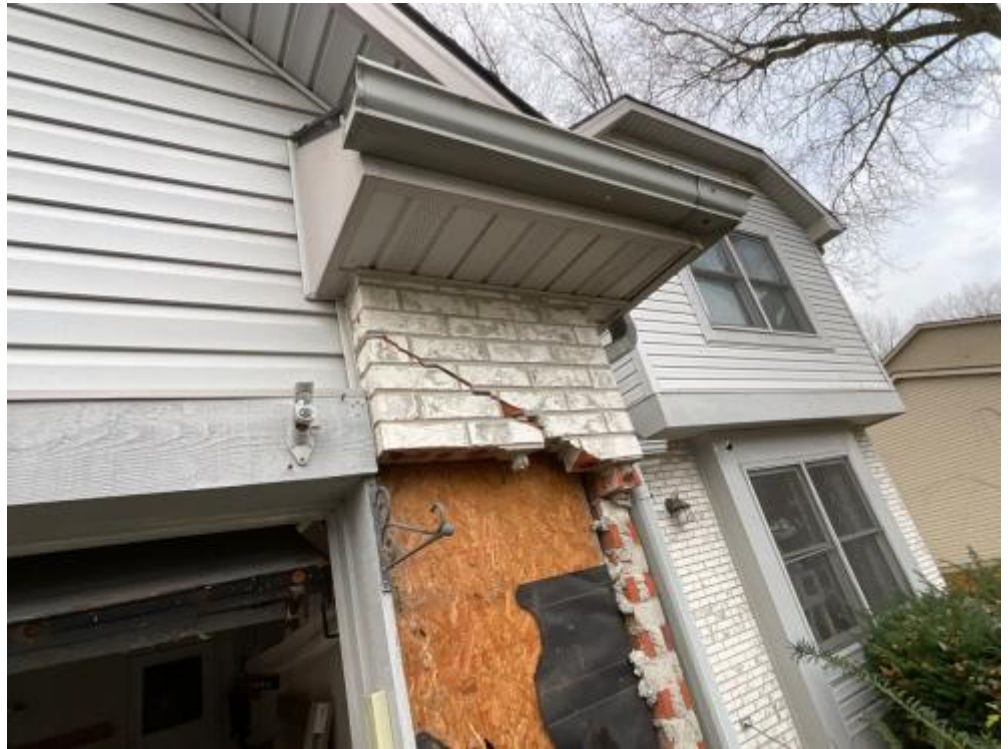
- 33 33-Attached Garage
Date Taken: 11/21/2024
Taken By: Steven Kujawski

The damaged section of brick
measures 2'5" wide by 8'8" tall.

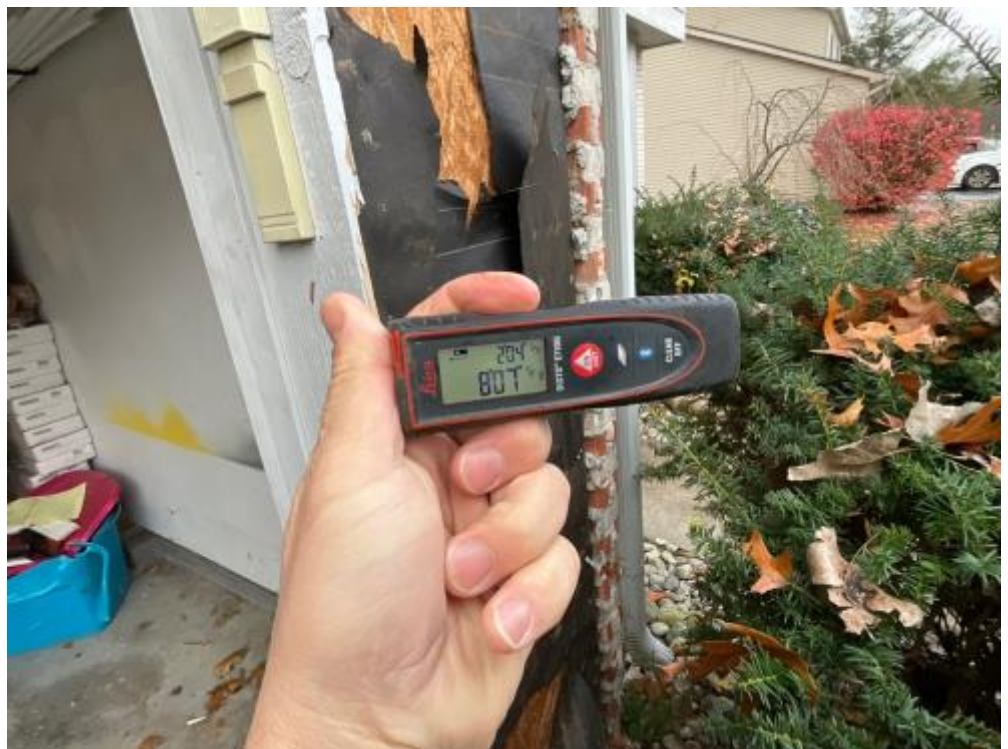
- 34 34-Attached Garage
Date Taken: 11/21/2024
Taken By: Steven Kujawski

The damaged section of brick
measures 2'5" wide by 8'8" tall.

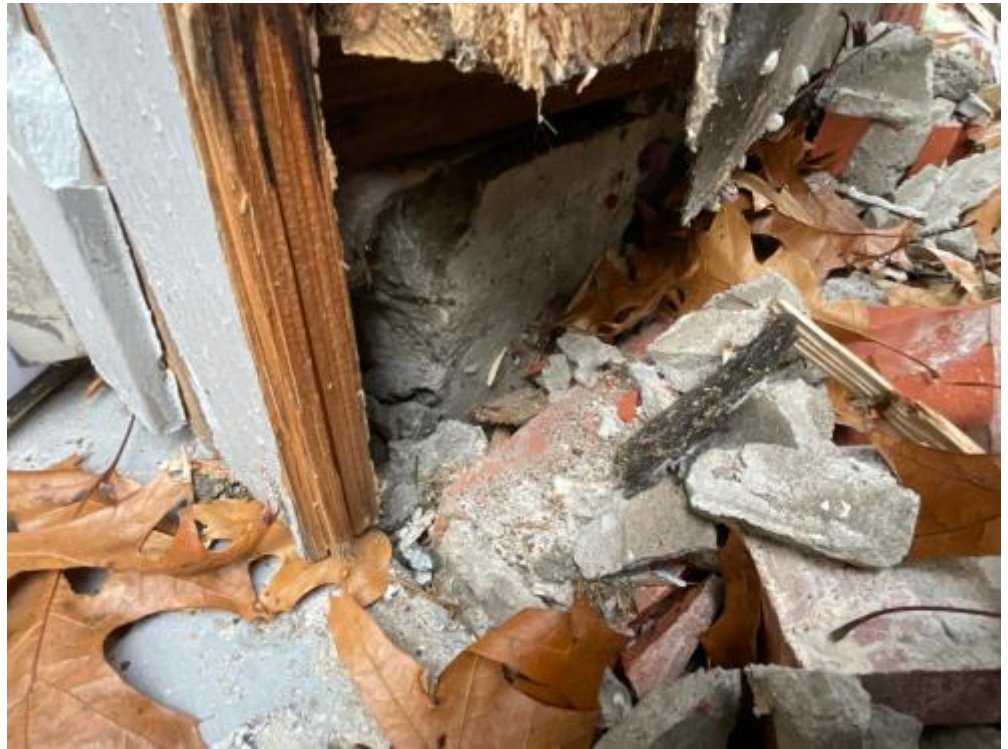
- 35 35-Attached Garage
Date Taken: 11/21/2024
Taken By: Steven Kujawski

The damaged section of brick
measures 2'5" wide by 8'8" tall.

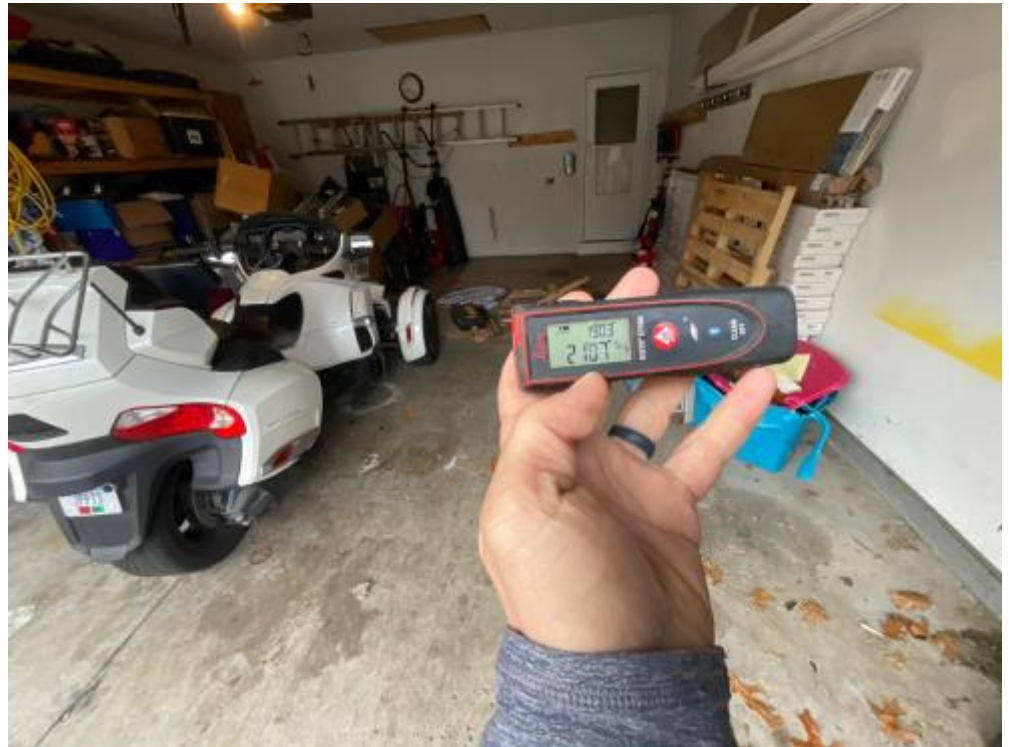
37 37-Attached Garage

The attached garage measures 21'8" wide by 19'3" deep.

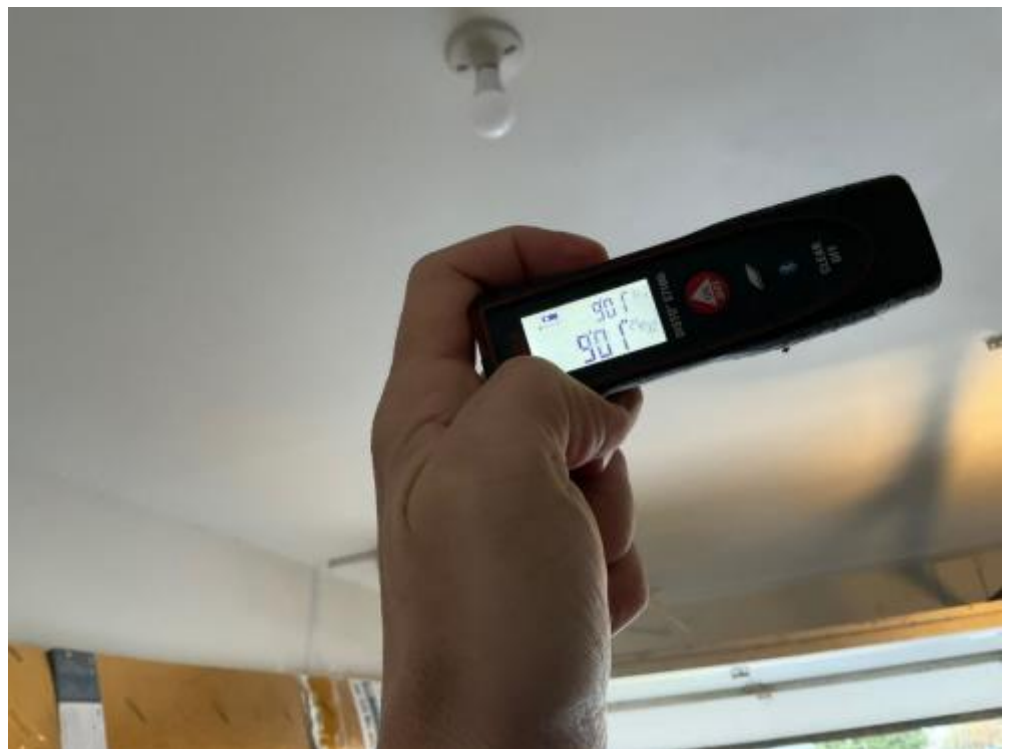
38 38-Attached Garage

The ceiling height in the attached garage measures 9'2" tall
