Analyzing Your NVT using GIS

Ver. 1.1 – May 3, 2024

A Quick-Start Guide for the Uninitiated

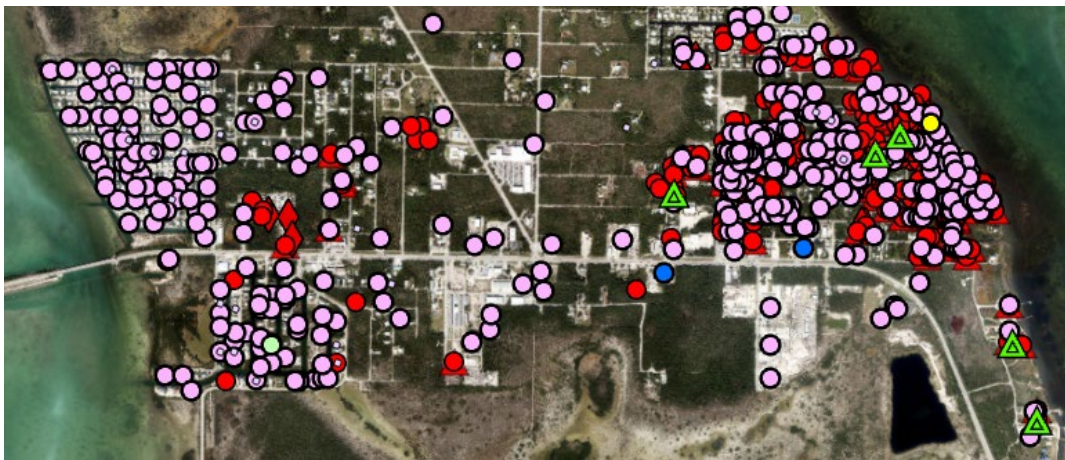
Figure 1 This GIS map example shows spatially located elevation certs, floodproofing certs, LOMAs, substantially damaged buildings, 1316 Declarations.

Auto-plotting points in bulk tends to place them all at the parcel's dead-center. This can cause points to become stacked under each other and hidden from view. It helps to employ an offset, so the points remain within the correct parcel but not under each other.

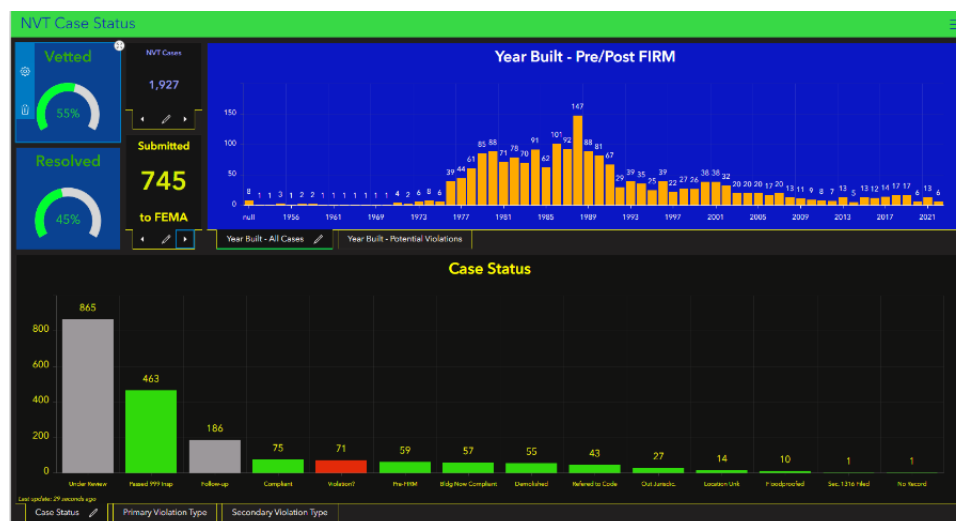
Creating a related GIS Dashboard provides a real-time progress report useful for keeping others updated and rendering reports to FEMA. Once such a dashboard has been setup, it'll be self-updating as changes are made to your NVT data. More about dashboards later.

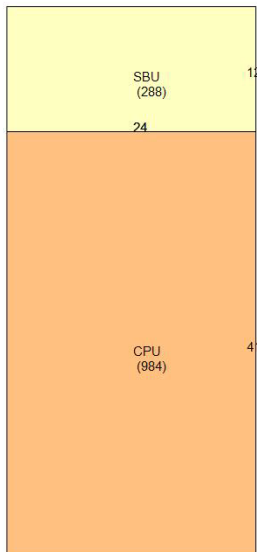
Building sketches from taxing agencies are a good reference for quickly triaging NVT listings. In this example, the ground level has an open carport area (CPU, orange), and is accompanied by at 288-sf utility enclosure (SBU, yellow).

Since the enclosure is less than the current maximum of 299-sf, the NVT concern is likely related to inadequate flood ventilation.

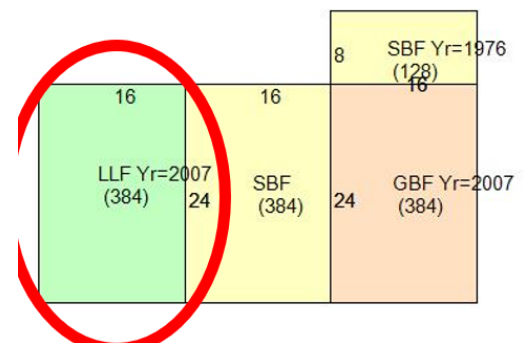
In this post-FIRM example, there are four separate enclosures at ground level: Garage, tan; two utility enclosures, yellow; living space, green.

Depending upon the year of construction compared to the floodplain ordinances in effect at the time, four enclosures of this size may have been permissible; yet habitable space wouldn't have been permissible. The follow-up necessitates an archives search to learn what was permitted and when.

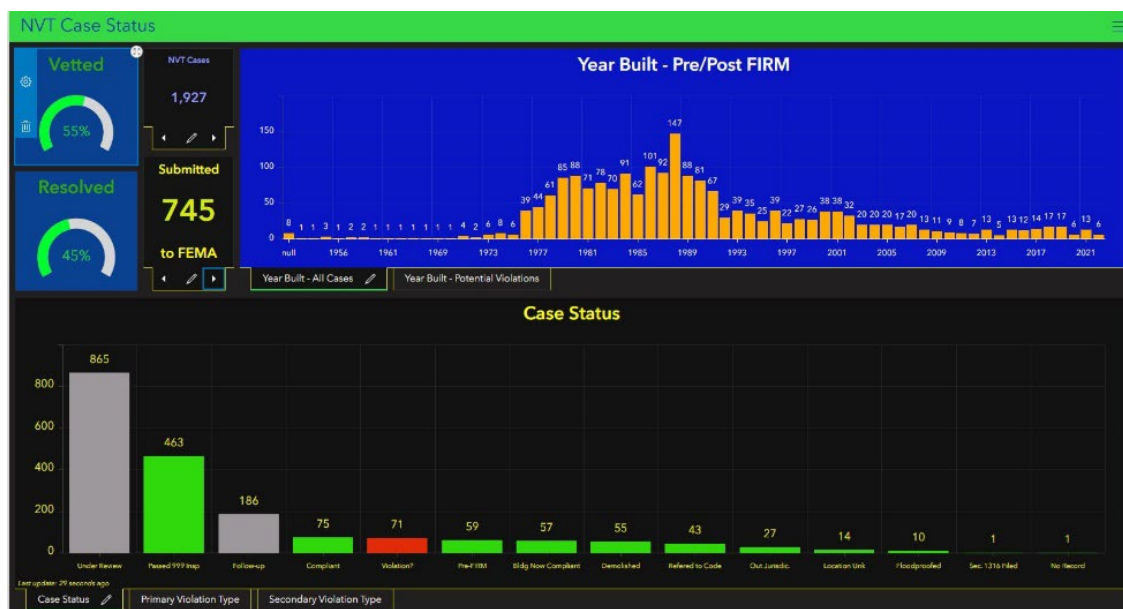
Once a dashboard has been setup, it's updated in real-time as your GIS data entries are made. A combination of gauges, indicators and charts can be customized to your needs. Related sub-charts become visible when clicking on the sub-tabs immediately beneath some of the charts.

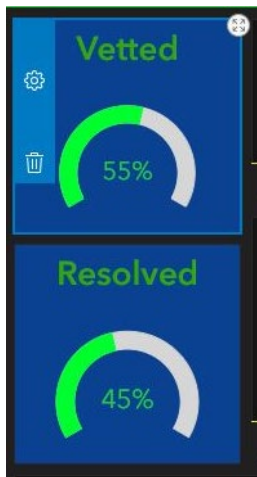
The “Vetted” and “Resolved” gauges are handy progress meters.

This pair of gauges shows triaging of the NVT listings is more than halfway done (55%). Of those reviewed so far, there was enough information to categorize 45% of the likely resolutions.

So far, only 10% need will require follow-up efforts.

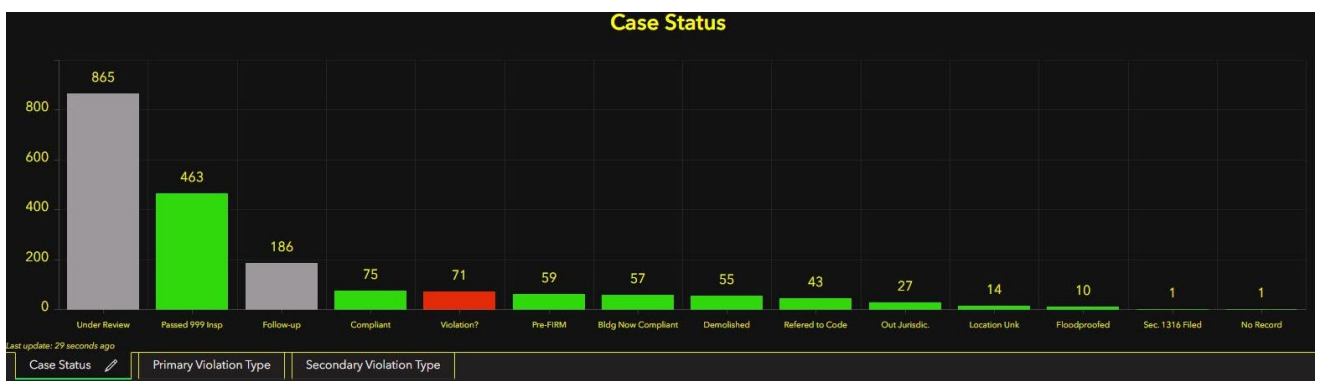
The case status chart shows individual counts of each status category. (see Status Categories)

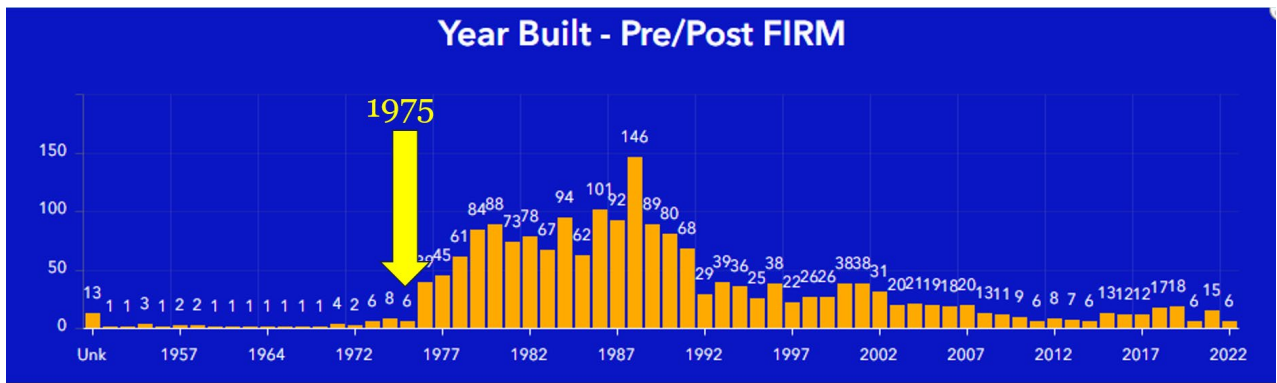
The year-built chart uses the property appraiser's construction date (Certificate of Occupancy date) to age the NVT structures. The pre-FIRM date (12/31/1974) for many communities is indicated by the yellow arrow. Initially the 'violation' listings for 1975 and 1976 were much higher, yet research disclosed a number of those completed buildings involved pre-FIRM permits and thus should be removed from the NVT.

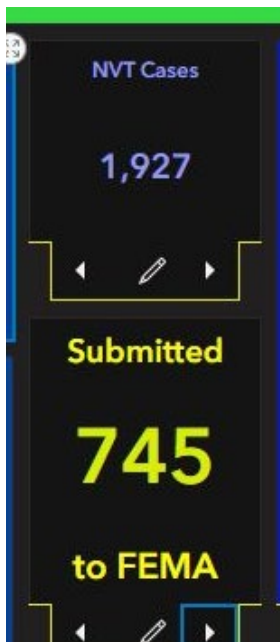
These indicators simply show the number of NVT listings followed by the number of resolutions submitted to FEMA to date.

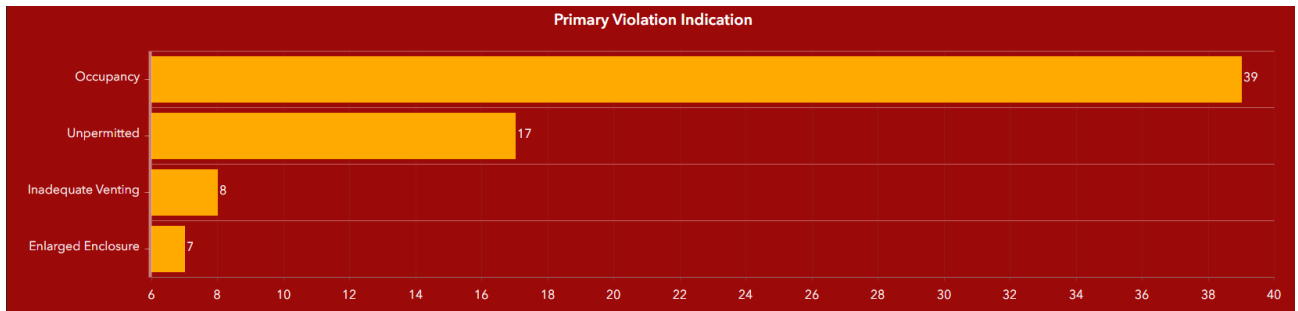
A sub-chart of potential floodplain violations further categorizes them by apparent cause to help define the scope of follow-up needed.
