Core herniation after implantation of a cervical artificial disc: case report

Materials and methods The authors describe the failure of a M6-C CAD (Spinal Kinetics, Sunnyvale, CA, USA).

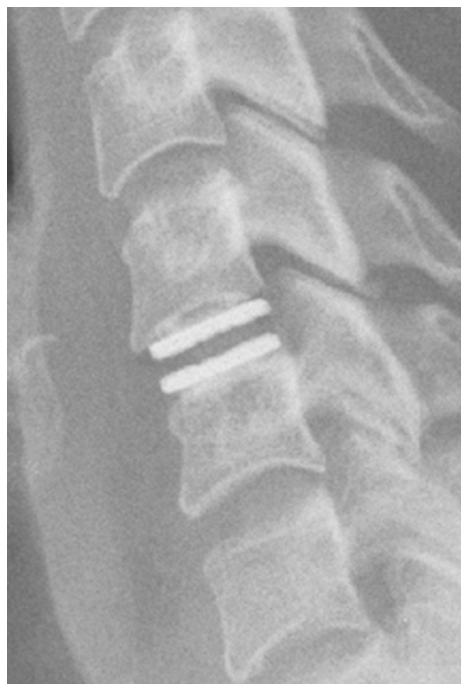
Fig. 1 Lateral cervical X-ray after first surgery

In 2007, a 39-year-old female received a CAD (M6-C, Spinal Kinetics, Sunnyvale, CA, USA) due to degenerative, symptomatic cervical disc herniation at level C5/6. After implantation of the device, C6 radiculopathy was resolved. Radiographic control imaging after the operation showed an accurate placement of the CAD (Fig. 1). As the patient was free of symptoms, no clinical or radiographic controls were performed. In 2012, the patient complained of new neck pain, nausea and vomiting in cervical flexion. There was no history of spinal trauma, tumor or infection preceding clinical deterioration. Cervical control radiography revealed a posteriorly displaced lower titanium plate, compared to the previous image (Fig. 2). Cervical magnetic resonance imaging (MRI) conducted at the same time showed a narrowed spinal canal with potential cervical medullar compression. As this finding was misleadingly interpreted to be based on metal artifacts caused by the CAD, no action was taken from this finding.

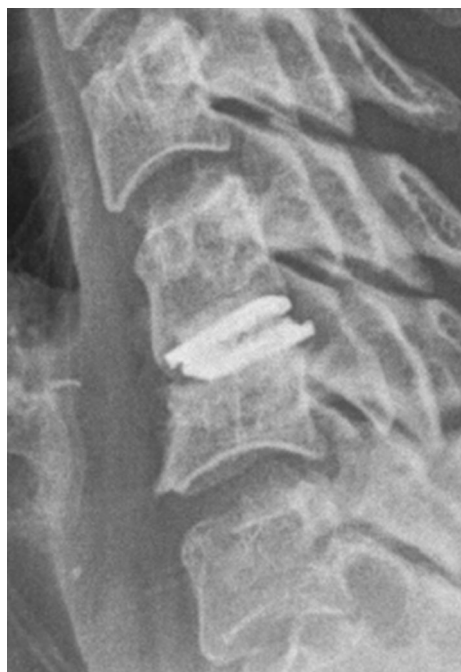
Fig. 2 Lateral cervical X-ray 5 years after surgery

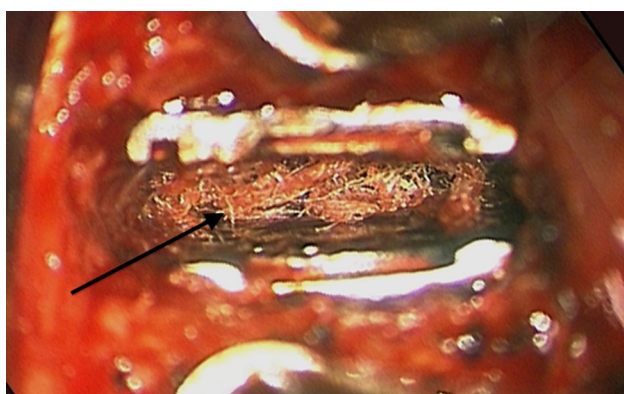
Fig. 5 Intraoperative view of the ventral fibers after removal of the outer sheath

Revision surgery was performed using the original right-sided ventral approach. Distraction retractor screws were placed in the adjacent vertebrae under fluoroscopic control. The segment was distracted to facilitate CAD removal. As the keels of the prosthesis were completely subsided into the upper and lower vertebra, removal of the CAD in one piece was not possible. Therefore, the ventral outer sheath of the CAD was incised (Fig. 4) and the fibers within the CAD removed (Fig. 5). At the dorsal end of the CAD, the posterior defect of the fibers and the displaced core of the CAD could be detected (Fig. 6). After removal of the core with a small nerve hook, the titanium endplates of the CAD could be easily detached with a dissector. Titanium endplates were subsided but not fused with the adjacent vertebra. Finally, a titanium cervical cage was implanted and additionally fixed using a ventral plate (Fig. 7). After revision surgery, clinical symptoms gradually resolved.
