Intradural migration of cervical posterior fixation rods

Case report We present a case of open reduction and fixation of traumatic C5/6 facet fracture dislocation with late complication in the form of intradural hardware migration.

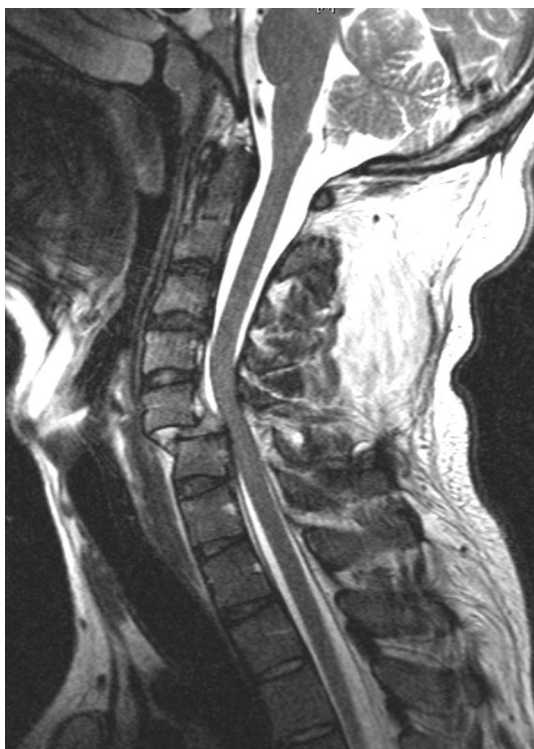
Fig. 1 MRI scan of cervical spine, sagittal view showing the C5/6 facet fracture dislocation

A 29-year-old man presented to the Accident and Emergency Department after having been involved in a rugby tackle during which he sustained a bilateral C5/6 facet fracture dislocation (Fig. 1). On presentation, there was no neurological deficit. He underwent anterior cervical discectomy, open reduction and fixation with an interbody cage and plate. In addition, he also had a posterior fixation of C5 and C6 with lateral mass screws, but no decompression and the posterior elements were not disturbed. Post-operatively, there were no complications and the patient made an excellent recovery. Although he did not return to playing rugby, he pursued several other sporting activities as before his injury and returned to full time work as an account manager.

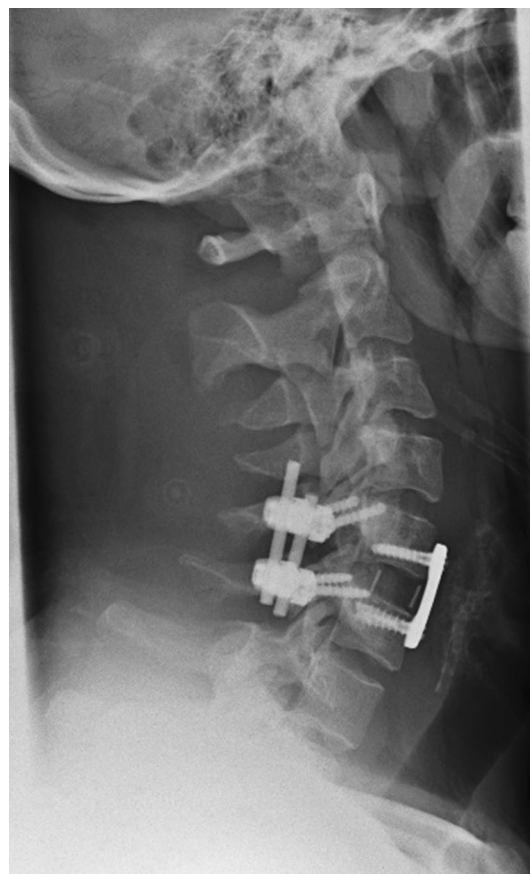
Fig. 2 Post-operative cervical X-ray at 3 months

The patient was seen in the follow-up clinic 3 months after his operation. At this stage, X-rays of the cervical spine were obtained and implant position and spinal alignment were deemed satisfactory (Fig. 2). The patient then moved out of area and was, therefore, not followed up further at our institution.

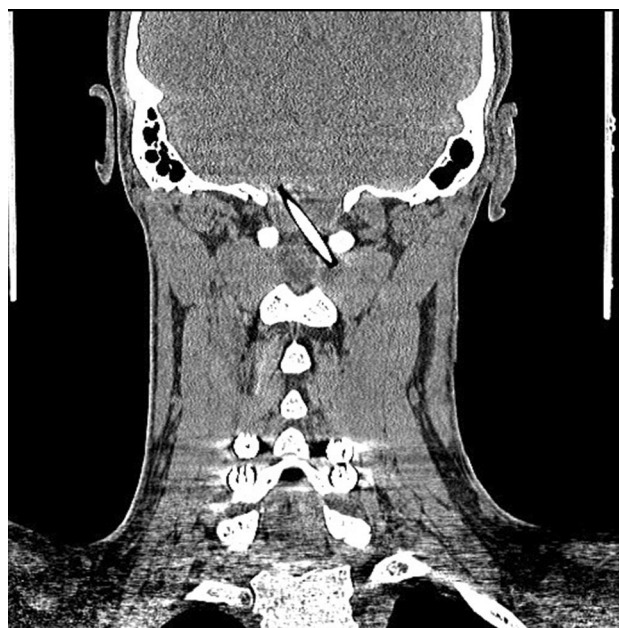
Fig. 3 CT cervical spine (coronal view). Position of the dislodged rod near the Foramen magnum

One rod was now situated in the vicinity of the Foramen magnum, the second rod in the musculature of the left lateral neck at the levels of C2–C4 with the tip embedded in the lamina of C2 (Figs. 3, 4, 5, 6). The MRI scan confirmed that one rod was in an intradural position (Fig. 7). However, the fixation at C5/6 looked solid with bony consolidation around the disc and cage.

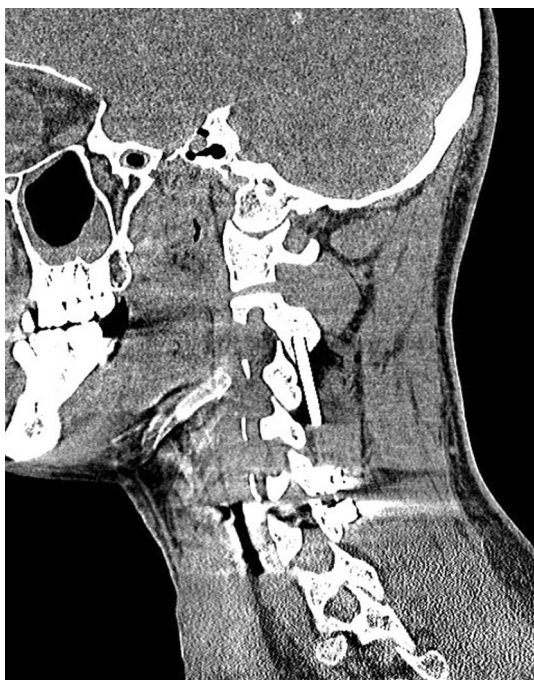
Fig. 4 CT cervical spine (sagittal view). Position of the dislodged rod in the neck

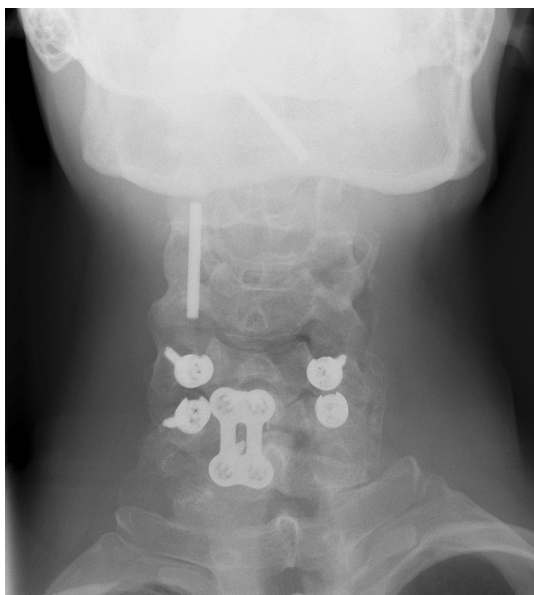
Fig. 5 X-ray cervical spine (ap view). Position of the dislodged rods in the neck and near the Foramen magnum

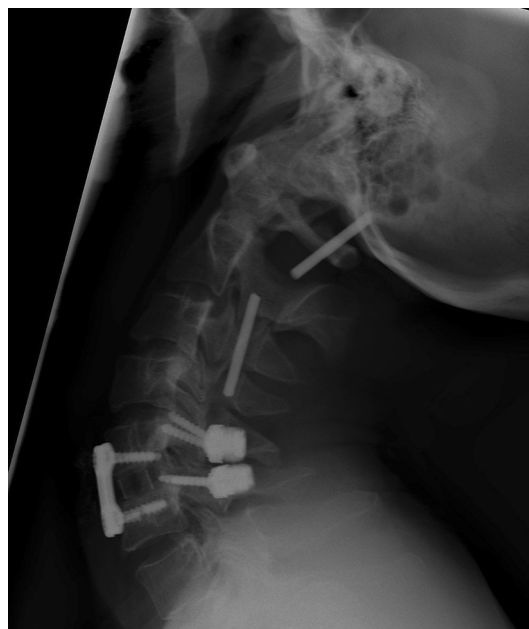
Fig. 6 X-ray cervical spine (lateral view). Position of the dislodged rods in the neck and near the Foramen magnum

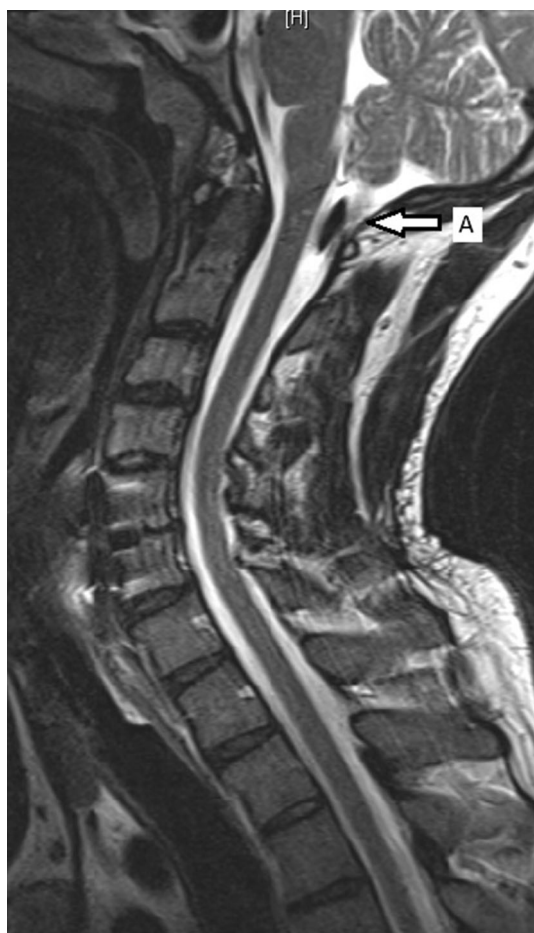
Fig. 7 MRI scan (sagittal view). Intradural position of the dislodged rod (A) at the Foramen magnum

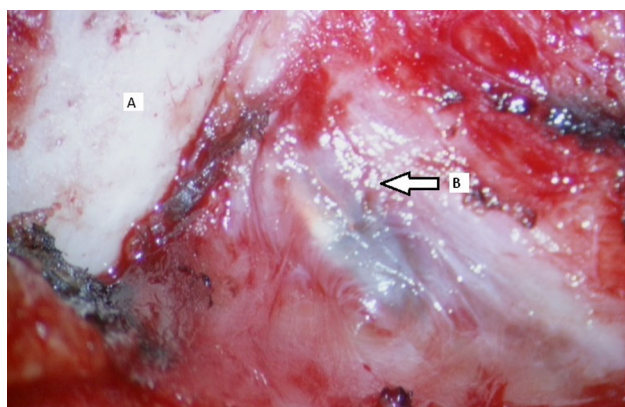
Fig. 8 Intraoperative picture. A C1 arch, B rod the rod visible through the healed dural defect

The patient was taken to theater the following day for removal of the dislodged rods. Through a midline incision cranial to the previous approach, the bony spine was exposed from C1 to C4. The right-sided rod was found in the paraspinal muscles around C2 and C3 and partially embedded into the C2 lamina; this rod was removed. The left-sided rod was visible though a partially healed dural defect between the C1 and C2 laminae, although no active CSF leak was observed (Fig. 8). A C1 laminectomy and widening of the foramen magnum were performed. The dura was opened over C1 and the rod was visible through the arachnoid layer. The arachnoid membrane was opened (Fig. 9) and the rod removed without complications. The dura was repaired and closed. The patient made an uneventful recovery remaining neurologically intact. He was reviewed in the outpatient clinic 10 days post-OP. Flexion–extension X-rays of the cervical spine obtained 3 months post-OP were entirely satisfactory as were the X-rays on his 2-year follow-up visit (Fig. 10).

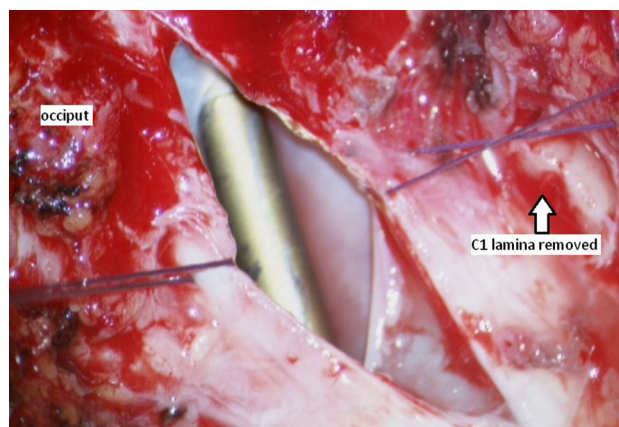
Fig. 9 Intra-operative picture. Rod positioned inside the thecal sac after opening of the meninges

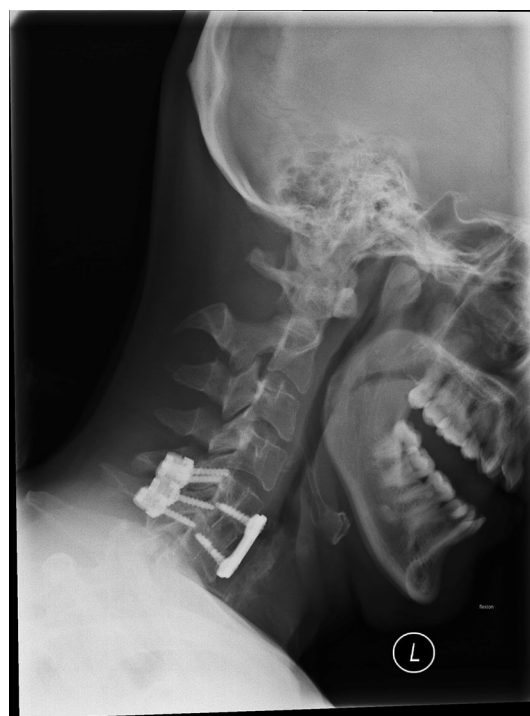
Fig. 10 Two-year follow-up X-ray (in flexion) showing the C5/6 anterior cervical discectomy and fusion with anterior plate and the lateral mass screw fixation
