## **Color Infrared Survey for Identification of Failing Onsite Treatment Systems**

William E. Roper, George Mason University and Alfonso Blanco, U.S. Environmental Protection Agency

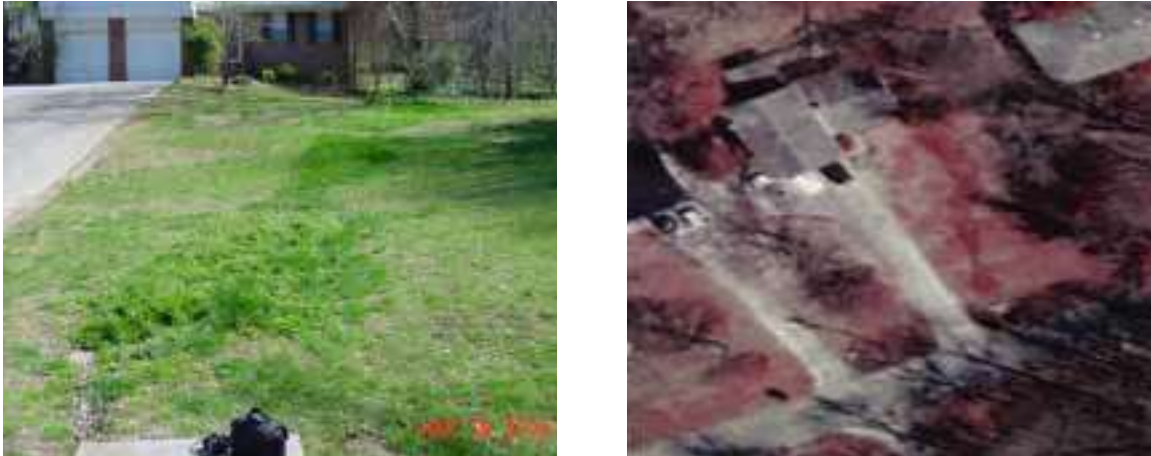
Figure 2: Signature of a failing septic system in true color at ground level and the airborne Infrared image of the same area with the darker red signature to the right of the home

The stressed vegetation pattern associated with the upward and lateral movement of the effluent wastewater reflects light differently than the adjacent vegetation on both CIR and standard photos. Because the CIR film records Near Infrared Electromagnetic wavelength (700 – 900 nm), and some visible (400 – 700 nm) wavelength the resulting images are more sensitive to reflected light. Vegetation can reflect as much as nine times as much NIR radiation as visible light, therefore, CIR photos can reveal changes in vegetation density and lushness invisible to the human eye and not recorded by conventional aerial photos. Depending on the health and age of the vegetation, it will affect the amount of CIR radiation been reflected. Healthy or productive areas are easily differentiated from dead or stressed vegetation. Similarly, water does not reflect; and the ponding of the effluent wastewater will show as particles of black or dark gray in the images. Aerial Photos taken with color infrared film will show the failures pattern, or photographic signature of an onsite treatment system as a deep red color outlining the subsurface drain-line absorption area.

dead vegetation. In addition, pooling water reflects almost none. These signatures allow an experienced analyst to identify, with a significant level of confidence, those properties with failing or stressed septic systems. It should be noted that CIR photography would only detect failures of systems where such failure results in the lateral or upward movement of effluent. CIR photography will not identify failures characterized by

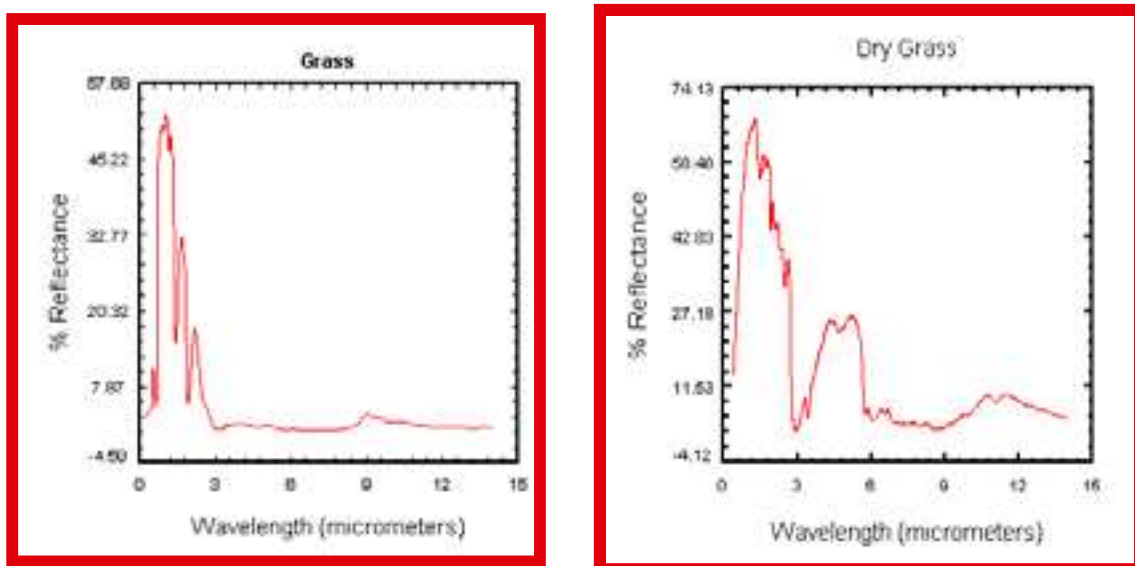
Figure 4: Comparison of spectral signatures of lush grass and dry grass from ASTER library

The data files received from JPL were opened with ENVI Version 4.0. Three different bands were chosen to analyze the image. The band numbers selected for Red was 53 Green was 19 and Blue was 31. As the pixel locations were changed on the scroll image, different spectral profiles were generated. The Spectral Signature was obtained from the ASTER Library and it is shown on Figure 4. Note the distinct difference between the lush and dry grass signatures. This characteristic is used to match signatures in the AVIRIS image to identify the areas of lush grass growth and the potential of leaking septic systems.
