## Case study: Mam Tor Landslips, UK

## Case study: The Bingham copper mine landslide and rock fall

## Case study: Debris flows and landslides in Vargas, Venezuela

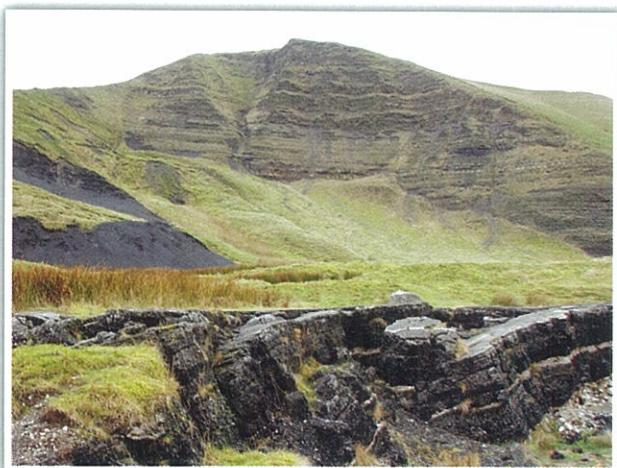
**Fig. 9.33** The slip face of the Mam Tor landslide

The large scale of the slip is evident in Fig. 9.33. Each layer of the exposed remains of the road represents a repair after a slip. At least five are visible and in places the repairs are two metres thick. Broken shale is seen in the centre left where the material is still slipping, aided by a spring, which issues where the brown vegetation is. Wet shale is very slippery, so layers above easily slide over wet layers below them. In the face of the scar, composed of thin beds of permeable sandstone and shale, small mudflows indicate where the wet shale has turned back to the mud it once was.

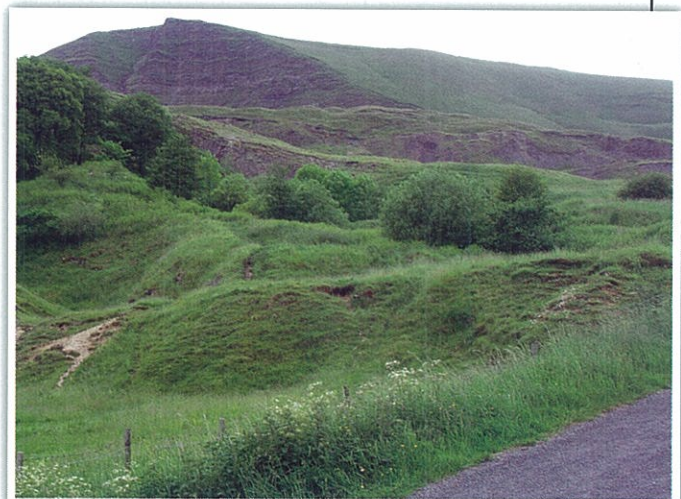
**Fig. 9.34** The steep foot of the debris flow with the scar behind it

Below the toe is a hummocky debris flow consisting of material from the landslide, which threatens to bury farm buildings in its path. The landslide and debris flow together are more than a kilometre long. The average flow movement is 250 mm per year, but is faster in wetter years. Recent research revealed that it has moved continuously by up to 500 mm per year since its formation.

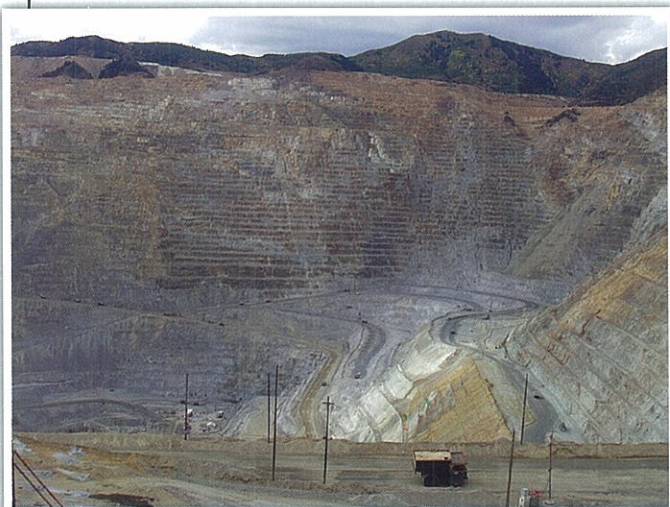
**Fig. 9.35** The 970 metres deep Bingham Canyon Copper mine before the landslide. Excavated waste is piled up in the background

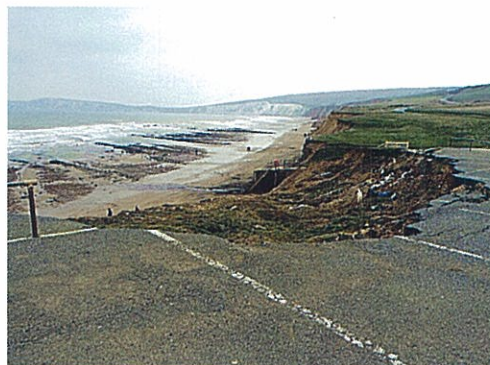
**Fig. 9.37** Mass movement destroying a car park built on sand and clay on the south coast of the UK

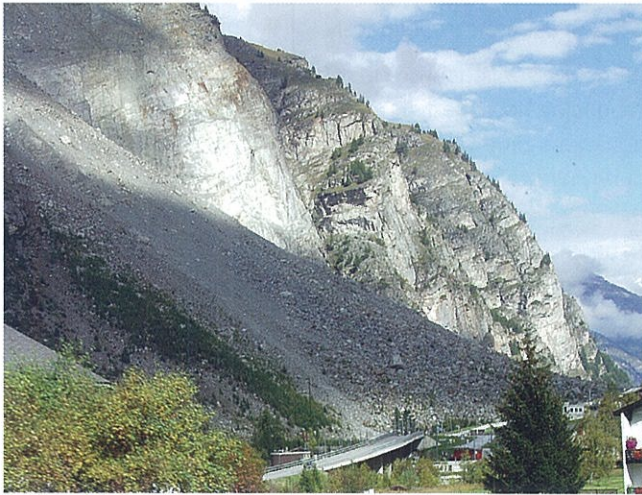
**Fig. 9.39** This landslide near Zermatt, Switzerland, blocked 100m of the road and only railway route from the main valley in 1991
