P68.40-2203-06

Remove/install		
1

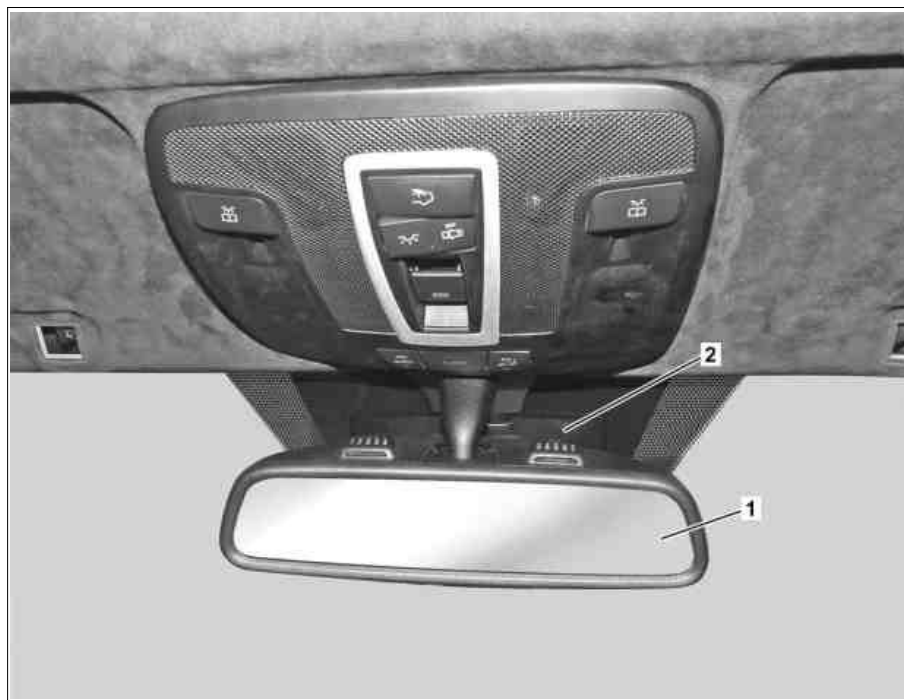
- 1 Inside rearview mirror
- 2 Cover

The separating point is located above the overhead control panel control unit (N70).	
4	Unclip cover (2)		
5	Remove rearview mirror (1)

Unclip inside rearview mirror (1) from bracket downward at an angle.	
6	Install in the reverse order		
7	Read out and erase the fault memory using Star Diagnosis		AD00.00-P-2000-04A
